Proposed Lands with Wilderness Characteristics:

Aquarius Mountains

A proposal report to the Bureau of Land Management,
Kingman Field Office, Arizona

ARIZONA WILDERNESS COALITION

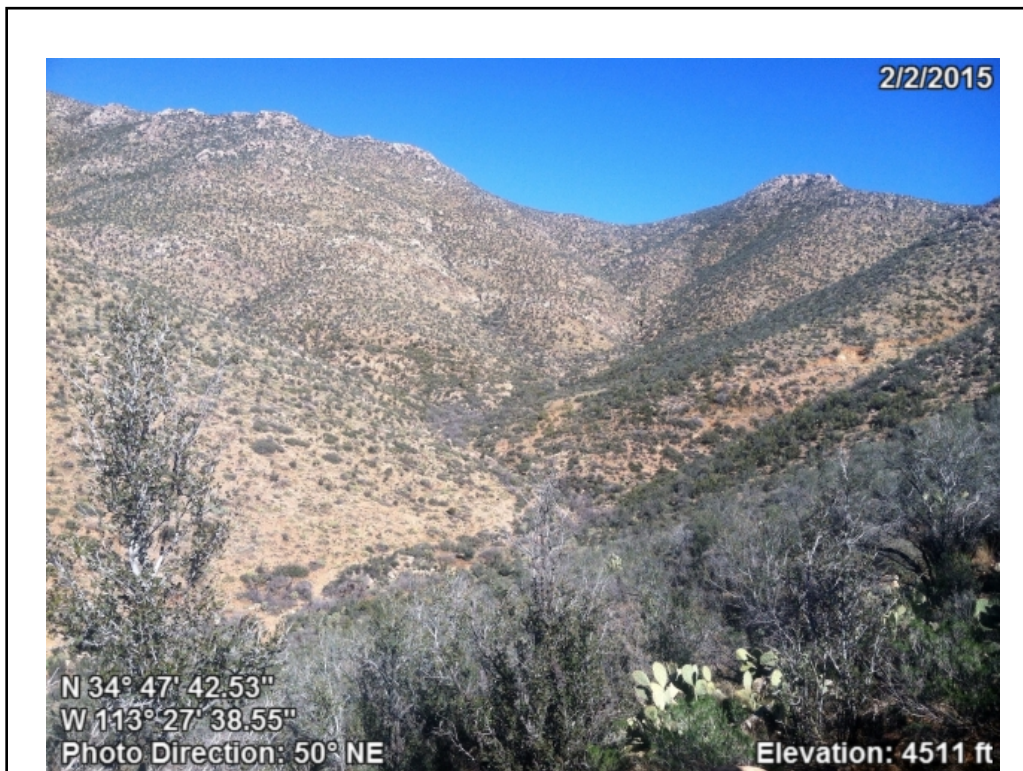
This photo, taken from waypoint 14, shows the immense mountainsides and craggy summits in the southern part of the unit. An abandoned mine prospect is in the picture, which is barely noticeable to the average visitor. The route to access the prospects no longer exists.

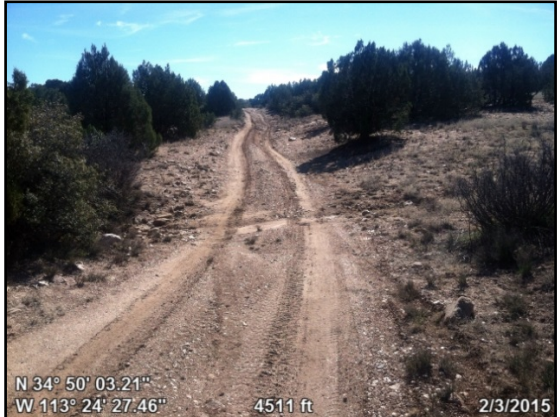
Attributes	
Title	Photopoint 001
Unit name	Aquarius Mtns
Route name	Not named
Determination	Road
Maintenance	None
Feature	Typical condition of Route/Way

Photopoint 001. Road looping into the unit.

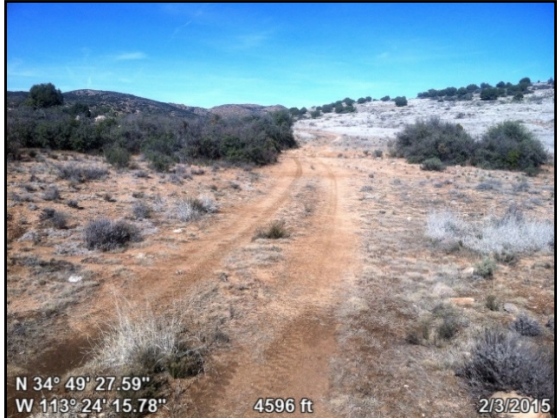
Attributes	
Title	Photopoint 002
Unit name	Aquarius Mtns
Route name	Not named
Determination	Road
Maintenance	None
Feature	Typical condition of Route/Way

Photopoint 002. This is the southern end of the Road depicted in Photopoint 1.

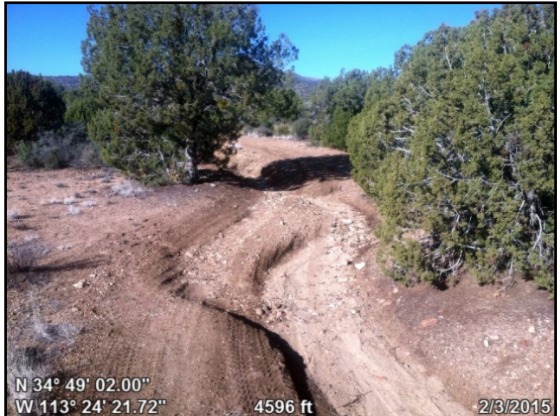
Attributes	
Title	Photopoint 003
Unit name	Aquarius Mtns
Route name	Not named
Determination	Way
Maintenance	None
Feature	Typical condition of Route/Way

Photopoint 003. A short cherrystem leading to a corral. Maintenance appeared to be imminent.

Continuing south on BLM Route 7657, Photopoint 3 shows a short cherrystem heading west into the proposed LWC unit. There is a campsite on this route, right near the main road. This cherrystem (wilderness inventory road) is actively used by ranchers and leads to a corral where there are piles of materials, apparently being prepped for corral maintenance. The cherrystem into the Aquarius Mountains unit ends at the corral and becomes a primitive route after the corral (west of the corral). Photopoint 4 shows the typical condition of the primitive route beyond the corral, which displays no

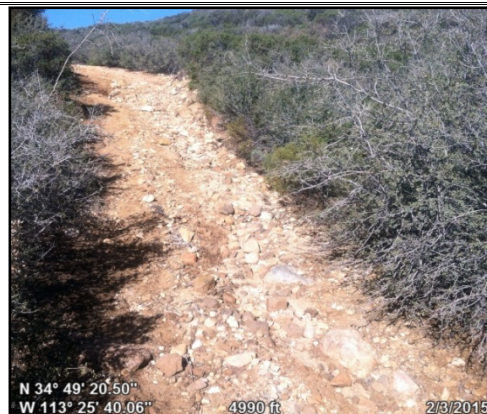
Title	Photopoint 004
Unit name	Aquarius Mtns
Route name	Not named
Determination	Way
Maintenance	None
Feature	Typical condition of Route/Way

Photopoint 004. Primitive route beyond cherrystem section.

evidence of construction or maintenance. Additionally, the primitive route corridor is extremely narrow in many places, growing in with vegetation and quite eroded. This way leads to Sam Spring, an undeveloped spring with an interesting stand of native trees surrounding it (see Photopoint 5).

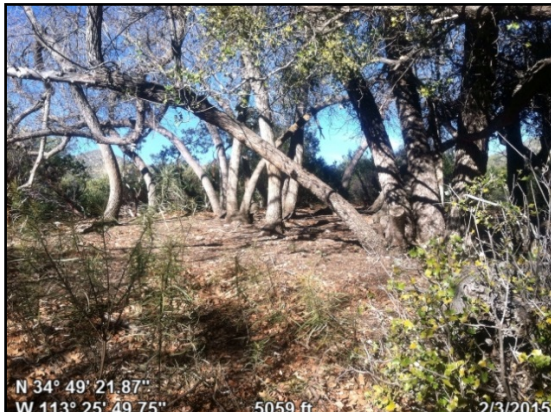
Title	Photopoint 004
Unit name	Aquarius Mtns
Route name	NA
Determination	NA
Maintenance	NA
Feature	Grove of deciduous and riparian trees surrounding natural spring.

Photopoint 005. Interesting grove of native trees surrounding Sam Spring.

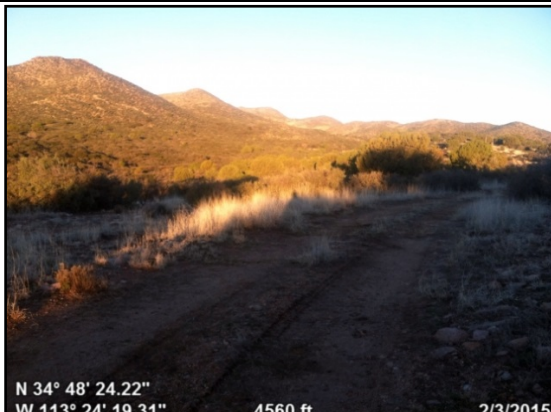
Title	Photopoint 006
Unit name	Aquarius Mtns
Route name	Not named
Determination	Way
Maintenance	None
Feature	Typical condition of Route/Way

Photopoint 006. Picture shows evidence of a lack of maintenance.

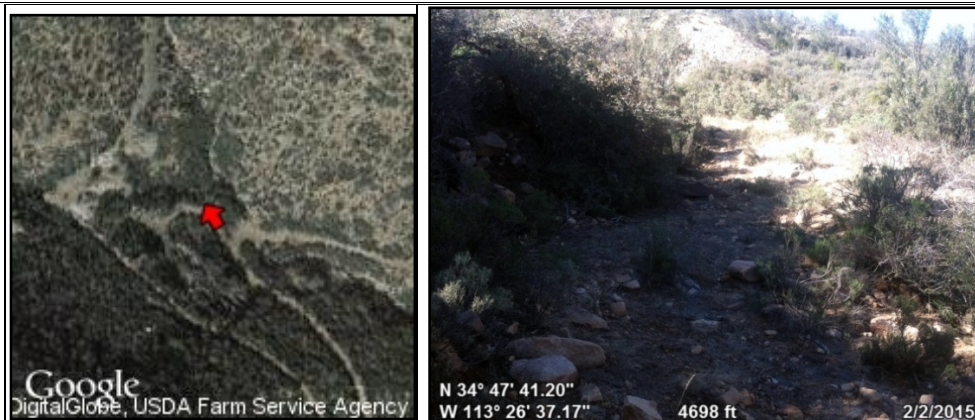
Title	Photopoint 007
Unit name	Aquarius Mtns
Route name	Not Named
Determination	Way
Maintenance	None
Feature	Typical condition of Route/Way

Photopoint 007. Rough primitive route that is revegetating.

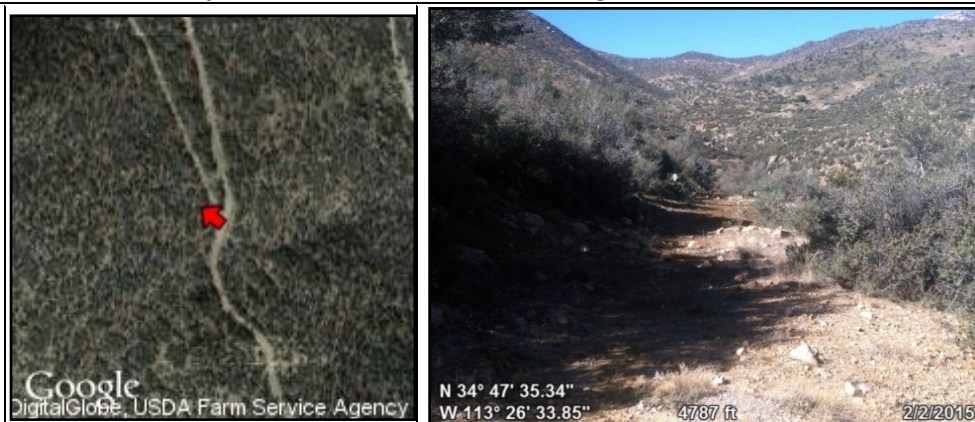
Title	Photopoint 008
Unit name	Aquarius Mtns
Route name	Not Named
Determination	Way
Maintenance	None
Feature	Typical condition of Route/Way

Photopoint 008. Primitive route leading to abandoned mine.

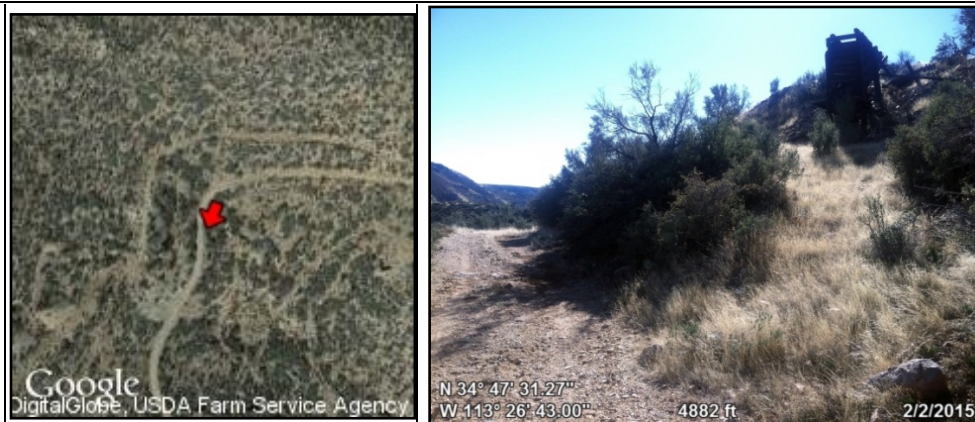
Title	Photopoint 009
Unit name	Aquarius Mtns
Route name	Not named
Determination	Way
Maintenance	Old evidence
Feature	Junction of Routes/Ways

Photopoint 009. Naturalized route below abandoned mining infrastructure.

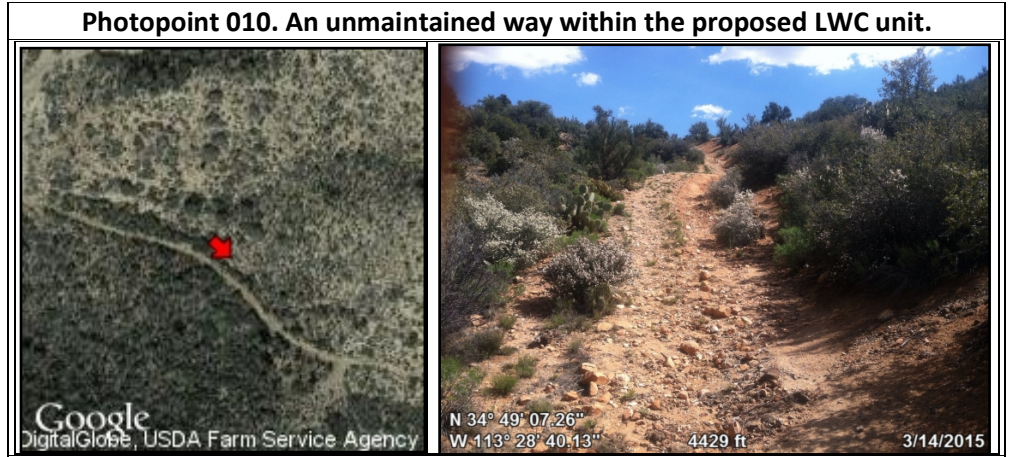
Attributes	
Title	Photopoint 010
Unit name	Aquarius Mtns
Route name	Not Named
Determination	Way
Maintenance	None
Feature	Typical condition of Route/Way

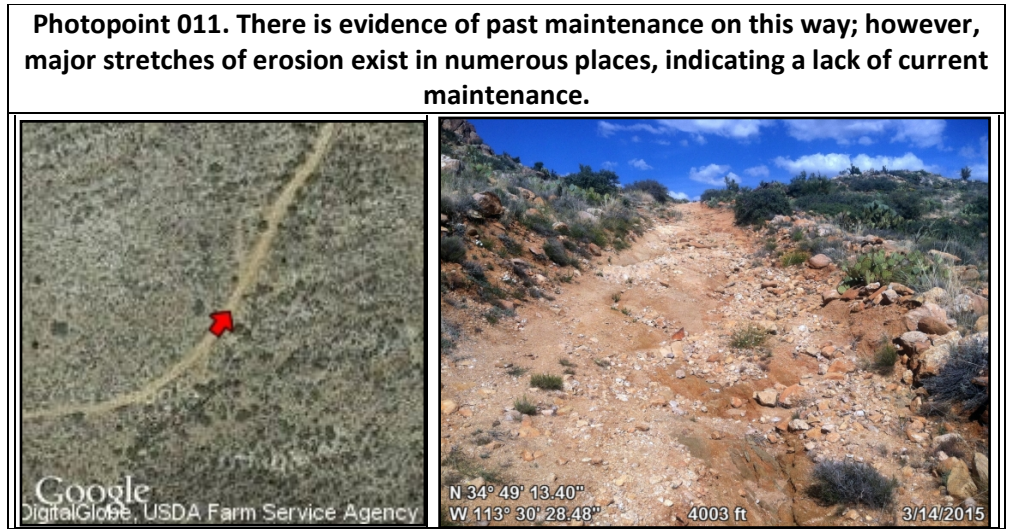
Attributes	
Title	Photopoint 011
Unit name	Aquarius Mtns
Route name	BLM Route 7659
Determination	Way
Maintenance	None
Feature	Erosion

Returning to BLM Route 7658, Photopoint 11 depicts a primitive route (BLM Route 7659) heading into the Aquarius Mountain Proposed LWC unit. Although this way was constructed and eventually leads to

a well and stock tank, it shows no apparent evidence of recent maintenance, and consequently is not a wilderness inventory road as defined by BLM Manual 6310. Photopoints 12 and 13 also show images of BLM Route 7659, and act as further evidence of erosion and a general lack of maintenance along this way. Photopoint 14 displays an image of a primitive route stemming from BLM Route 7659, heading east. This unnamed way may have been constructed, but contains no apparent evidence of maintenance, and its purpose is unknown. Photopoint 15 depicts a junction of two ways. Photopoint 15 serves as evidence that the way seen in Photopoint 14 (way on left in Photopoint 15) gets fainter as it travels east. The primitive route on the right in the photograph for Photopoint 15 shows no evidence that it is receiving maintenance, and it is a way as well. The way on the right continues down into a wash. Waypoint 10 marks the location where the BLM route inventory displays a route going southwest down a wash. There was no evidence of vehicular use of this wash, and even the BLM route inventory data calls this a “cattle trail”.

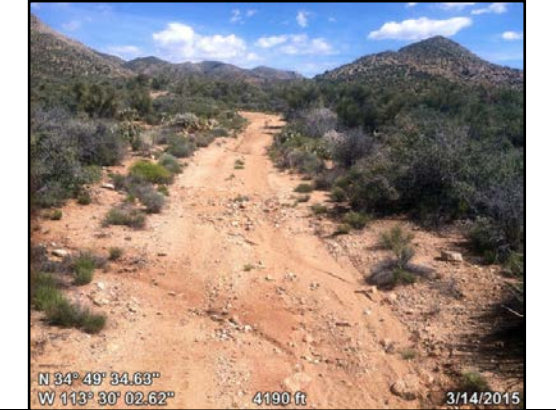
Attributes	
Title	Photopoint 014
Unit name	Aquarius Mtns
Route name	Not named
Determination	Way
Maintenance	None
Feature	Typical condition of Route/Way

Photopoint 014. Another primitive route that stems from BLM Route 7659.

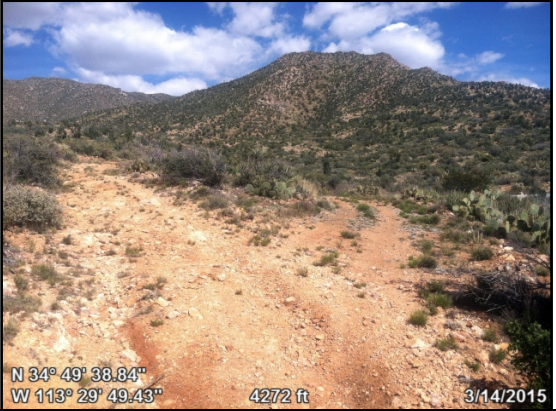
Attributes	
Title	Photopoint 015
Unit name	Aquarius Mtns
Route name	Not named
Determination	Way
Maintenance	None
Feature	Typical condition of Route/Way

Photopoint 015. A junction of two ways.

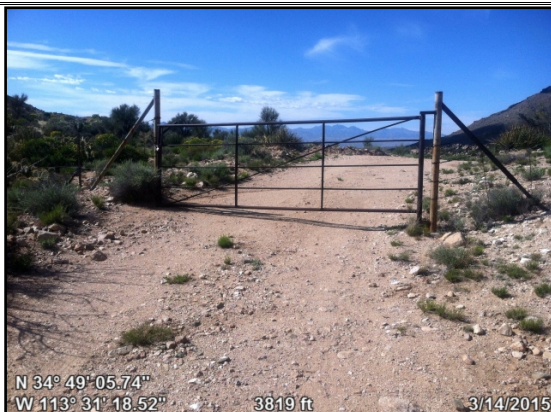
Title	Photopoint 016
Unit name	Aquarius Mtns
Route name	Not named
Determination	Road
Maintenance	Recent blade
Feature	Closure point

Photopoint 016. Point of closure on this cherrystemmed road.

Returning to BLM Route 7658 and traveling west, Photopoint 16 is the next point of interest. Photopoint 16 displays an image of an unnamed route that has closed off to public use at this locked gated. Photopoint 17 shows the condition of this road beyond the gate. The wilderness inventory road displayed in Photopoints 16 and 17 was constructed and has received a recent blade. This road appears to lead to a ranch house and corral. Because of the maintenance and regular use we have cherrystemmed the route and excluded the compound from because of impacts to naturalness.

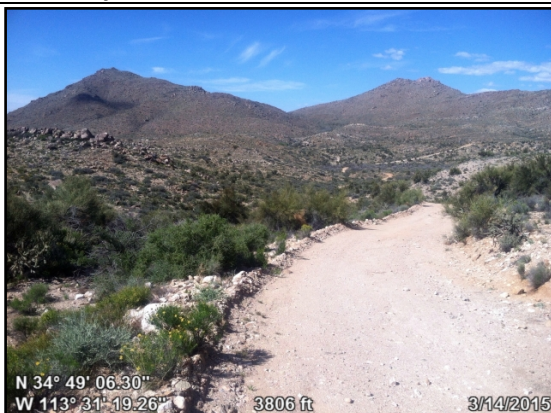
Title	Photopoint 017
Unit name	Aquarius Mtns
Route name	Not named
Determination	Road
Maintenance	Recent blade
Feature	Typical condition of Route/Way

Photopoint 017. A wilderness inventory road with obvious maintenance.

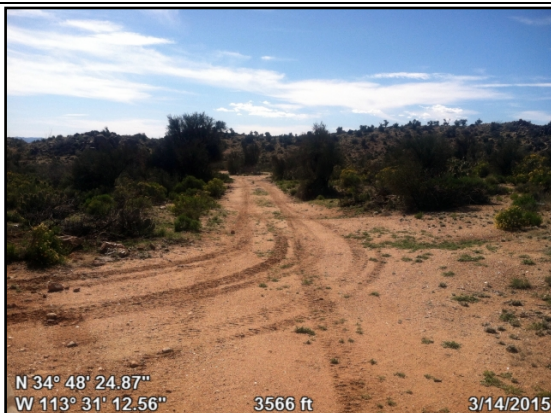
Title	Photopoint 018
Unit name	Aquarius Mtns
Route name	Not Named
Determination	Way
Maintenance	None
Feature	Junction of Routes/Ways

Photopoint 018. A short way leading to a campsite.

BLM Route 7658 continues as the Aquarius Mountains Proposed LWC unit boundary, and turns to the south. Photopoint 18 displays a short spur primitive route that leads to a campsite. As the photo shows, this way contains no evidence of construction; and is being kept open solely by the passage of vehicles. Due to a lack of evidence of mechanical maintenance, this is a primitive route, not a road. At Waypoint 11, the LWC unit boundary becomes the BLM property bound, and turns to the west. Photopoint 19 depicts a primitive route that eventually enters the Aquarius Mountains LWC unit from the south. As the photo illustrates, this is a way that shows no evidenced of construction or maintenance; making it a primitive route, not a wilderness inventory road.

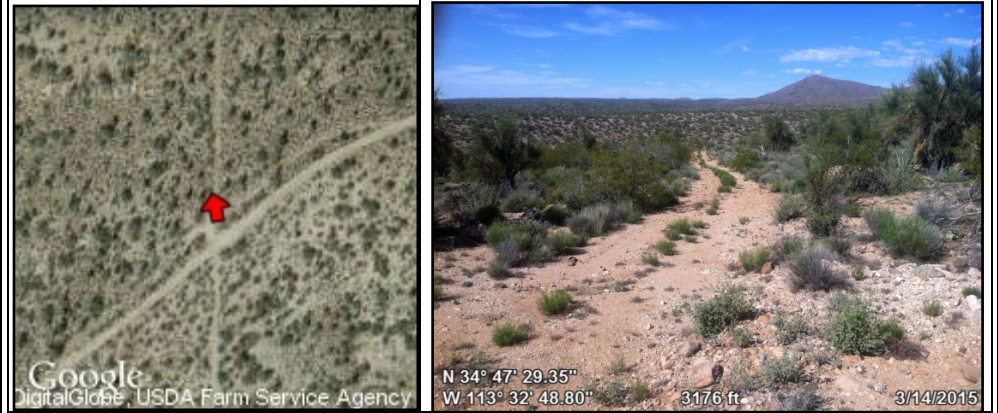
Attributes	
Title	Photopoint 019
Unit name	Aquarius Mtns
Route name	Not named
Determination	Way
Maintenance	None
Feature	Typical condition of Route/Way

Photopoint 019. This primitive route eventually zigzags in and out of the unit for a short distance in the far southwestern unit corner.
