Proposed Lands with Wilderness Characteristics:

Joshua Tree Forest

A proposal report to the Bureau of Land Management,  
Kingman Field Office, Arizona

ARIZONA WILDERNESS COALITION

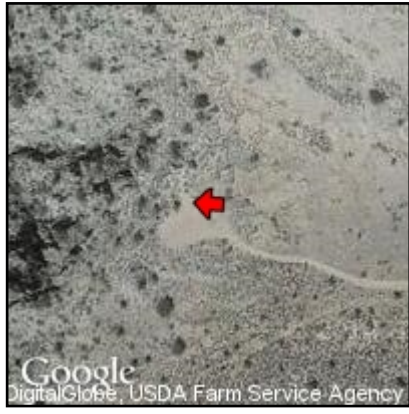
Attributes	
Title	Photopoint 001
Unit name	Joshua Tree
Route name	Not Named
Determination	Way
Maintenance	None
Feature	End of route at campsite

**Photopoint 001. Looking west from a viewpoint.**

maintained solely by the passage of vehicles. This way contains no evidence that it was constructed; no sign of mechanical maintenance; and ends at an out-of-service water catchment. The fine soils found in this area are highly susceptible to wind-blown erosion with vehicle use. If the dilapidated infrastructure were to be removed, and the route closed to vehicle traffic; the woodland basin could be restored to a more wild and pristine nature. Photopoint 4 was taken of the same primitive route farther south. This photo serves as further evidence that this way is not receiving maintenance. Much of the way is significantly eroded. There is a parallel old primitive route that washed out, and the currently used track is on its way to the same state. Photopoint 5 was taken farther south along this route. Photopoint 5 depicts a dilapidated water catchment tank. Photopoint 6 was taken just past this unused infrastructure and shows yet another photograph of this unmaintained way. Photopoint 7 displays a primitive route stemming to the west of the previously described way. Photopoint 7 shows that there is no evidence of construction of this way, and it is not being maintained. This primitive route ends at a campsite and a view towards Lake Mead (Photopoint 8).

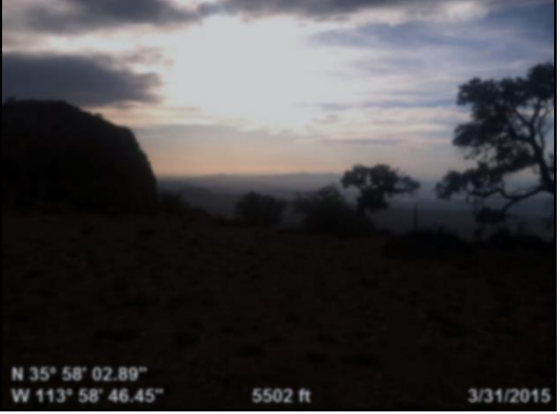
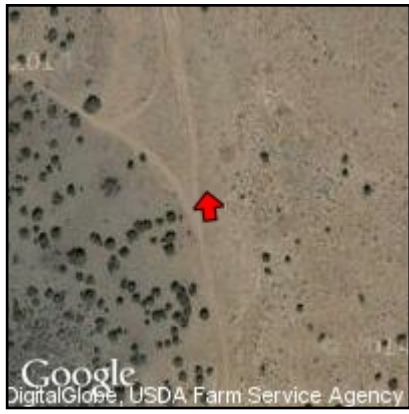
Attributes	
Title	Photopoint 002
Unit name	Joshua Tree Forest
Route name	BLM 7099
Determination	Way
Maintenance	None
Feature	Typical condition of Route/Way

**Photopoint 002. An unmaintained primitive route.**

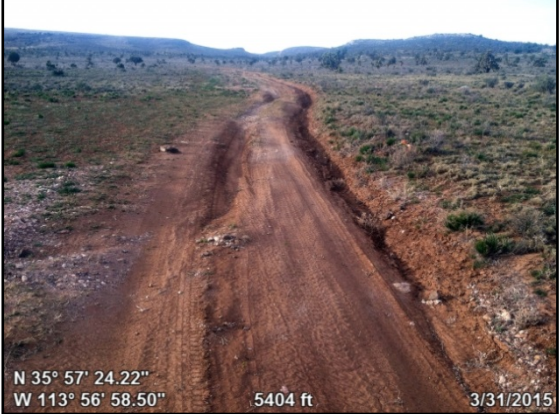
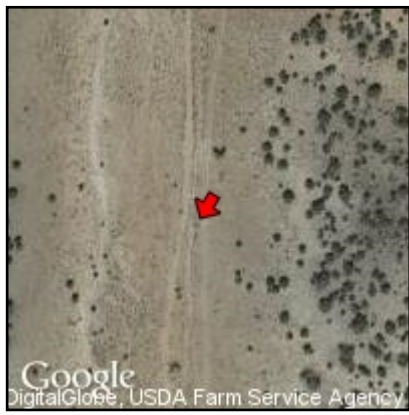
Attributes	
Title	Photopoint 003
Unit name	Joshua Tree Forest
Route name	Not named
Determination	Way
Maintenance	None
Feature	Typical condition of Route/Way

**Photopoint 003. A way that ends at a dilapidated water catchment.**

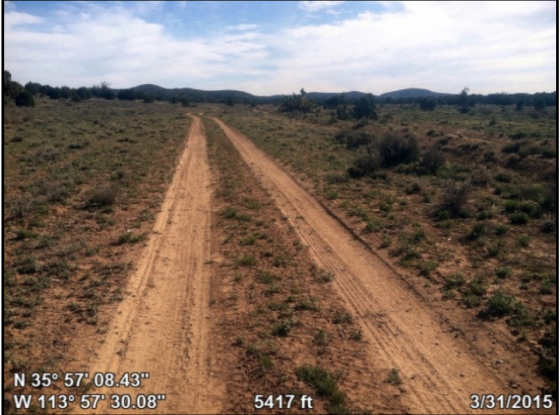
Attributes	
Title	Photopoint 004
Unit name	Joshua Tree Forest
Route name	Not Named
Determination	Way
Maintenance	None
Feature	Erosion

N 35° 57' 08.43"  
W 113° 57' 30.08"      5417 ft      3/31/2015

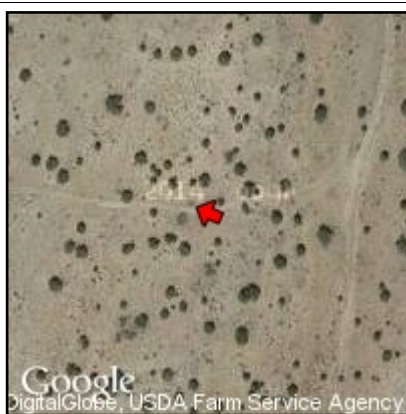
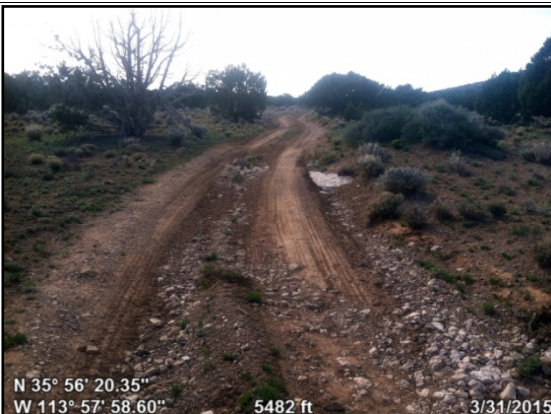
Title	Photopoint 007
Unit name	Joshua Tree Forest
Route name	Not Named
Determination	Way
Maintenance	None
Feature	Typical condition of Route/Way

**Photopoint 007. Another unnamed, unmaintained way.**

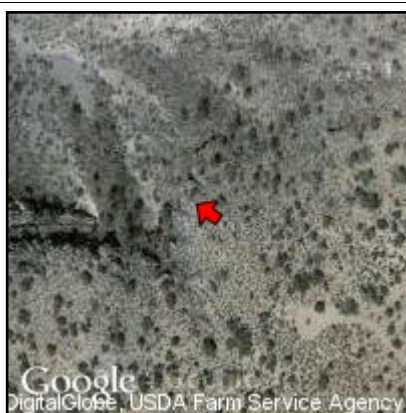
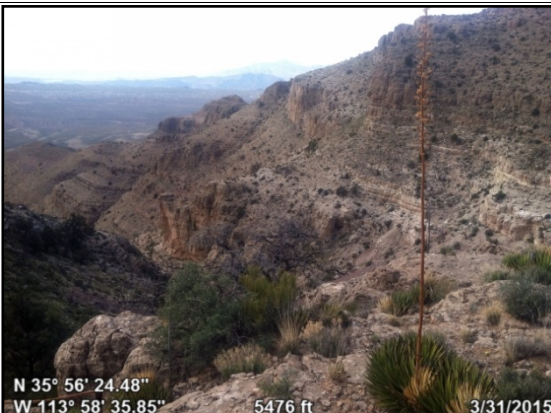
Title	Photopoint 008
Unit name	Joshua Tree Forest
Route name	N/A
Determination	N/A
Maintenance	N/A
Feature	Scenic/Landscape

**Photopoint 008. The view at the end of the way.**

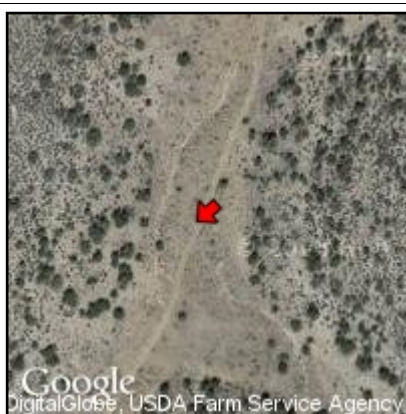
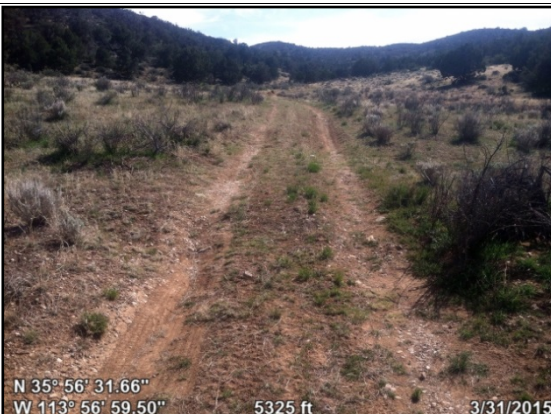
Title	Photopoint 009
Unit name	Joshua Tree Forest
Route name	BLM Route 7099
Determination	Way
Maintenance	None
Feature	Typical condition of Route/Way

**Photopoint 009. Primitive route that leads to an AZ Game and Fish wildlife water catchment.**

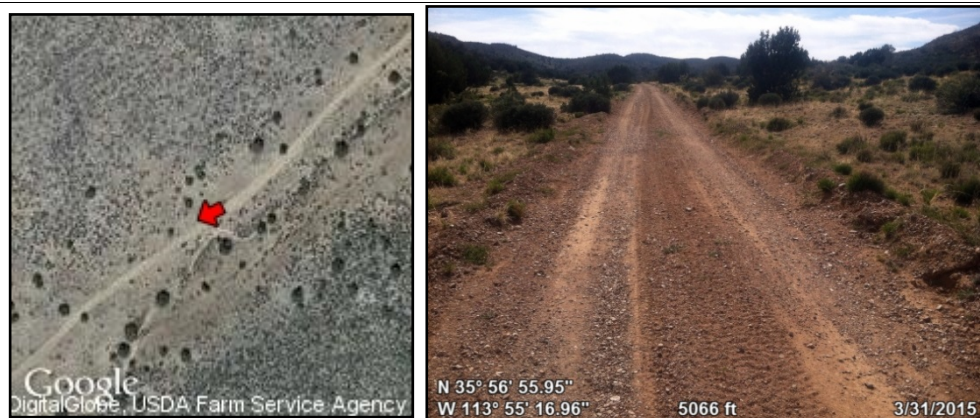
Title	Photopoint 010
Unit name	Joshua Tree Forest
Route name	BLM Route 7084
Determination	Road
Maintenance	Recent blade
Feature	Typical condition of Route/Way

**Photopoint 010. A wilderness inventory road along the LWC unit eastern bound.**

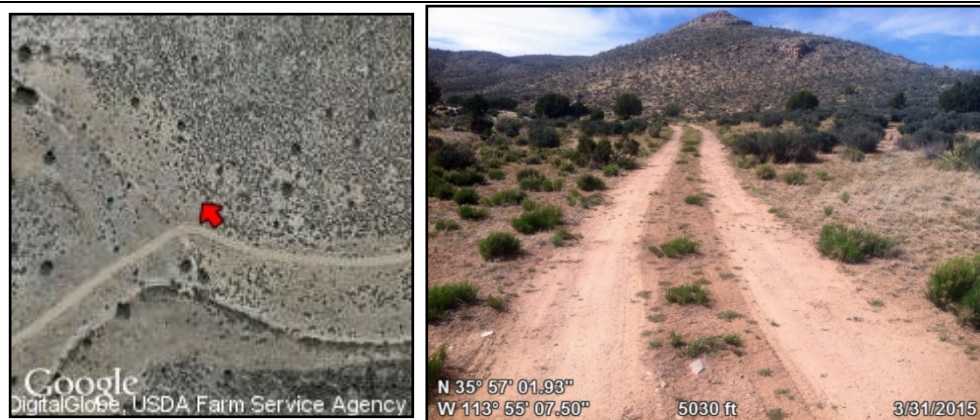
Title	Photopoint 011
Unit name	Joshua Tree Forest
Route name	BLM Route 7084
Determination	Road
Maintenance	Likely if needed
Feature	Typical condition of Route/Way

**Photopoint 011. User-created bypass of a recently washed out gully along the wilderness inventory road.**

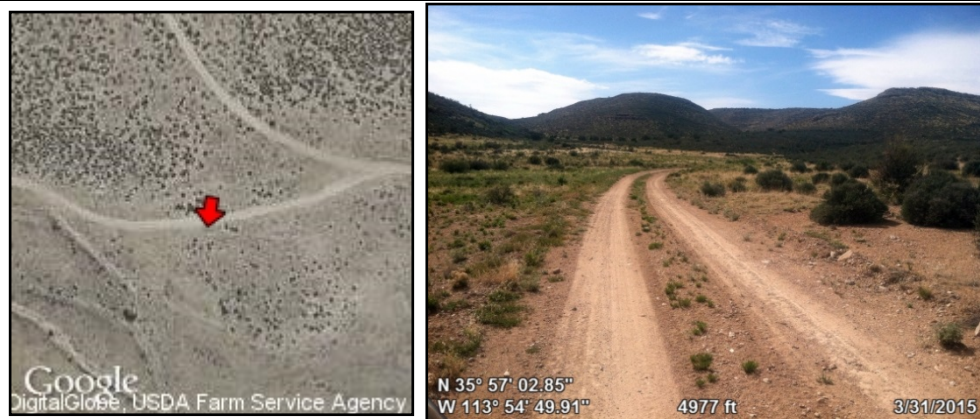
Title	Photopoint 012
Unit name	Joshua Tree Forest
Route name	BLM Route 7084
Determination	Road
Maintenance	Recent blade
Feature	Typical condition of Route/Way

**Photopoint 012. Another image of the wilderness inventory road.**

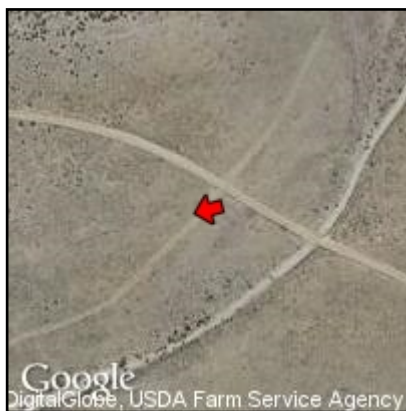
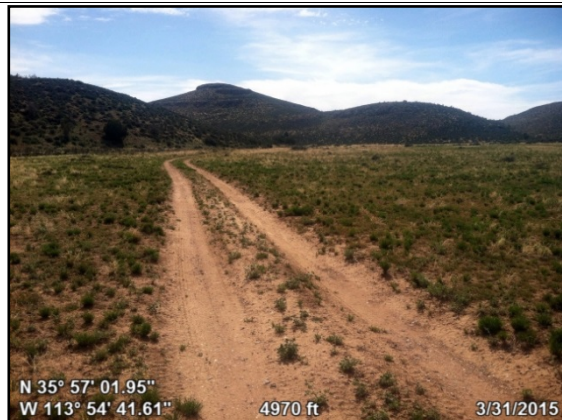
Title	Photopoint 013
Unit name	Joshua Tree Forest
Route name	Not named
Determination	Way
Maintenance	None
Feature	Typical condition of Route/Way

**Photopoint 013. An unnamed primitive route entering the eastern unit boundary.**

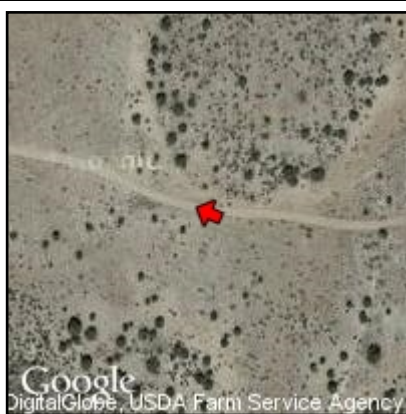
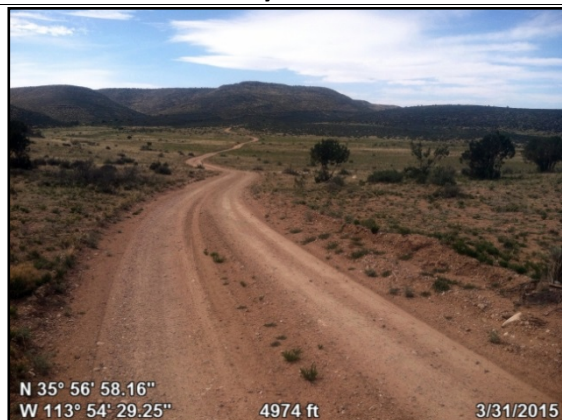
Title	Photopoint 014
Unit name	Joshua Tree
Route name	BLM Route 7097
Determination	Road
Maintenance	Recent blade
Feature	Typical condition of Route/Way

**Photopoint 014. Wilderness inventory road.**

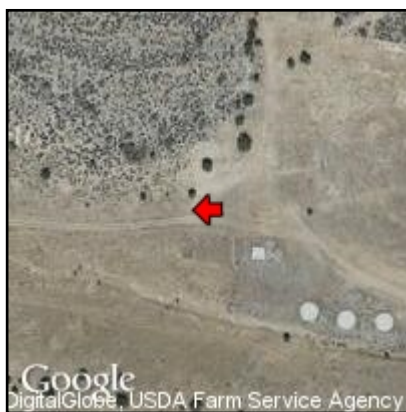
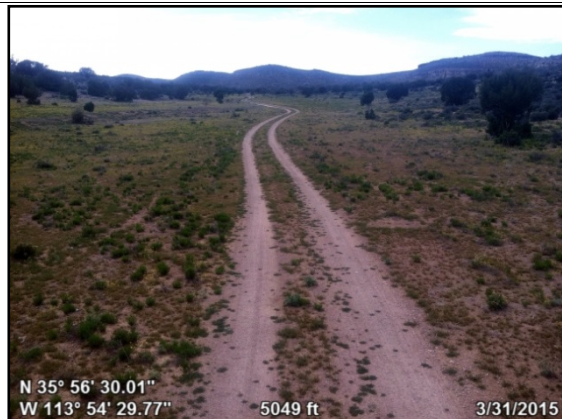
Title	Photopoint 015
Unit name	Joshua Tree Forest
Route name	BLM Route 7082
Determination	Way
Maintenance	None
Feature	Typical condition of Route/Way

**Photopoint 015. An unmaintained way that leads to undeveloped private land.**

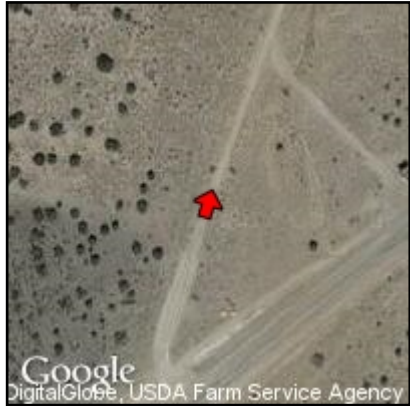
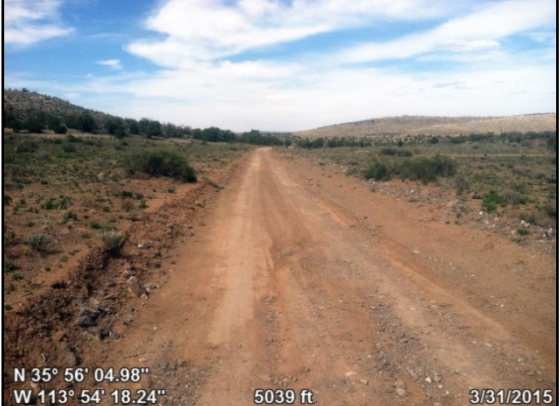
Attributes	
Title	Photopoint 016
Unit name	Joshua Tree Forest
Route name	BLM Route 7097
Determination	Road
Maintenance	Recent blade
Feature	Typical condition of Route/Way

**Photopoint 016. Wilderness inventory road along the LWC unit eastern bound.**

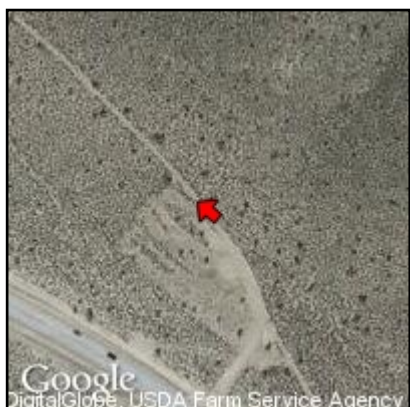
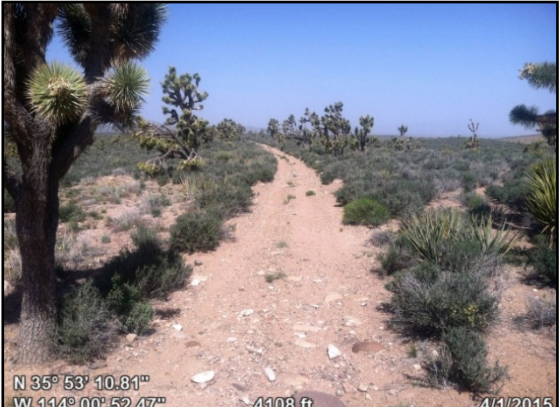
Attributes	
Title	Photopoint 018
Unit name	Joshua Tree Forest
Route name	BLM Route 7051
Determination	Way
Maintenance	None
Feature	Typical condition of Route/Way

**Photopoint 018. A narrow primitive route that appears to be kept open solely by the passage of vehicles.**

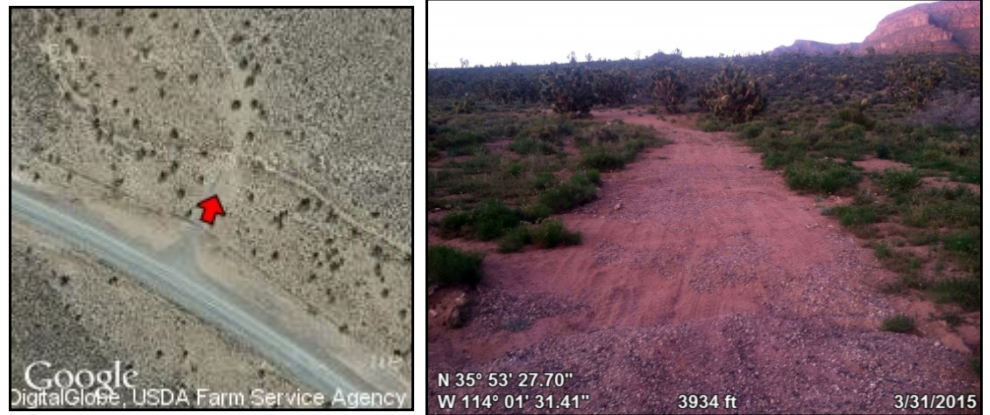
Title	Photopoint 019
Unit name	Joshua Tree Forest
Route name	Not named
Determination	Way
Maintenance	None
Feature	Typical condition of Route/Way

**Photopoint 019. A way heading to the northwest from Diamond Bar Road along the southern LWC unit boundary.**

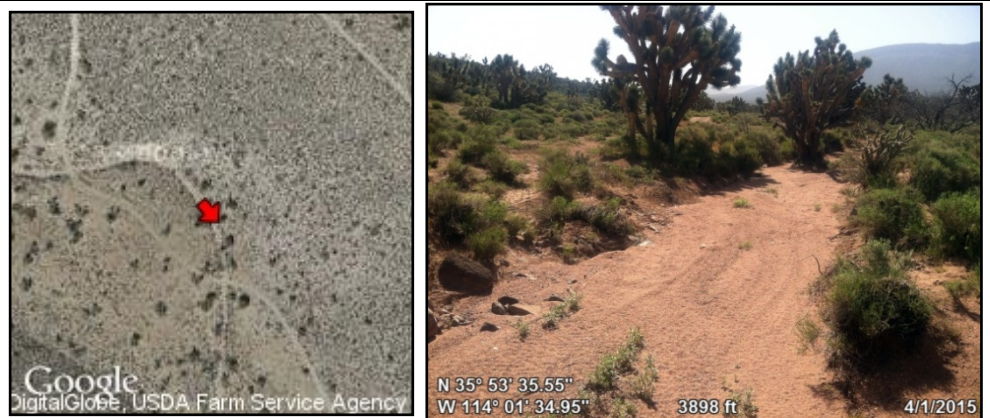
Title	Photopoint 020
Unit name	Joshua Tree Forest
Route name	Not Named
Determination	Way
Maintenance	None
Feature	Trampling of vegetation to access wash

**Photopoint 020. A user-created primitive route.**

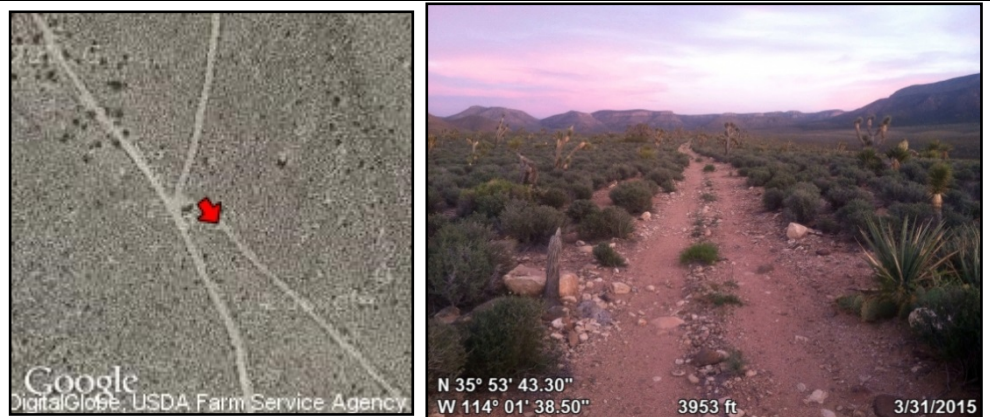
Title	Photopoint 021
Unit name	Joshua Tree Forest
Route name	BLM Route 7051
Determination	Way
Maintenance	None
Feature	Typical condition of Route/Way

**Photopoint 021. A way within the southwestern part of the unit. This way is clearly not being maintained nor does it access any infrastructure.**

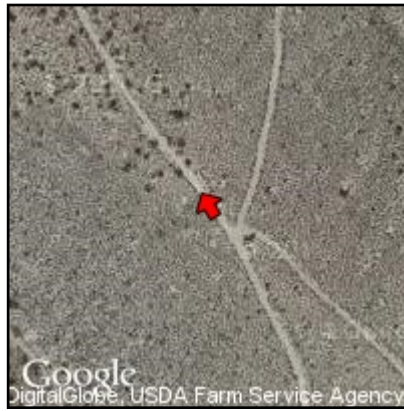
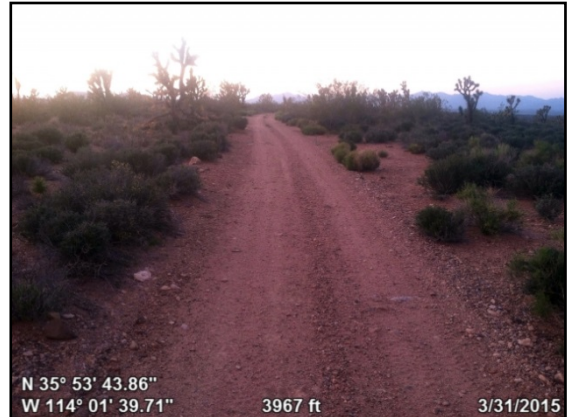
Attributes	
Title	Photopoint 022
Unit name	Joshua Tree Forest
Route name	BLM Route 7051
Determination	Way
Maintenance	None
Feature	Typical condition of Route/Way

**Photopoint 022. An smooth section of BLM Route 7051, which is used almost exclusively by ATV's. The Friends of the Joshua Tree Forest have identified increasing ATV traffic as a threat to the forest and the ACEC.**

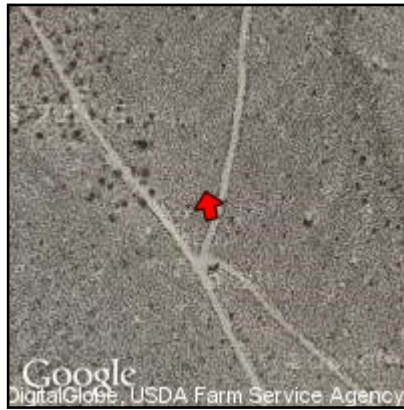
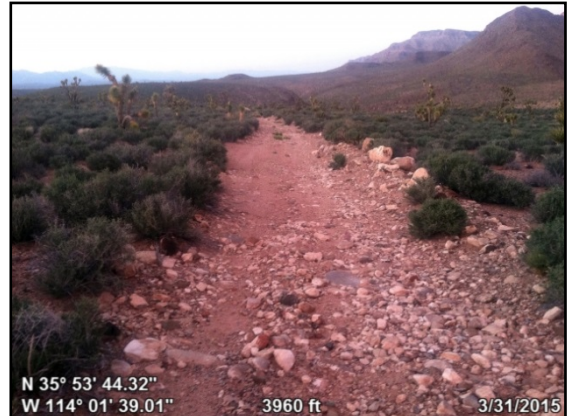
Attributes	
Title	Photopoint 023
Unit name	Joshua Tree Forest
Route name	Not named
Determination	Way
Maintenance	Old evidence
Feature	Typical eroded condition of Route/Way

**Photopoint 023. A primitive route looking north.**

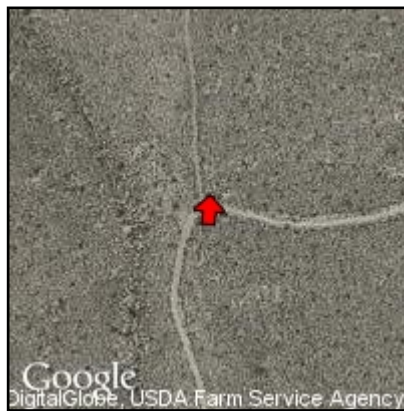
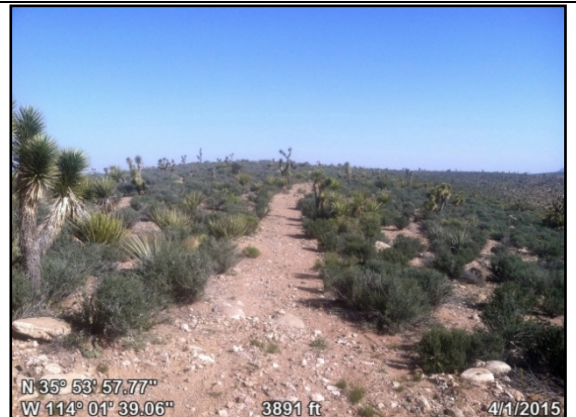
Attributes	
Title	Photopoint 024
Unit name	Joshua Tree Forest
Route name	Not named
Determination	Way
Maintenance	None
Feature	Typical condition of Route/Way

**Photopoint 024. A narrow primitive route only four to six feet wide.**

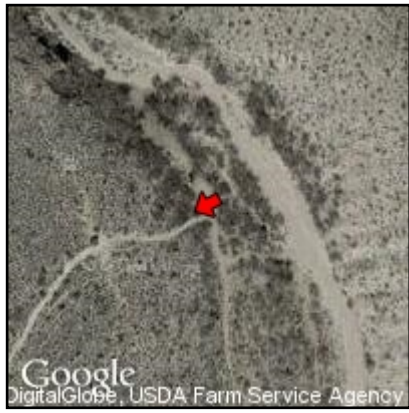
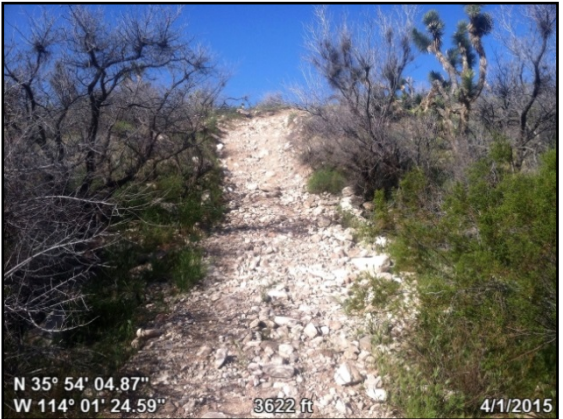
Attributes	
Title	Photopoint 027
Unit name	Joshua Tree Forest
Route name	BLM Route 7089
Determination	Way
Maintenance	None
Feature	Typical condition of Route/Way

**Photopoint 027. An unmaintained wash route below Grapevine Windmill that dead ends at Lake Mead NRA, where it is closed to motorized travel.**

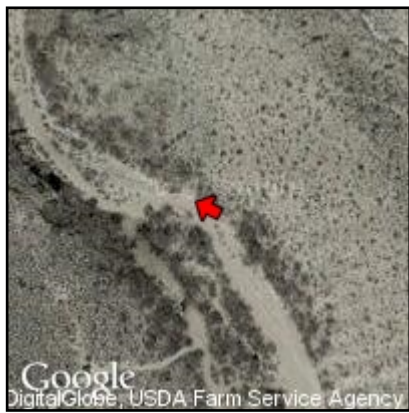
Title	Photopoint 028
Unit name	Joshua Tree
Route name	BLM Route 7093
Determination	Way
Maintenance	None
Feature	Typical condition of Route/Way

**Photopoint 028. Another unmaintained primitive route.**

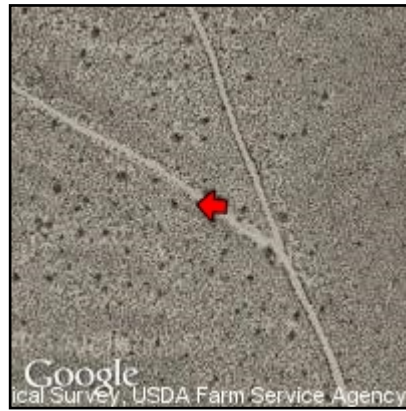
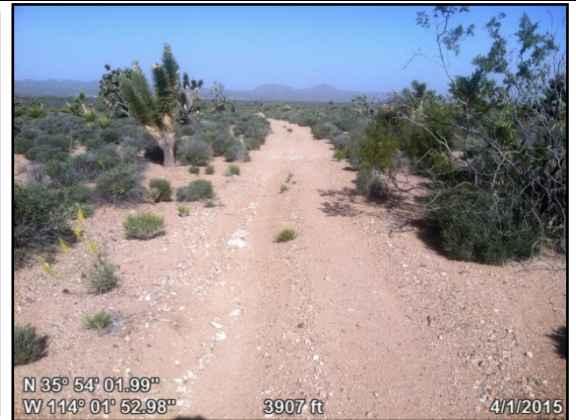
Title	Photopoint 029
Unit name	Joshua Tree Forest
Route name	BLM Route 7051
Determination	Way
Maintenance	None
Feature	Typical condition of Route/Way

**Photopoint 029. Looking north up BLM 7051, which is not maintained.  
Almost all traffic consists of ATV's.**

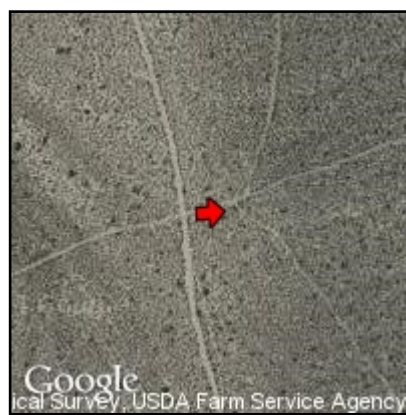
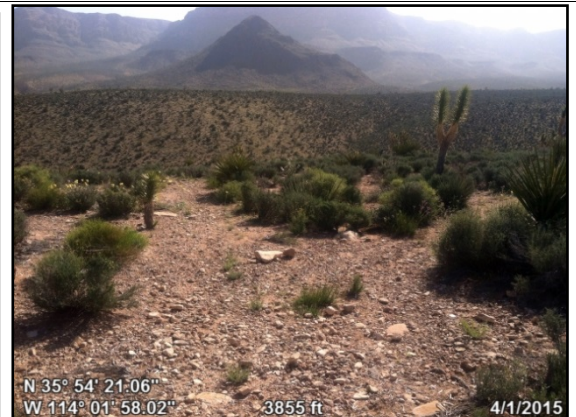
Title	Photopoint 030
Unit name	Joshua Tree Forest
Route name	Not Named
Determination	Reclaimed
Maintenance	None
Feature	Revegetated

**Photopoint 030. There are three ways that leave from this point. All are heavily  
revegetated with native plants, are completely unused, and fading into  
naturalness.**

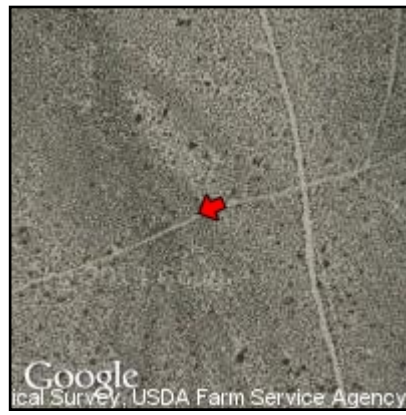
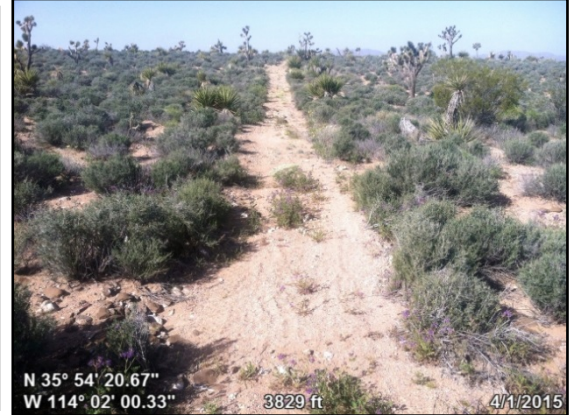
Title	Photopoint 032
Unit name	Joshua Tree Forest
Route name	Not Named
Determination	Way
Maintenance	None
Feature	Typical condition of Route/Way

**Photopoint 032. This way is revegetating and gets very scant use.**

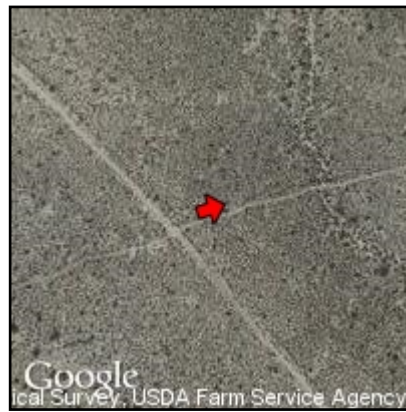
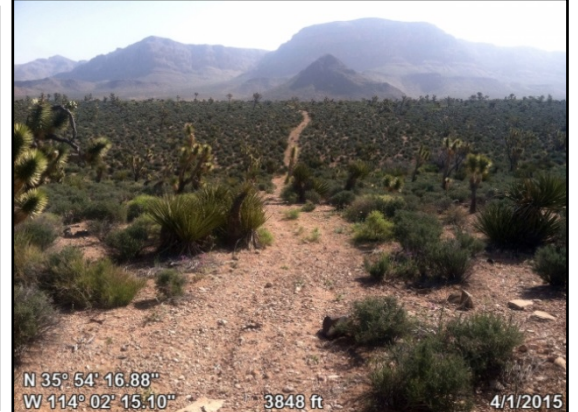
Title	Photopoint 033
Unit name	Joshua Tree Forest
Route name	Not Named
Determination	Way
Maintenance	None
Feature	Revegetating

**Photopoint 033. This primitive route is kept open solely by the passage of occasional recreational vehicles.**

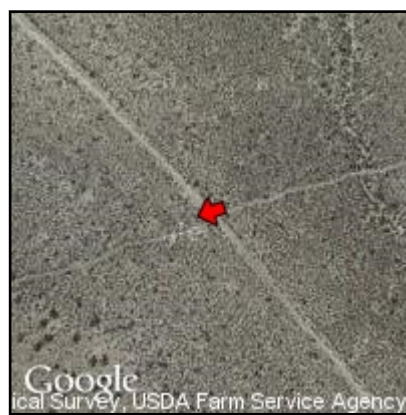
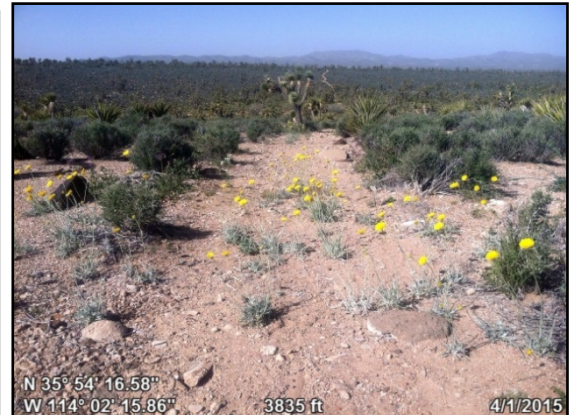
Attributes	
Title	Photopoint 034
Unit name	Joshua Tree Forest
Route name	Not named
Determination	Way
Maintenance	None
Feature	Typical condition of Route/Way

**Photopoint 034. This unnamed way is kept open solely by the passage of recreational vehicles.**

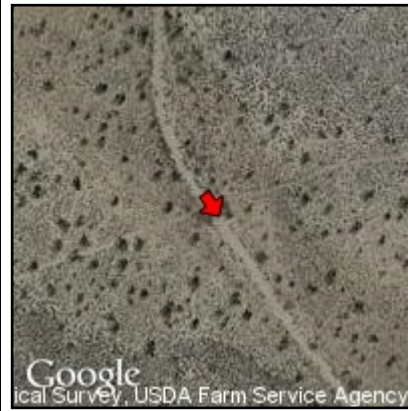
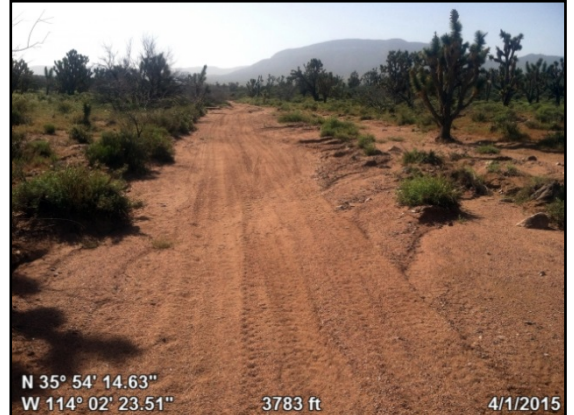
Attributes	
Title	Photopoint 035
Unit name	Joshua Tree Forest
Route name	Not named
Determination	Way
Maintenance	None
Feature	Typical condition of Route/Way

**Photopoint 035. This primitive route is kept open solely by the passage of recreational vehicles; if it is ever even used.**

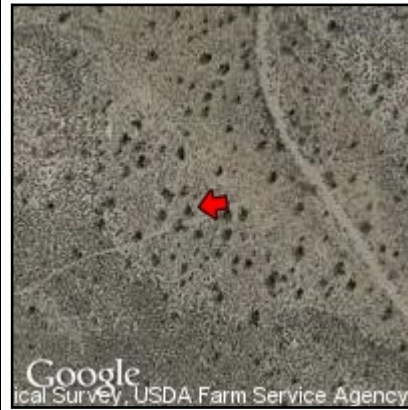
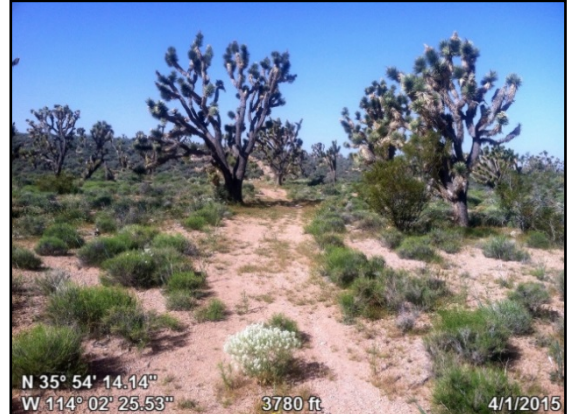
Attributes	
Title	Photopoint 036
Unit name	Joshua Tree Forest
Route name	BLM Route 7095
Determination	Way
Maintenance	None
Feature	Typical condition of Route/Way

**Photopoint 036. This revegetating way is hardly ever used.**

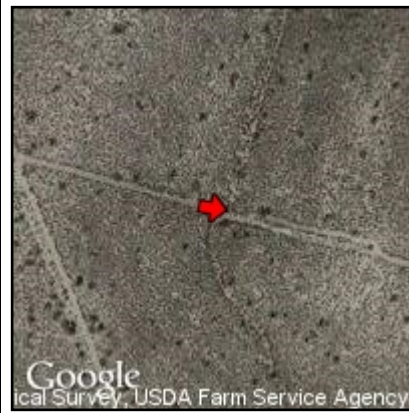
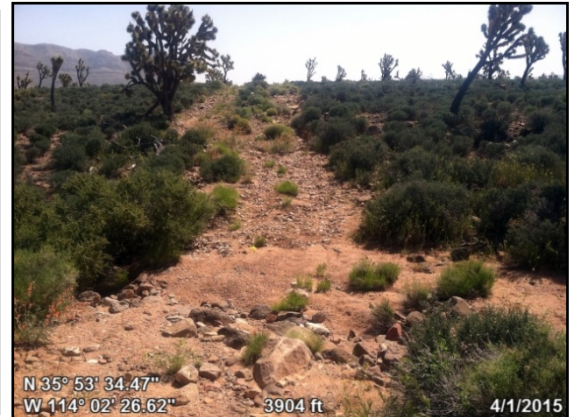
Attributes	
Title	Photopoint 037
Unit name	Joshua Tree Forest
Route name	Not named
Determination	Revegetating Way
Maintenance	None
Feature	Erosion and revegetating tracks

**Photopoint 037. This primitive route is clearly not being maintained, and will be reclaimed by nature quite soon.**

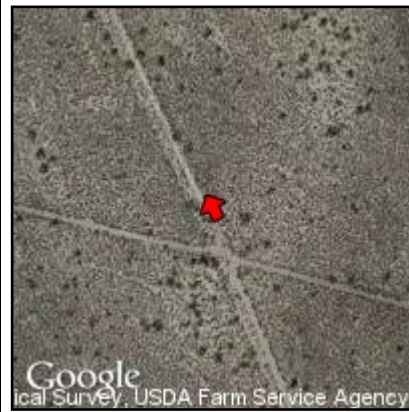
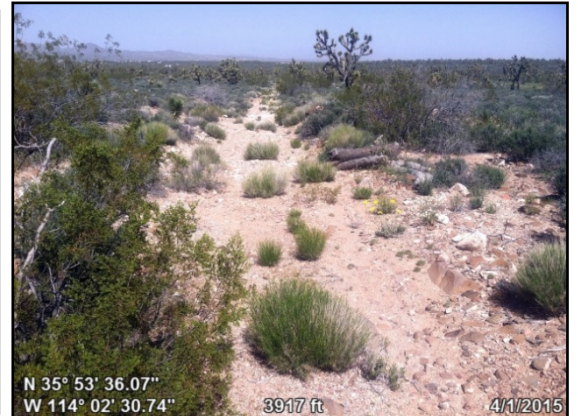
Attributes	
Title	Photopoint 039
Unit name	Joshua Tree Forest
Route name	Not named
Determination	Road
Maintenance	Old evidence
Feature	Typical condition of Route/Way

**Photopoint 039. Wilderness inventory road that also contains a waterline.**

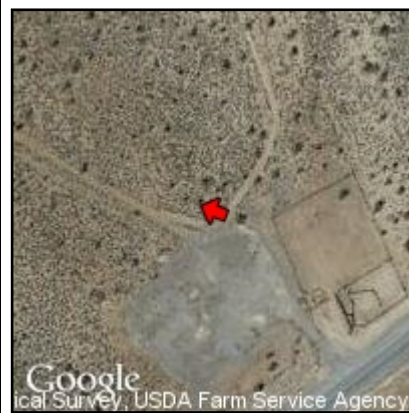
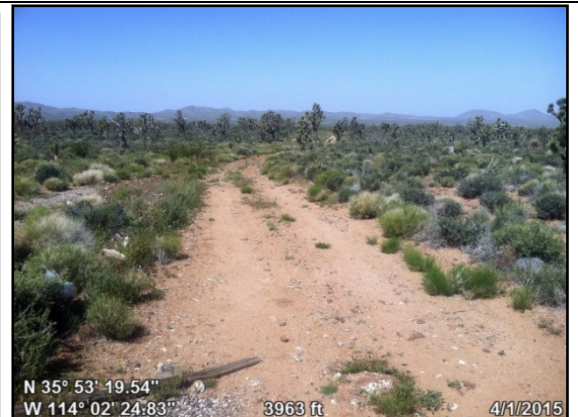
Attributes	
Title	Photopoint 040
Unit name	Joshua Tree Forest
Route name	Not named
Determination	Way
Maintenance	None
Feature	Typical condition of Route/Way

**Photopoint 040. A way as it enters private property.**

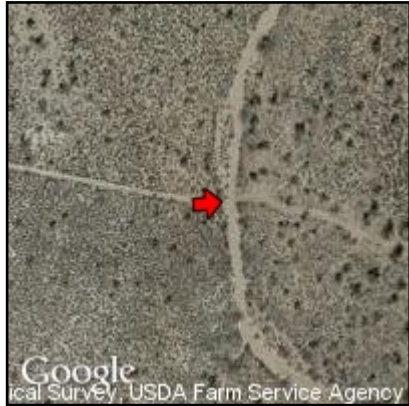
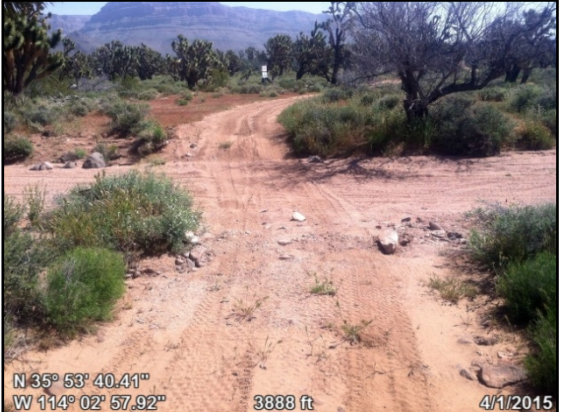
Attributes	
Title	Photopoint 041
Unit name	Joshua Tree Forest
Route name	Not named
Determination	Way
Maintenance	None
Feature	Typical condition of Route/Way

**Photopoint 041. A primitive route as it leaves private property.**

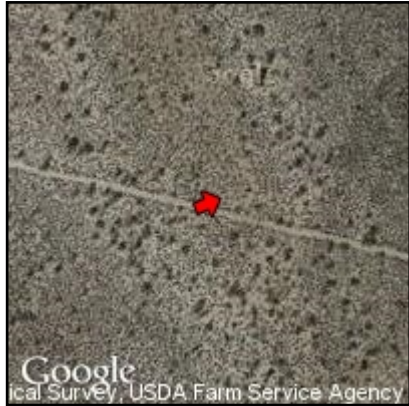
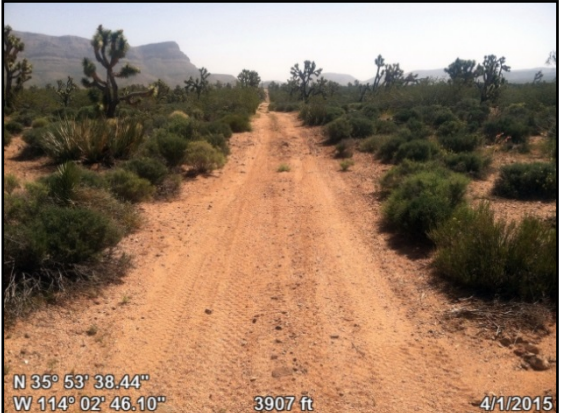
Attributes	
Title	Photopoint 042
Unit name	Joshua Tree Forest
Route name	BLM Route 7093
Determination	Way
Maintenance	None
Feature	Typical condition of Route/Way

**Photopoint 042. An unmaintained way as it enters BLM property.**

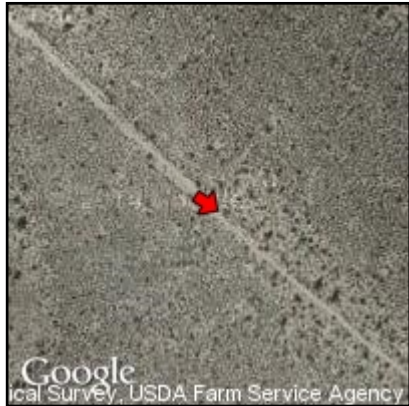
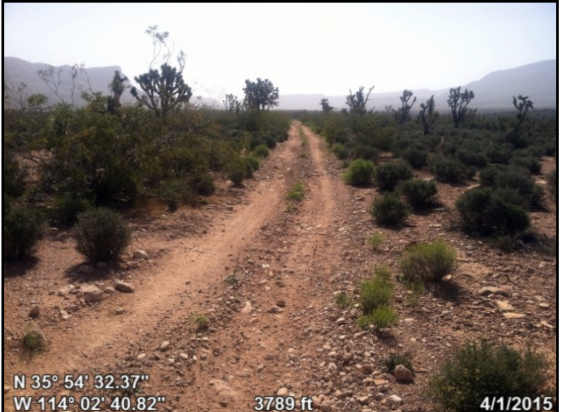
Attributes	
Title	Photopoint 043
Unit name	Joshua Tree Forest
Route name	BLM Route 7051
Determination	Way
Maintenance	None
Feature	Typical condition of Route/Way

**Photopoint 043. The northern end of BLM Route 7051, which is not mechanically maintained, just like the southern end.  
On occasion, recreational users will move large rocks by hand.**

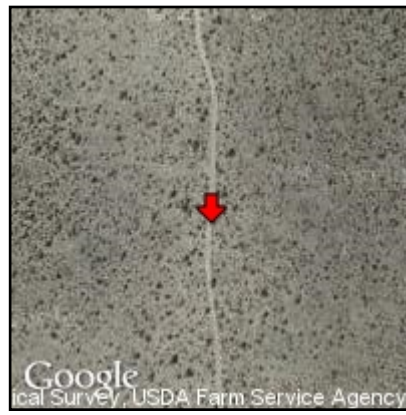
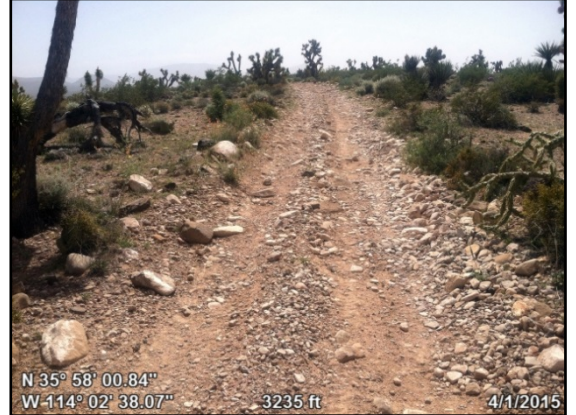
Attributes	
Title	Photopoint 044
Unit name	Joshua Tree Forest
Route name	NPS way that leads to BLM Route 7089
Determination	Way
Maintenance	None
Feature	Typical condition of Route/Way

**Photopoint 044. An unmaintained, primitive wash route on NPS land that receives some vehicular use despite being closed to mototized travel.**
