Proposed Lands with Wilderness Characteristics:

Poachie Range

A proposal report to the Bureau of Land Management,
Kingman Field Office, Arizona

August, 2015

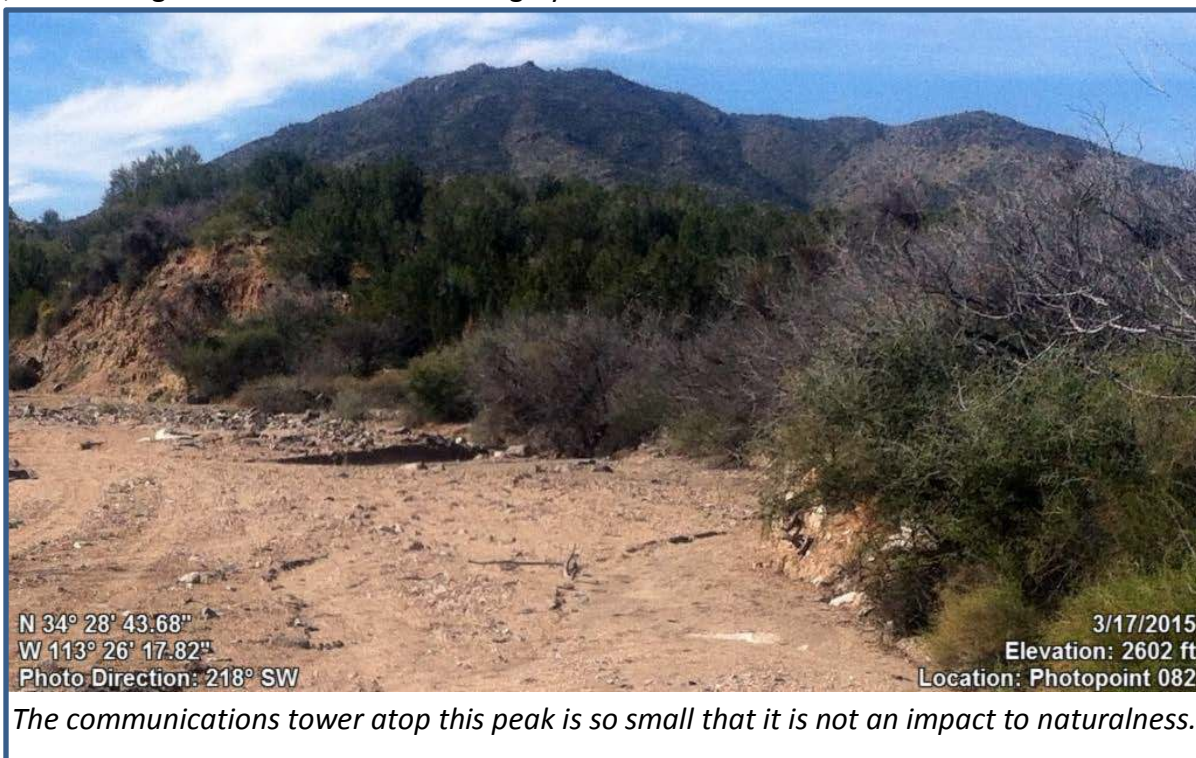
A communications site and associated access road has been excluded from the proposed LWC. This installation is located at the top of the mountain (Point “B” on preceding map and seen in photo below) in the far western end of the unit (Section 24 in T13N, R12W). This installation does not substantially detract from the naturalness of the unit for the average visitor because impacts outside of the LWC do not affect the naturalness within the LWC. Again, the BLM states that ...“Human impacts outside the area will not normally be considered when assessing naturalness of an area” (BLM Manual 6310, p. 7). We agree with this reasoning, and provide further evidence seen in the photograph below, that this installation and the access road are substantially unnoticeable to the average visitor, and especially considering how small the installation is, consisting of a single 30 foot tower, single solar panel, and small generator enclosed in a roughly 12 x 16 foot fenced area.

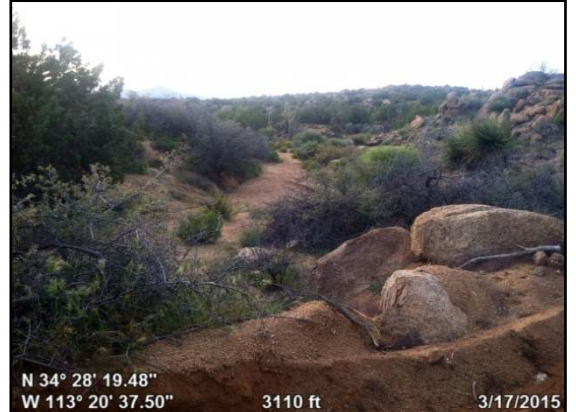
Photopoint 007. Other end of the way seen in Photopoint 6.

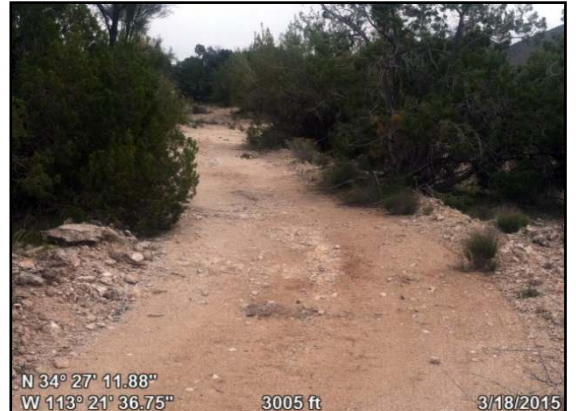
Title	Photopoint 008
Unit name	Poachie Range
Route name	Not named
Determination	Way
Maintenance	Old evidence
Feature	Typical condition of Route/Way

Photopoint 008. Semi-recent maintenance stops here on this way.

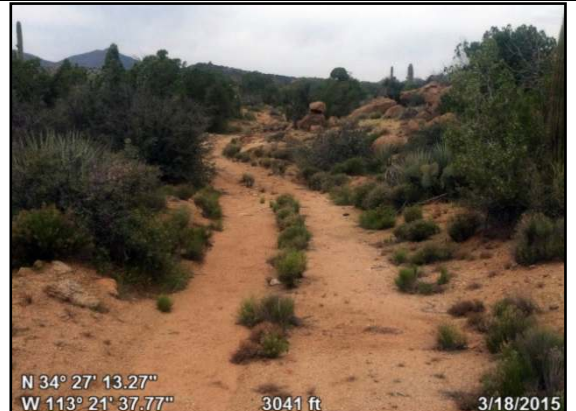
Title	Photopoint 009
Unit name	Poachie Range
Route name	Not named
Determination	Way
Maintenance	None
Feature	Typical condition of Route/Way

Photopoint 009. A primitive route that heads west into the LWC unit.

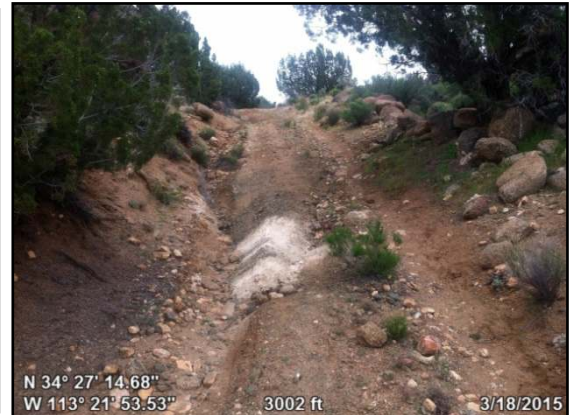
Attributes	
Title	Photopoint 010
Unit name	Poachie Range
Route name	Not named
Determination	Way
Maintenance	None
Feature	Erosion

Photopoint 010. Erosion indicating a lack of maintenance on the way seen in Photopoints 8 & 9.

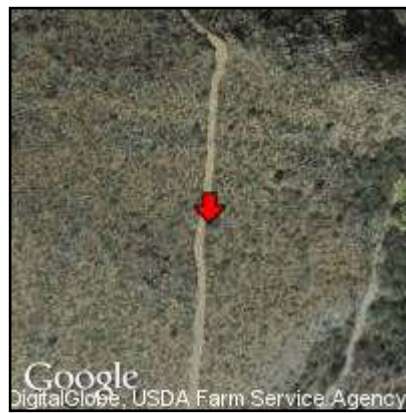
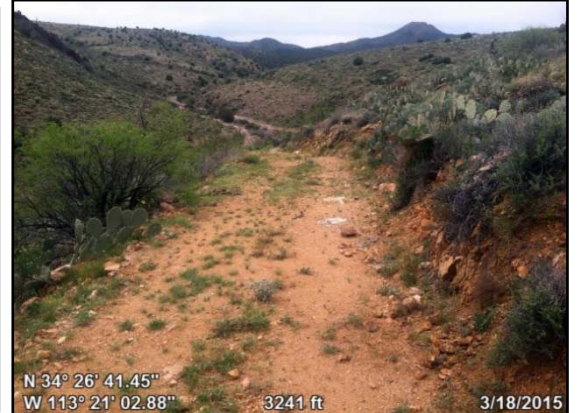
Attributes	
Title	Photopoint 011
Unit name	Poachie Range
Route name	Not named
Determination	Way
Maintenance	Old evidence
Feature	Typical condition of Route/Way

Photopoint 011. A primitive route leaving private property and entering BLM land within the proposed LWC unit.

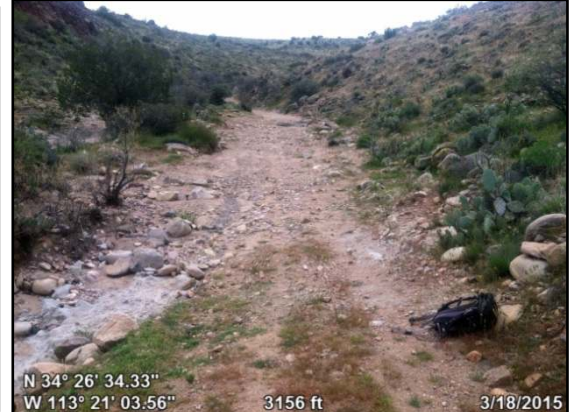
Attributes	
Title	Photopoint 012
Unit name	Poachie Range
Route name	Not named
Determination	Way
Maintenance	Old evidence
Feature	Typical condition of Route/Way

Photopoint 012. Taken where route meets wash, signed as private property on BLM, but is not the property boundary. No evidence of vehicular use at all.

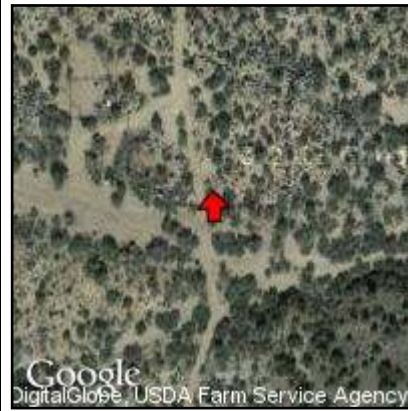
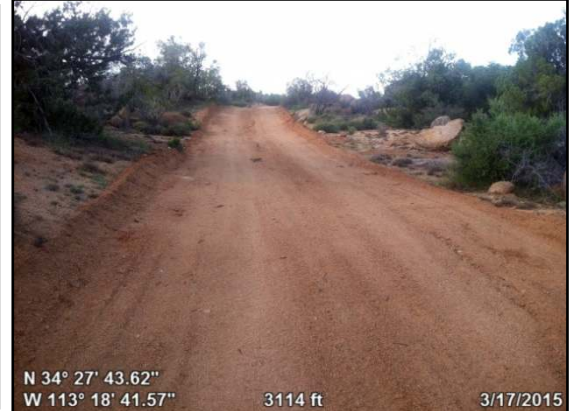
Attributes	
Title	Photopoint 013
Unit name	Poachie Range
Route name	BLM Route 7541
Determination	Road
Maintenance	Recent blade
Feature	Typical condition of Route/Way

Photopoint 013. A wilderness inventory road that is a cherrystem to private property. Eventually changes names from BLM Route 7541 to BLM Route 7541A.

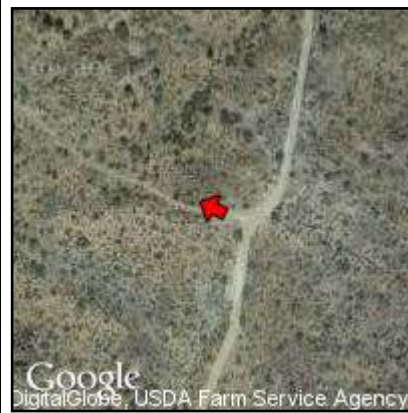
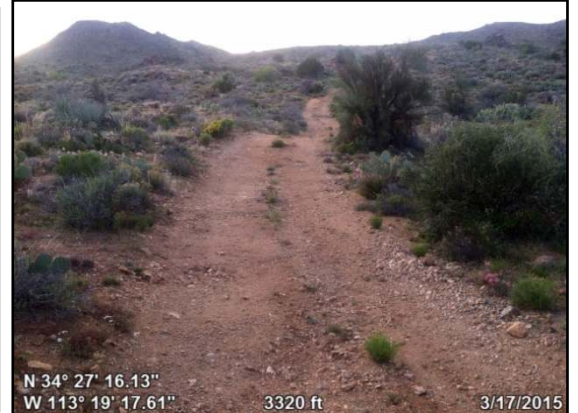
Attributes	
Title	Photopoint 014
Unit name	Poachie Range
Route name	BLM 7541
Determination	Way
Maintenance	None
Feature	Typical condition of Route/Way

Photopoint 014. BLM Route 7541 turns to the west here and becomes a way.

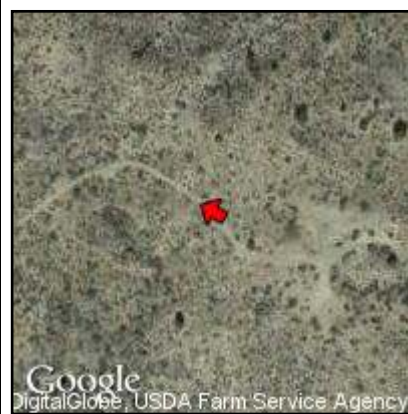
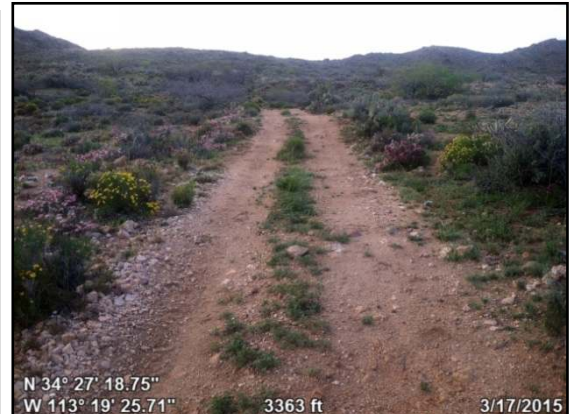
Attributes	
Title	Photopoint 015
Unit name	Poachie Range
Route name	BLM 7541
Determination	Way
Maintenance	None
Feature	Typical condition of Route/Way

Photopoint 015. Looking west down this primitive route.

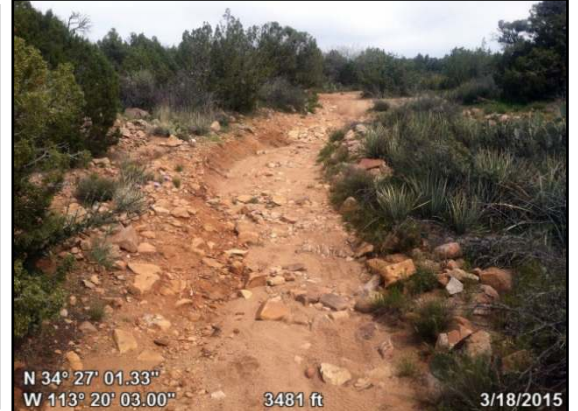
Attributes	
Title	Photopoint 016
Unit name	Poachie Range
Route name	BLM Route 7541
Determination	Way
Maintenance	None
Feature	Typical condition of Route/Way

Photopoint 016. Evidence of erosion and a lack of maintenance on this section of BLM Route 7541.

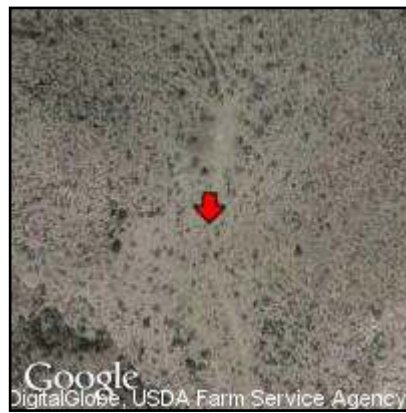
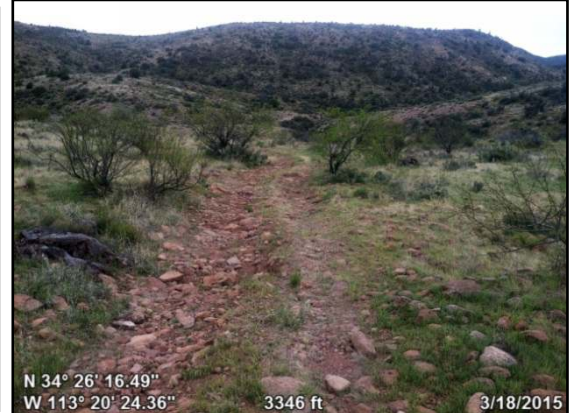
Attributes	
Title	Photopoint 017
Unit name	Poachie Range
Route name	BLM Route 7541
Determination	Way
Maintenance	None
Feature	Typical condition of Route/Way

Photopoint 017. Where the route crosses slopes and mesas it is an extremely rough surface of cobbles thickly grown in with vegetation that is kept stunted only by the trampling of vehicles.

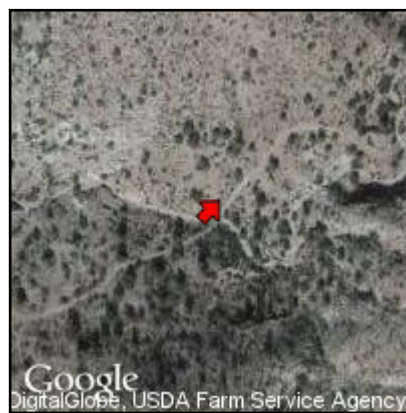
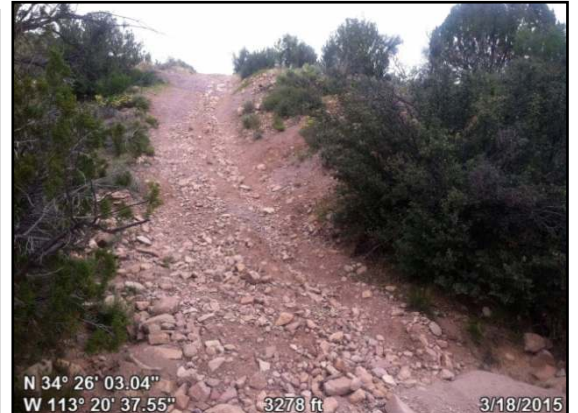
Attributes	
Title	Photopoint 018
Unit name	Poachie Range
Route name	BLM Route 7541
Determination	Way
Maintenance	None
Feature	Typical condition of Route/Way

Photopoint 018. Much of the route is badly eroded, unsustainably steep, and only the width of an ATV. Where the route parallels washes it is significantly off-camber, indicating that it had never been mechanically constructed, or all evidence has naturalized due to having never been maintained.

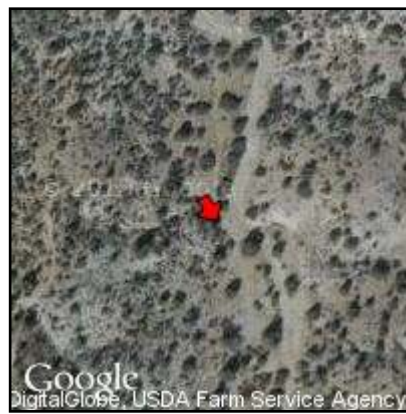
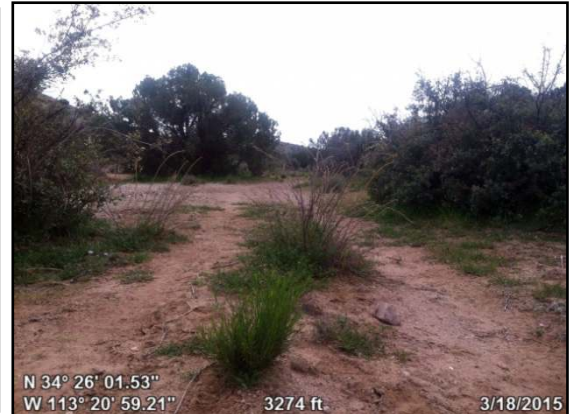
Title	Photopoint 019
Unit name	Poachie Range
Route name	BLM Route 7541
Determination	Way
Maintenance	None
Feature	Revegetating

Photopoint 019. Vegetation growing in the middle of this primitive route.

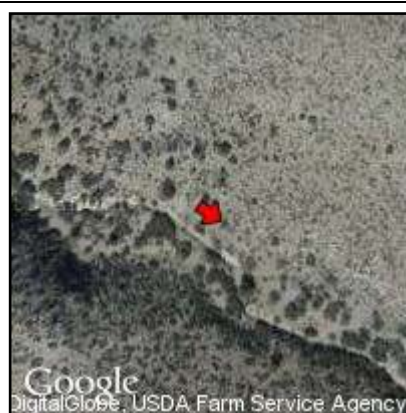
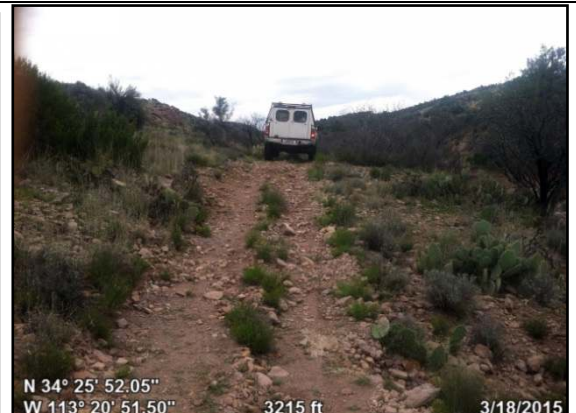
Title	Photopoint 021
Unit name	Poachie Range
Route name	BLM Route 7541
Determination	Way
Maintenance	None
Feature	Typical condition of Route/Way

Photopoint 021. This primitive route is more narrow than a truck.

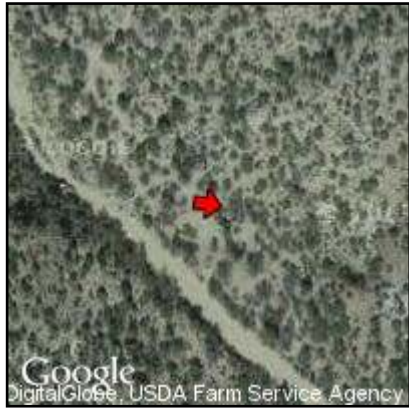
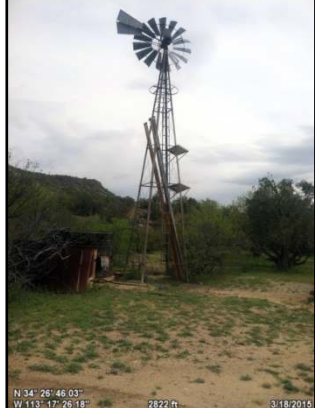
Attributes	
Title	Photopoint 024
Unit name	Poachie Range
Route name	BLM Route 7439
Determination	Way
Maintenance	None
Feature	Delapidated windmill

Photopoint 024. A delapidated windmill at the end of BLM Route 7439.

H = maintained corral, **excluded from unit**
 I = non-functioning windmill, water tank full of trash, well-pipe pulled out (*photopoint 24*)
 J = unmaintained corral in disrepair, decaying into the ground
 K = new well and steel tank
 L = small corral, historic cowboy camp
 M = feed/water trough
 N = primitive campsites O = Historic, abandoned homestead

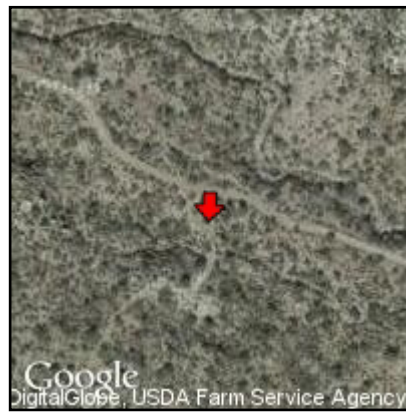
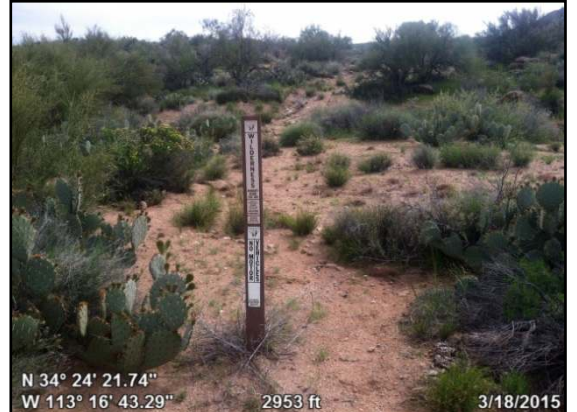
Title	Photopoint 025
Unit name	Poachie Range
Route name	Not named
Determination	Reclaimed
Maintenance	None
Feature	Revegetated

Photopoint 025. This old way that goes into the wilderness has naturalized. It should not be a cherrystem into the Arrastra Mountain Wilderness because, as this photo documents, it is not a wilderness inventory road.

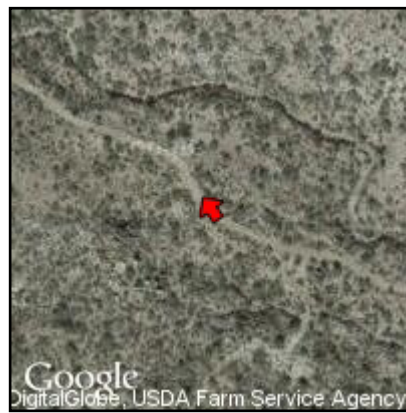
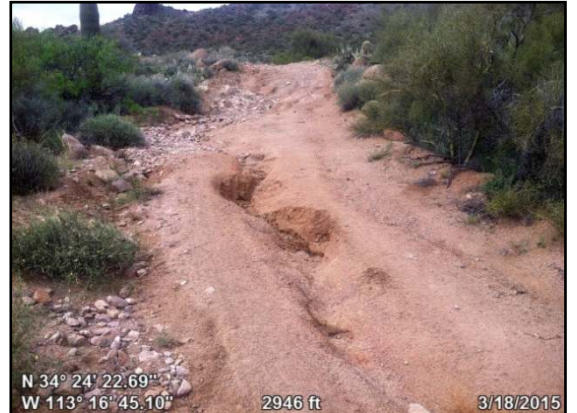
Title	Photopoint 026
Unit name	Poachie Range
Route name	BLM Route 7532
Determination	Way
Maintenance	None
Feature	Erosion

Photopoint 026. Erosion along this primitive route.

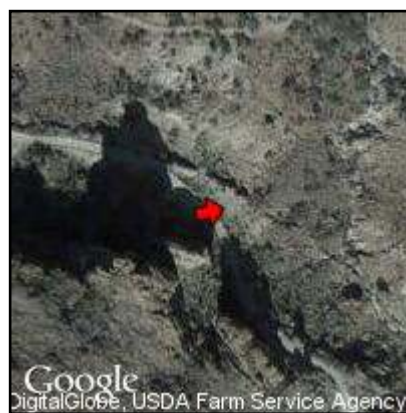
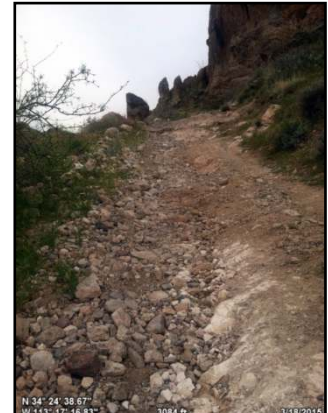
Title	Photopoint 027
Unit name	Poachie Range
Route name	BLM Route 7532
Determination	Way
Maintenance	None
Feature	Erosion

Photopoint 027. More evidence of severe erosion on BLM Route 7532.

- 3) BLM Route 7532, which forms approximately four miles of the wilderness boundary between Waypoint 2 and Photopoint 35, is currently not maintained, and has fallen into disrepair with numerous steep, heavily eroded sections (see Photopoints 26 & 27). The ways that depart from this route are either closed by BLM, or are similarly unmaintained primitive routes (see Photopoints 28 through 34). The route dead ends at an impassable crossing of upper Placeritas Creek (see Photopoint 35). A rustic cowboy camp is situated at the end of BLM Route 7532C, which could be accessed by horseback or administrative use permissions.

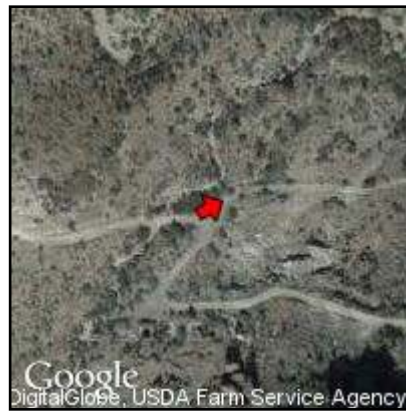
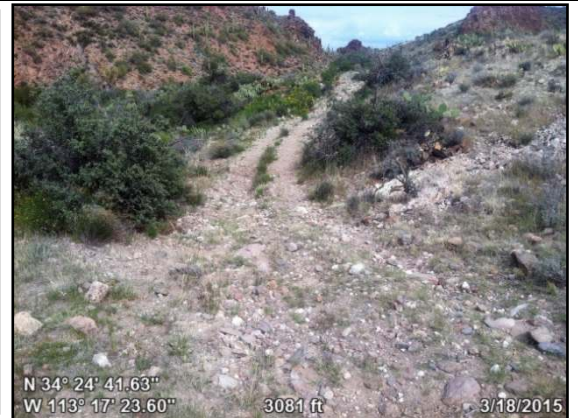
Title	Photopoint 028
Unit name	Poachie Range
Route name	Not named
Determination	Way
Maintenance	None
Feature	Typical condition of Route/Way

Photopoint 028. A way branching from BLM Route 7532.

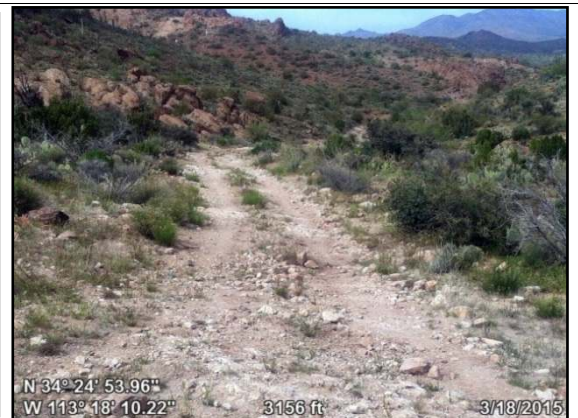
Title	Photopoint 029
Unit name	Poachie Range
Route name	BLM Route 7532
Determination	Way
Maintenance	None
Feature	Typical condition of Route/Way

Photopoint 029. There is a lack of maintenance on this way, making it a primitive route.

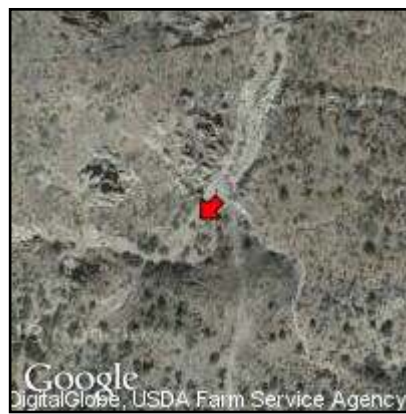
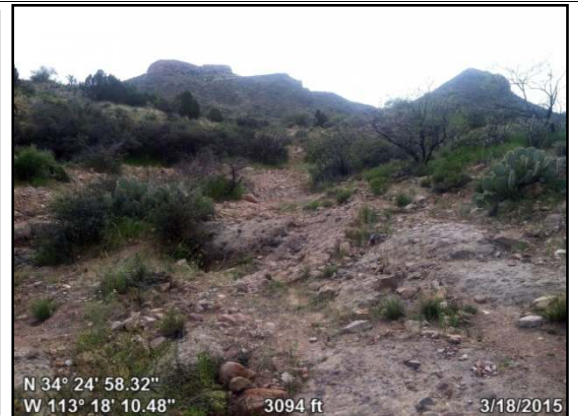
Title	Photopoint 030
Unit name	Poachie Range
Route name	BLM Route 7532D
Determination	Way
Maintenance	None
Feature	Typical condition of Route/Way

Photopoint 030. This way is obviously not being maintained.

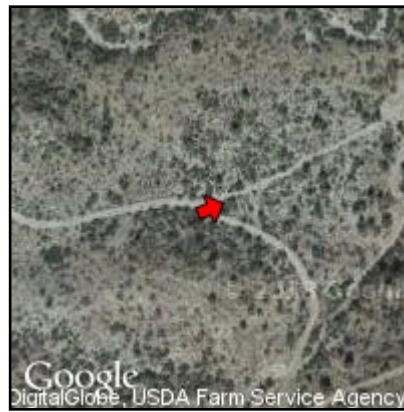
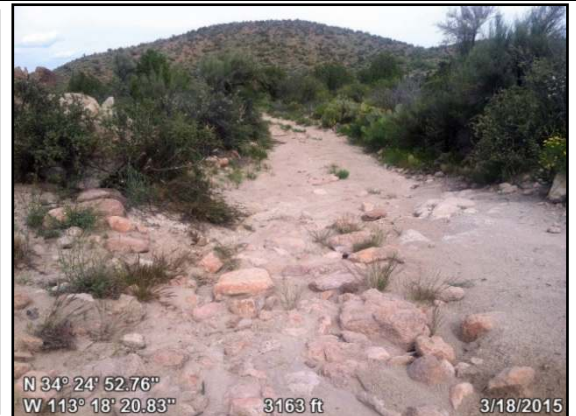
Title	Photopoint 031
Unit name	Poachie Range
Route name	BLM Route 7532D
Determination	Way
Maintenance	None
Feature	Erosion

Photopoint 031. Obvious lack of maintenance here as well.

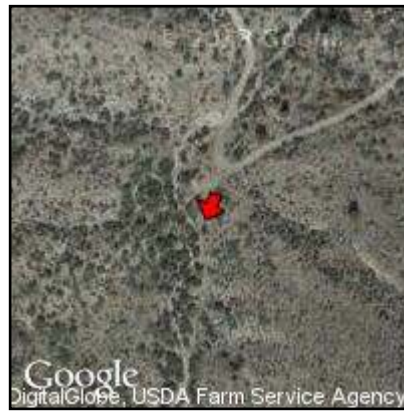
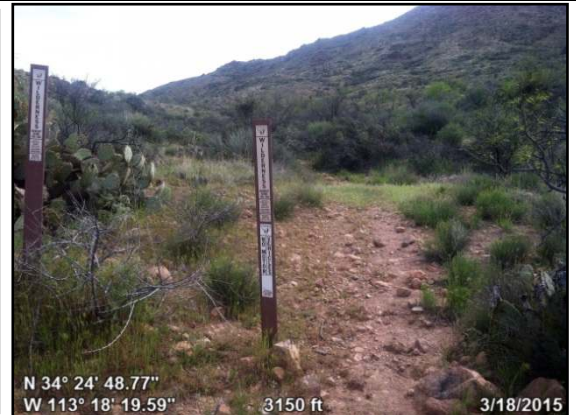
Title	Photopoint 032
Unit name	Poachie Range
Route name	Not named
Determination	Not a road or a way
Maintenance	None
Feature	Revegetated

Photopoint 032. This is a picture of an old way that forms another cherrystem into the Arrastra Mountain Wilderness. This is not a wilderness inventory road and should not be a cherrystem into the wilderness.

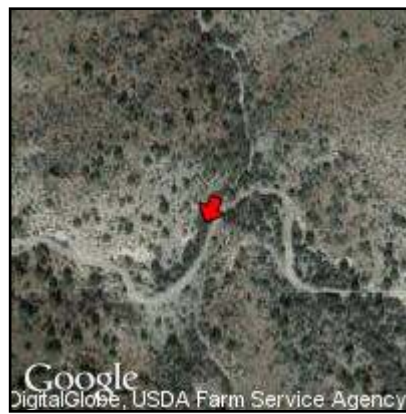
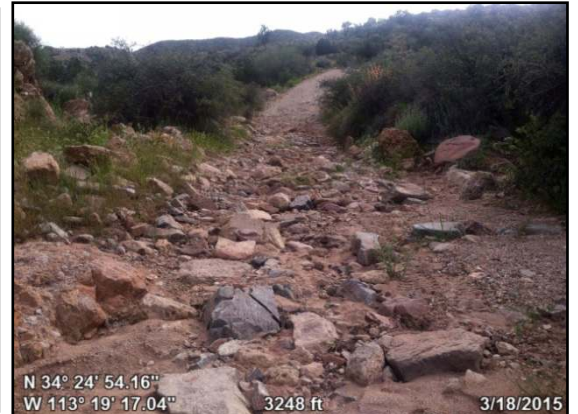
Photopoint 034. Further lack of maintenance along BLM Route 7532.

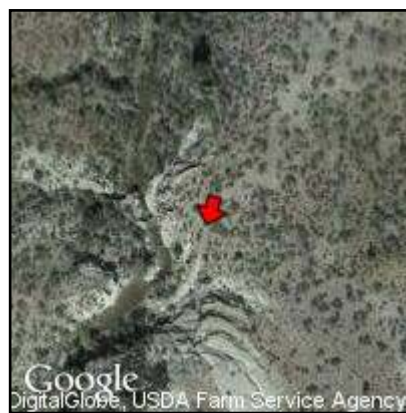
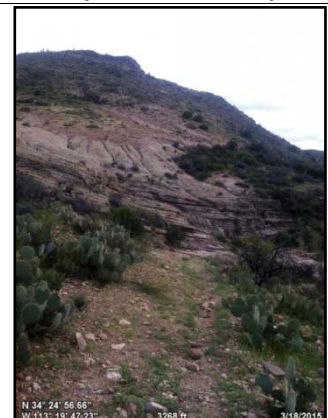
Title	Photopoint 035
Unit name	Poachie Range
Route name	BLM Route 7532
Determination	Reclaimed
Maintenance	None
Feature	Typical condition of Route/Way

Photopoint 035. This is no longer a primitive route. It is impossible to cross this section of Placeritas Creek, and no evidence of any vehicle attempts was found.

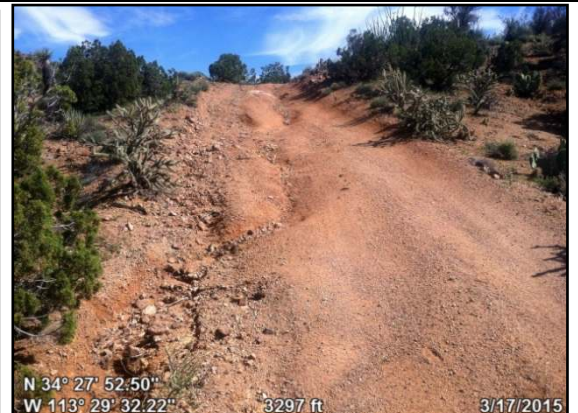
Photopoint 036. Evidence of erosion and a lack of maintenance on BLM Route 7523.

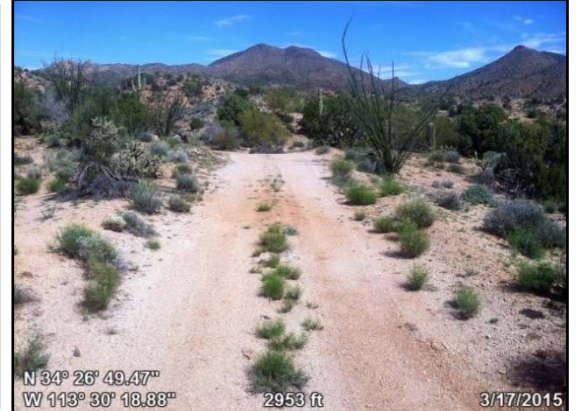
Attributes	
Title	Photopoint 037
Unit name	Poachie Range
Route name	BLM Route 7523
Determination	Way
Maintenance	None
Feature	Typical condition of Route/Way

Photopoint 037. Much of way follows dry washes. Where it follows low ridges it appears that no maintenance has been performed since construction.

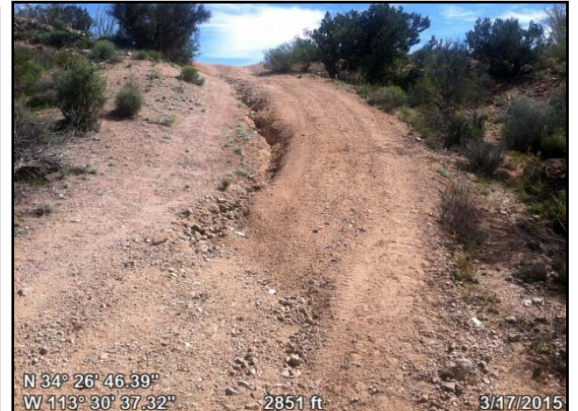
Attributes	
Title	Photopoint 038
Unit name	Poachie Range
Route name	BLM Route 7523
Determination	Way
Maintenance	None
Feature	Typical condition of Route/Way

Photopoint 038. Erosion along BLM Route 7523. This way should not be a cherrystem into the Arrastra Mountains Wilderness.

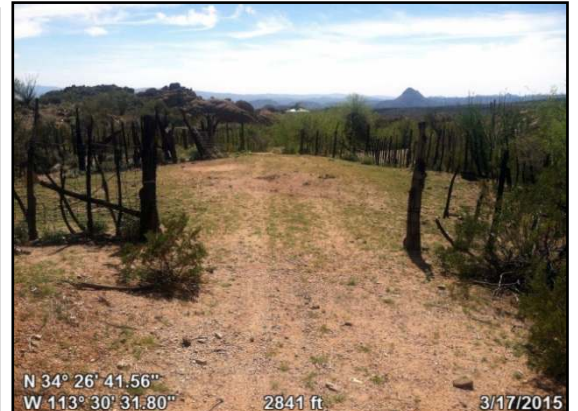
Attributes	
Title	Photopoint 039
Unit name	Poachie Range
Route name	BLM Route 7523
Determination	Way
Maintenance	None
Feature	Livestock Watering/Feeding station in disrepair

Photopoint 039. The way passes through this old corral. The watering systems are in total disrepair; rubbermaid tub has not been used for years; solar panel wiring severed and sun faded; and spring is growing in and naturalizing

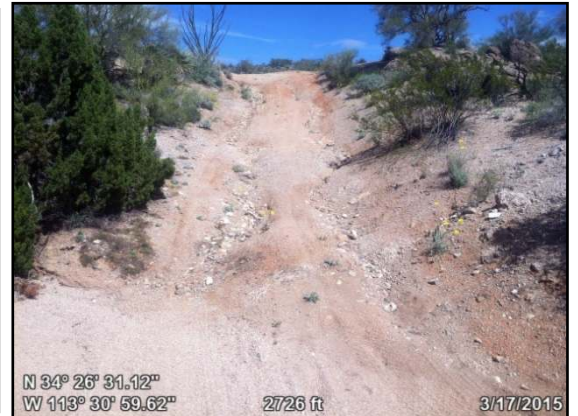
Attributes	
Title	Photopoint 040
Unit name	Poachie Range
Route name	BLM Route 7523
Determination	Way
Maintenance	None
Feature	Typical condition of Route/Way

Photopoint 040. Erosion indicating a lack of maintenance on this way. This is not a wilderness inventory road and should not be a cherrystem into the Arrastra Mountain Wilderness.

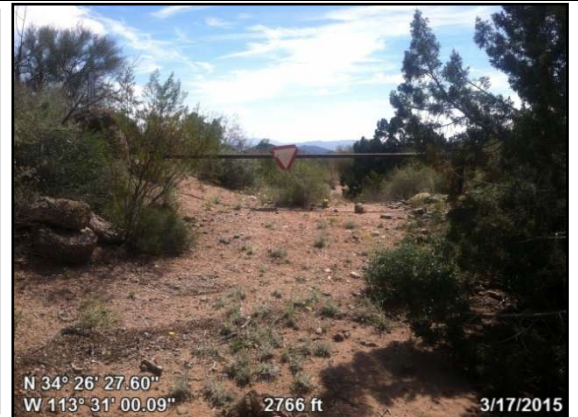
Attributes	
Title	Photopoint 041
Unit name	Poachie Range
Route name	BLM Route 7523
Determination	Way
Maintenance	None
Feature	Closure point

Photopoint 041. BLM has blocked the way and there is no illegal passage.

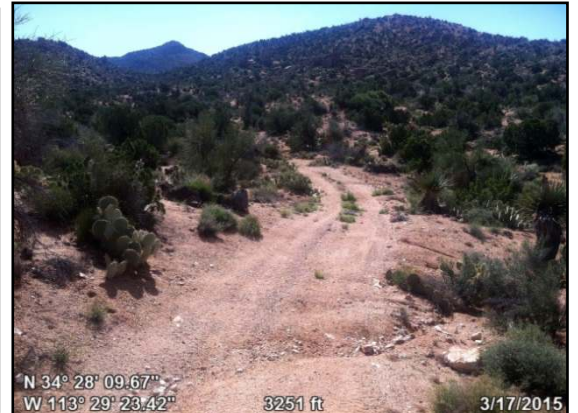
Attributes	
Title	Photopoint 042
Unit name	Poachie Range
Route name	Not Named
Determination	Way
Maintenance	None
Feature	Typical condition of Route/Way

Photopoint 042. Lack of maintenance indicated by erosion, and vegetation growing in the median of this unnamed way.

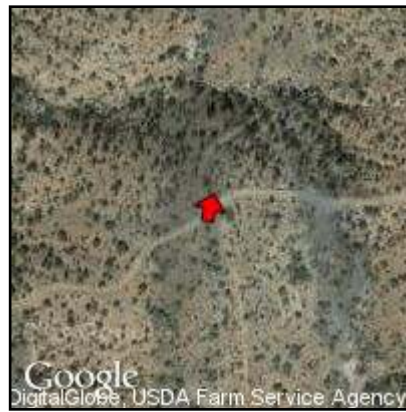
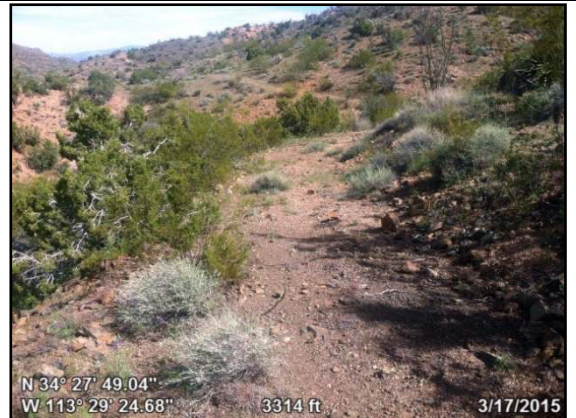
Title	Photopoint 043
Unit name	Poachie Range
Route name	Not Named
Determination	Reclaimed
Maintenance	None
Feature	Revegetated

Photopoint 043. This old way has naturalized.

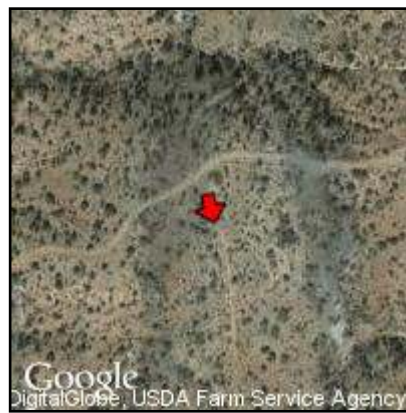
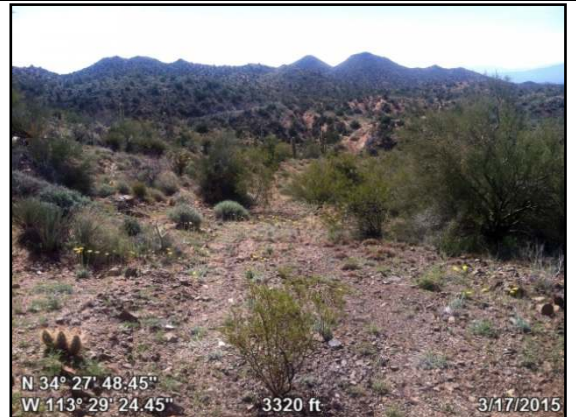
Title	Photopoint 044
Unit name	Poachie Range
Route name	Not Named
Determination	Reclaimed
Maintenance	None
Feature	Revegetated

Photopoint 044. This old way has been reclaimed by nature.

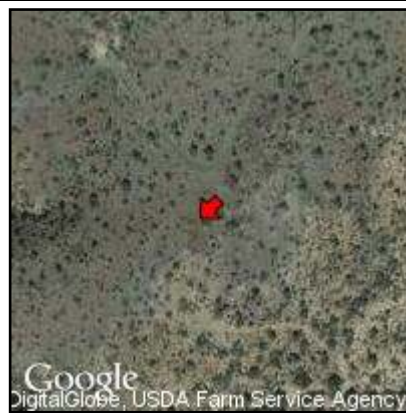
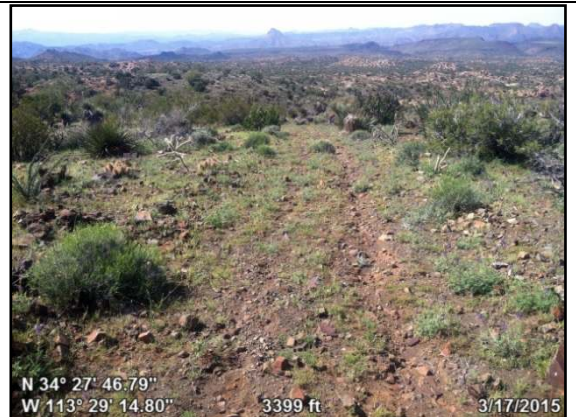
Title	Photopoint 045
Unit name	Poachie Range
Route name	Not Named
Determination	Reclaimed
Maintenance	None
Feature	Revegetated

Photopoint 045. This old primitive route has revegetated.

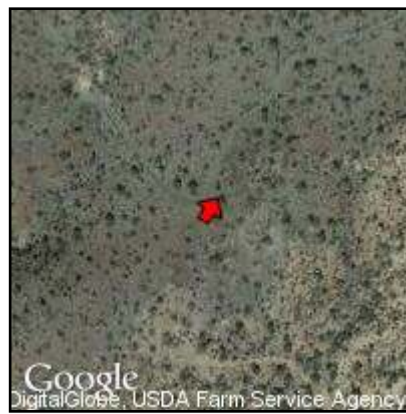
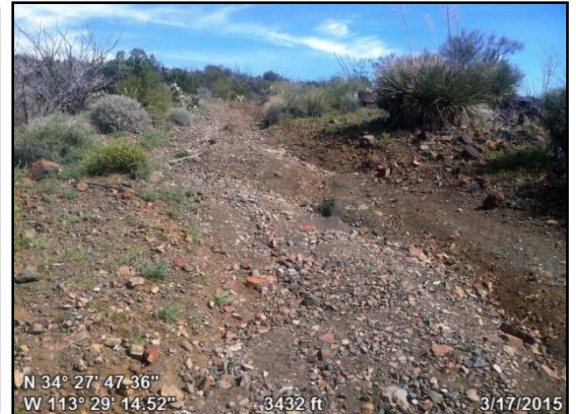
Title	Photopoint 046
Unit name	Poachie Range
Route name	BLM Route 7526
Determination	Way
Maintenance	None
Feature	Typical condition of Route/Way

Photopoint 046. Evidence of erosion along this primitive route.

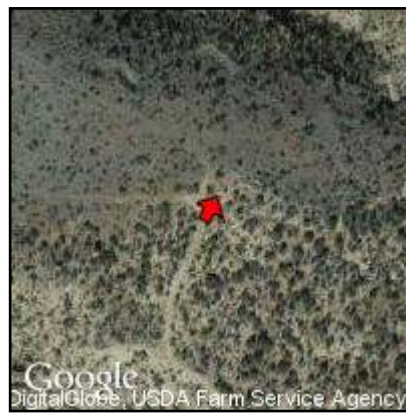
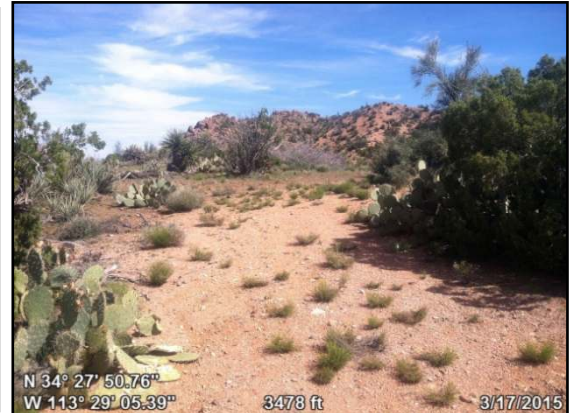
Title	Photopoint 047
Unit name	Poachie Range
Route name	Not Named
Determination	Reclaimed
Maintenance	None
Feature	Revegetated

Photopoint 047. This old way has been reclaimed and contains no evidence of use.

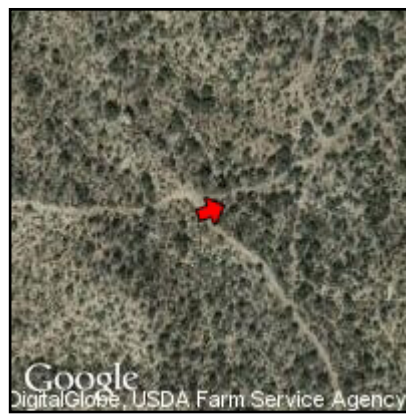
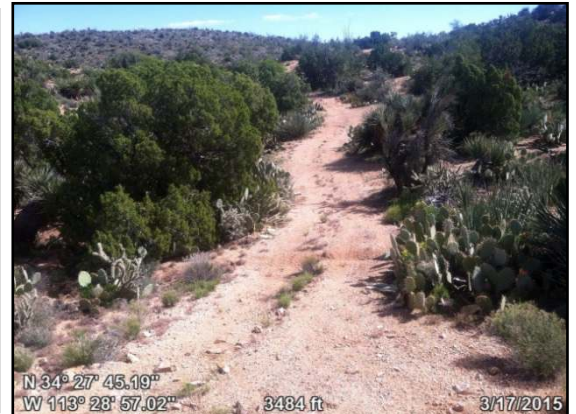
Title	Photopoint 048
Unit name	Poachie Range
Route name	Not Named
Determination	Way
Maintenance	None
Feature	Typical condition of Route/Way

Photopoint 048. A way branching from BLM Route 7526.

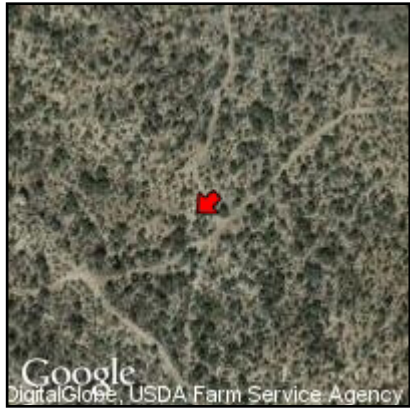
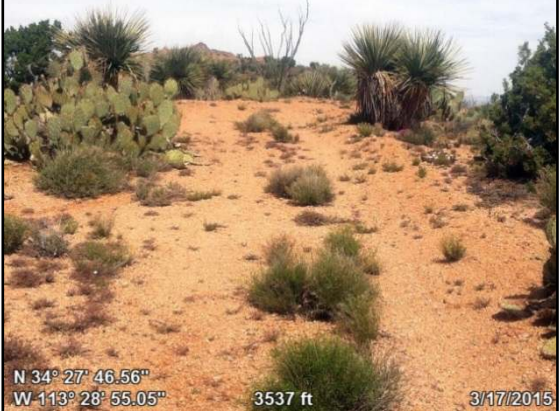
Attributes	
Title	Photopoint 049
Unit name	Poachie Range
Route name	Not Named
Determination	Way
Maintenance	None
Feature	Typical condition of Route/Way

Photopoint 049. This way is unused and revegetating.

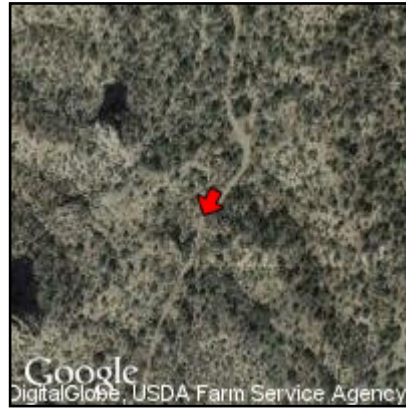
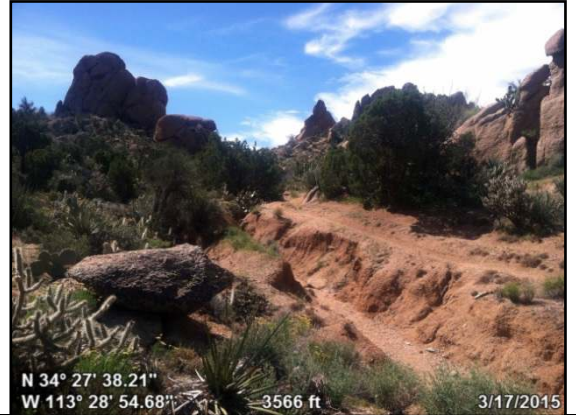
Attributes	
Title	Photopoint 052
Unit name	Poachie Range
Route name	Not named
Determination	Way
Maintenance	None
Feature	Erosion

Photopoint 052. More erosion along this way. Vehicle passage is impossible. Only foot travel can pass this point.

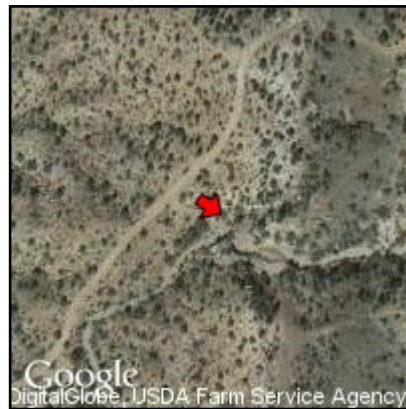
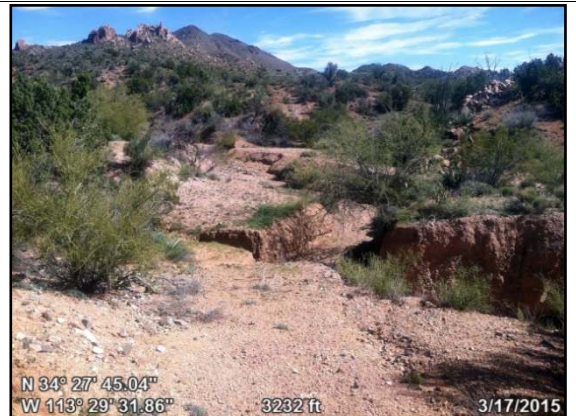
Attributes	
Title	Photopoint 053
Unit name	Poachie Range
Route name	Not Named
Determination	Reclaimed
Maintenance	None
Feature	Revegetated

Photopoint 053. This old way has been deeply eroded and is impassable.

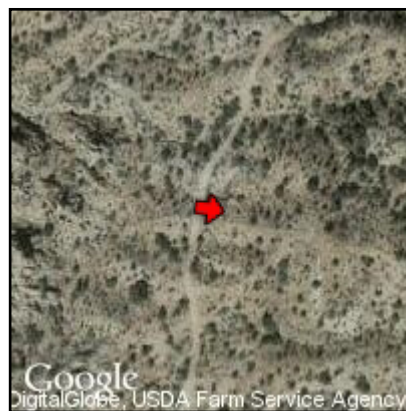
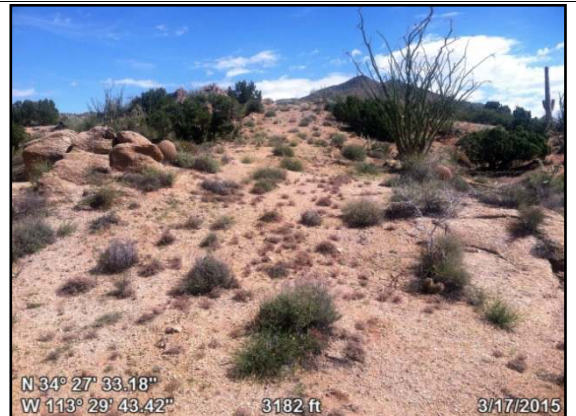
Attributes	
Title	Photopoint 054
Unit name	Poachie Range
Route name	Not Named
Determination	Reclaimed
Maintenance	None
Feature	Revegetated

Photopoint 054. Another old way that has revegetated.

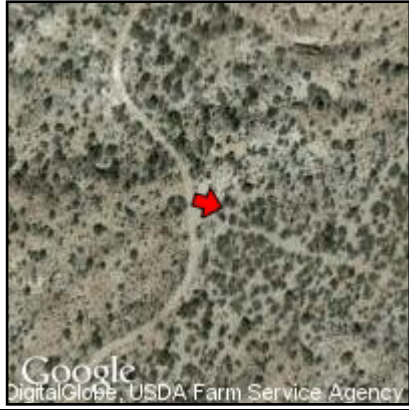
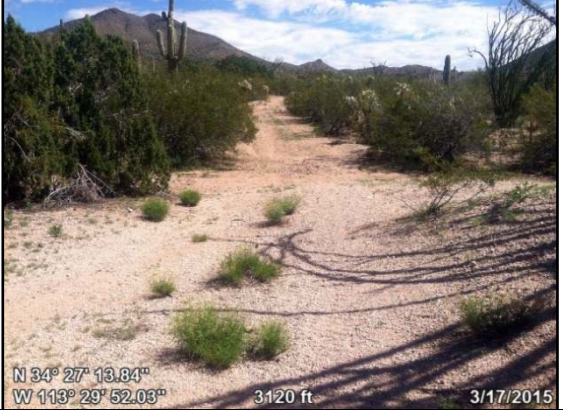
Attributes	
Title	Photopoint 055
Unit name	Poachie Range
Route name	Not Named
Determination	Way
Maintenance	None
Feature	Typical condition of Route/Way

Photopoint 055. Even the BLM route data says that this way is reclaiming.

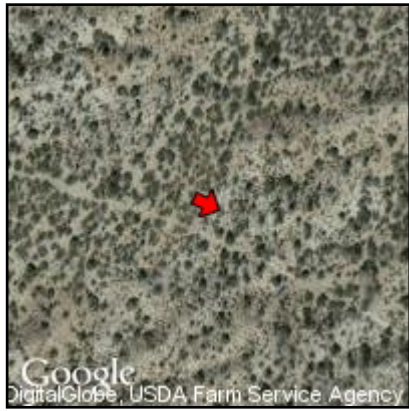
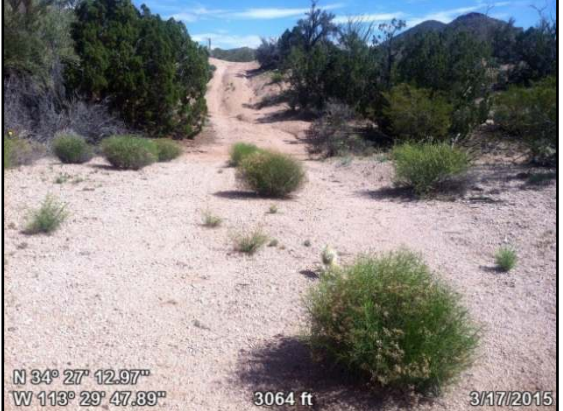
Attributes	
Title	Photopoint 056
Unit name	Poachie Range
Route name	Not Named
Determination	Way
Maintenance	None
Feature	Typical condition of Route/Way

Photopoint 056. Maintained solely by the passage of vehicles.

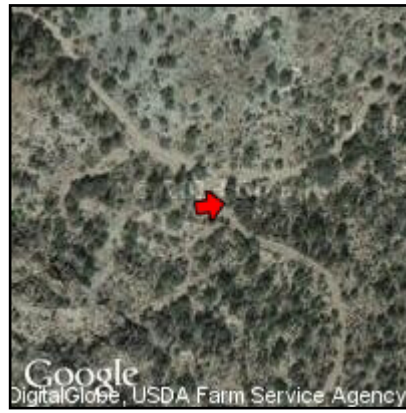
Attributes	
Title	Photopoint 058
Unit name	Poachie Range
Route name	BLM 7524
Determination	Way
Maintenance	None
Feature	Typical condition of Route/Way

Photopoint 058. This way branches from BLM Route 7524A. It follows a wash and shows no signs of construction or maintenance.

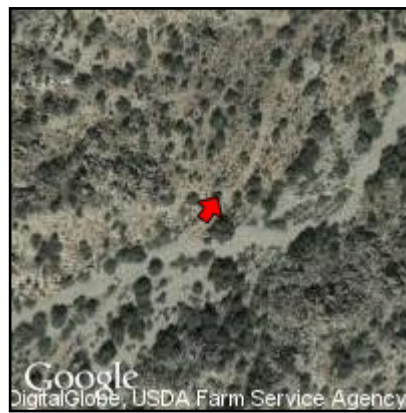
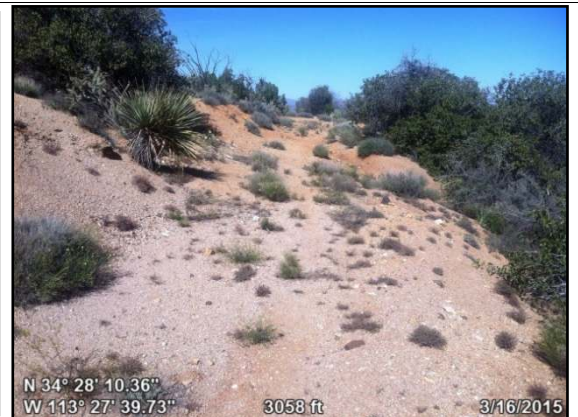
Attributes	
Title	Photopoint 059
Unit name	Poachie Range
Route name	Not named
Determination	Reclaimed
Maintenance	None
Feature	Typical condition of Route/Way

Photopoint 059. An old way that has been reclaimed.

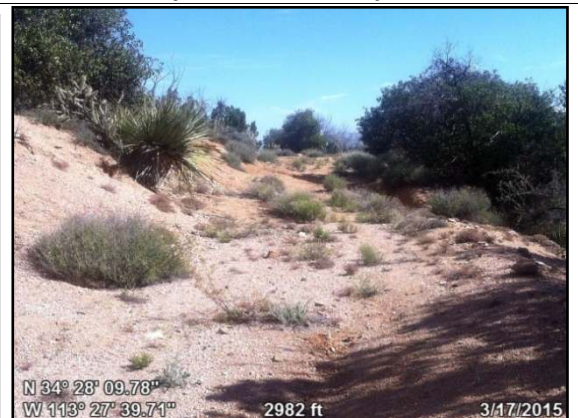
Attributes	
Title	Photopoint 060
Unit name	Poachie Range
Route name	Not Named
Determination	Way
Maintenance	None
Feature	Revegetating

Photopoint 060. There is evidence of extremely low use of this primitive route.

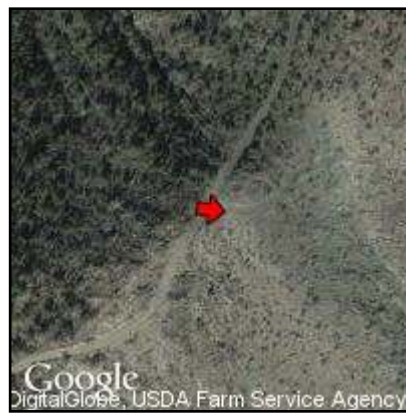
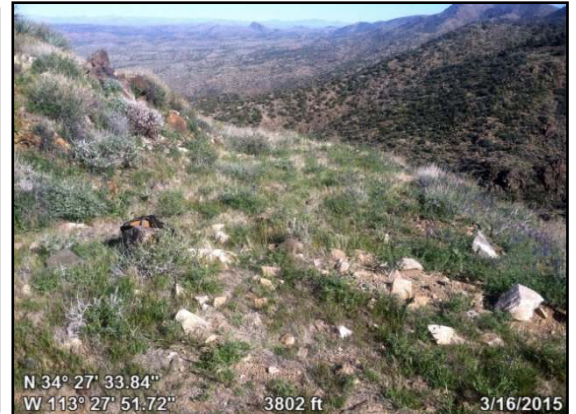
Title	Photopoint 064
Unit name	Poachie Range
Route name	Not Named
Determination	Reclaimed
Maintenance	None
Feature	Revegetated

Photopoint 064. This old section of the road is now revegetated.

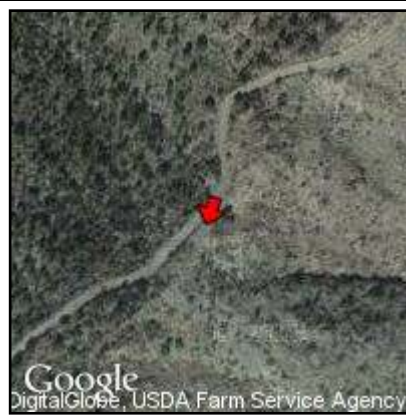
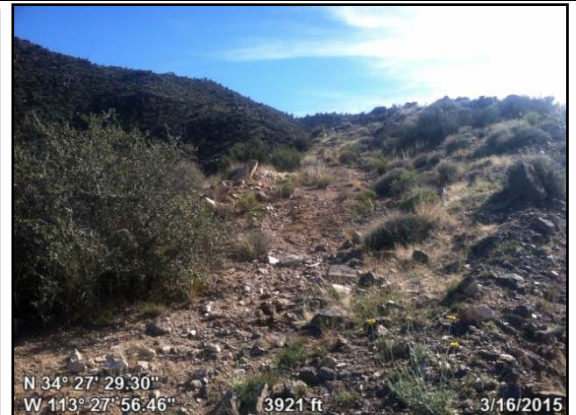
Title	Photopoint 065
Unit name	Poachie Range
Route name	Not Named
Determination	Reclaimed
Maintenance	None
Feature	Revegetated

Photopoint 065. This old road bed is reclaimed.

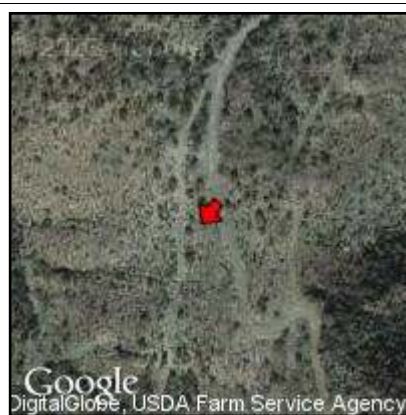
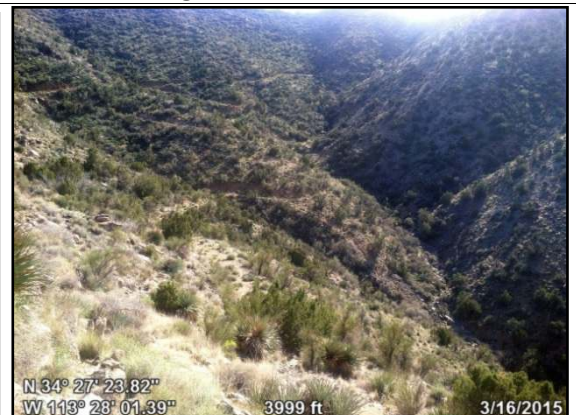
Title	Photopoint 066
Unit name	Poachie Range
Route name	Not named
Determination	Reclaimed
Maintenance	None
Feature	Revegetated

Photopoint 066. Note that the old mine diggings in this picture are substantially unnoticeable to the average visitor.

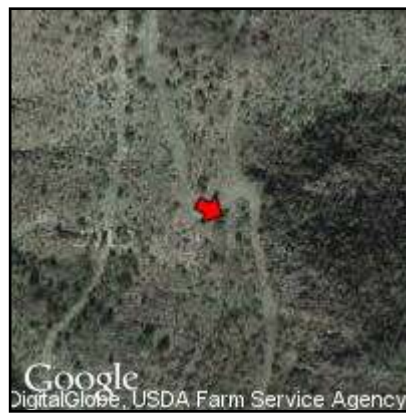
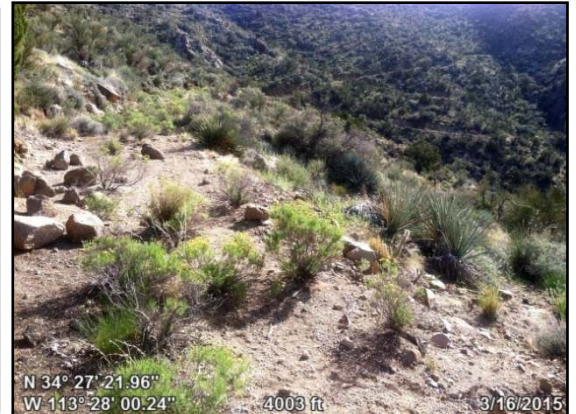
Title	Photopoint 067
Unit name	Poachie Range
Route name	Not Named
Determination	Reclaimed
Maintenance	None
Feature	Revegetated

Photopoint 067. Another reclaimed section of the old road.

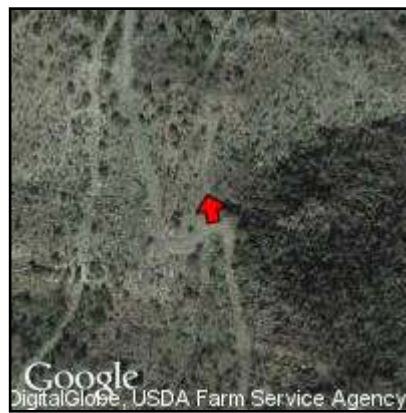
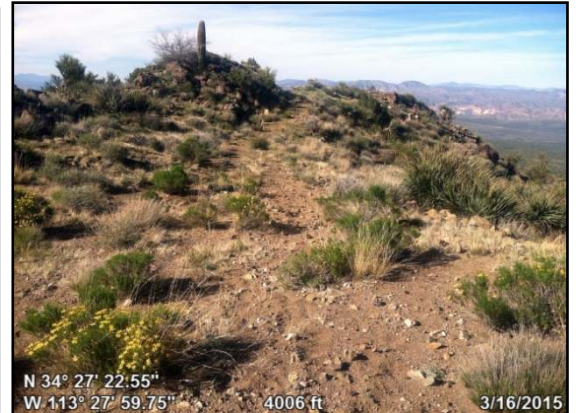
Title	Photopoint 068
Unit name	Poachie Range
Route name	Not Named
Determination	Reclaimed
Maintenance	None
Feature	Revegetated

Photopoint 068. Looking at another revegetated old way.
