Proposed Lands with Wilderness Characteristics:

Poachie Range

A proposal report to the Bureau of Land Management,
Kingman Field Office, Arizona

August, 2015

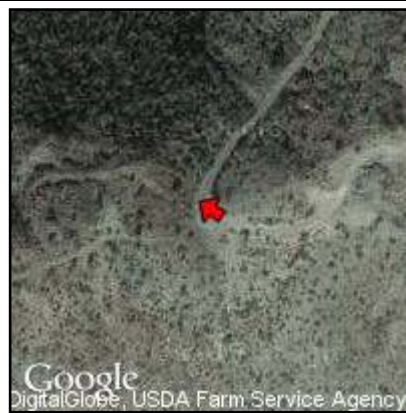
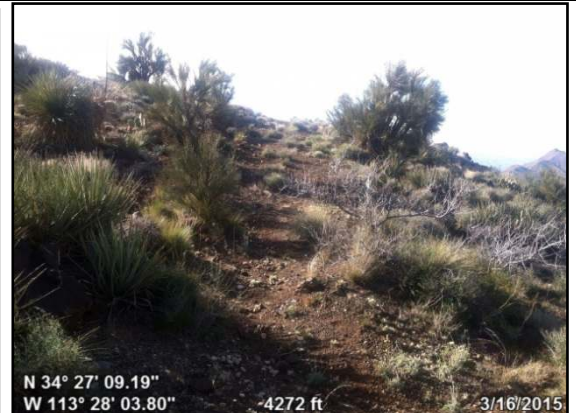
Title	Photopoint 069
Unit name	Poachie Range
Route name	Not Named
Determination	Reclaimed
Maintenance	None
Feature	Revegetated

Photopoint 069. This old way has been reclaimed.

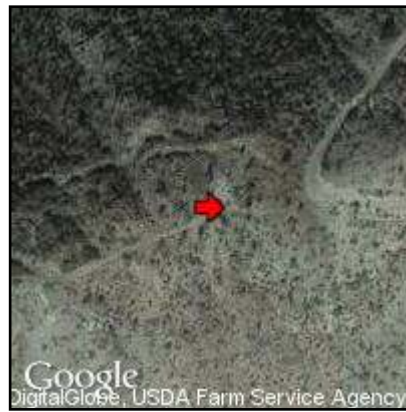
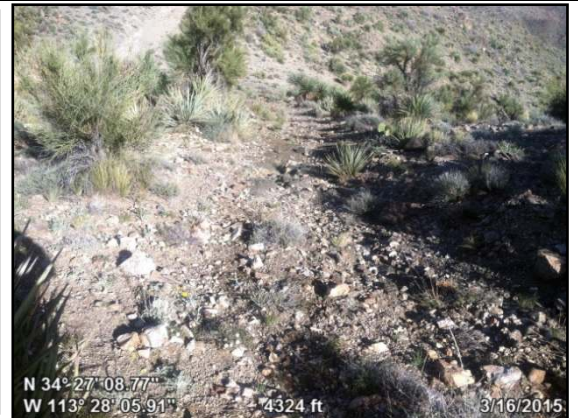
Title	Photopoint 070
Unit name	Poachie Range
Route name	Not Named
Determination	Reclaimed
Maintenance	None
Feature	Revegetated

Photopoint 070. Another old way that is reclaimed.

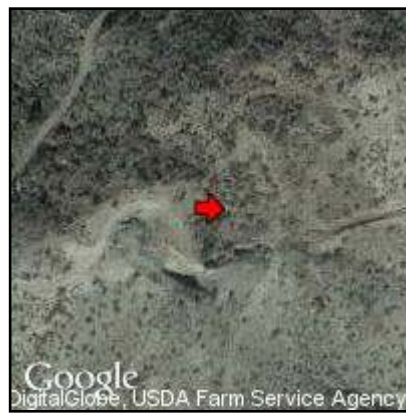
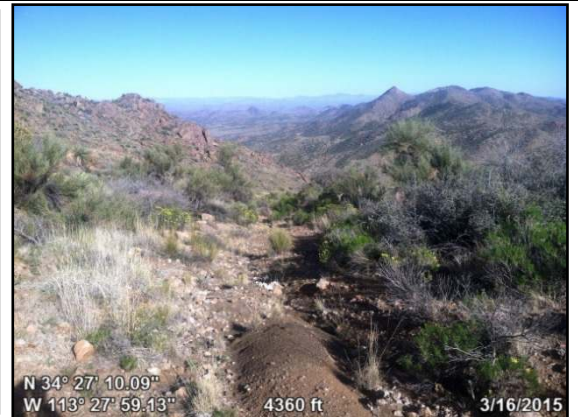
Title	Photopoint 071
Unit name	Poachie Range
Route name	Not Named
Determination	Reclaimed
Maintenance	None
Feature	Revegetated

Photopoint 071. Looking east at another old way that is revegetated.

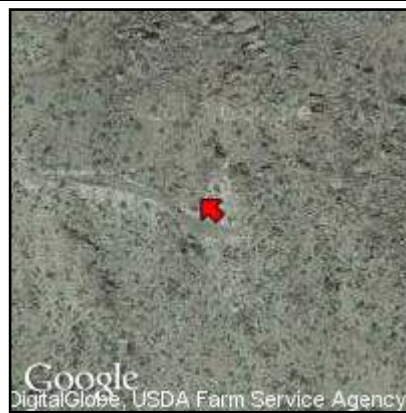
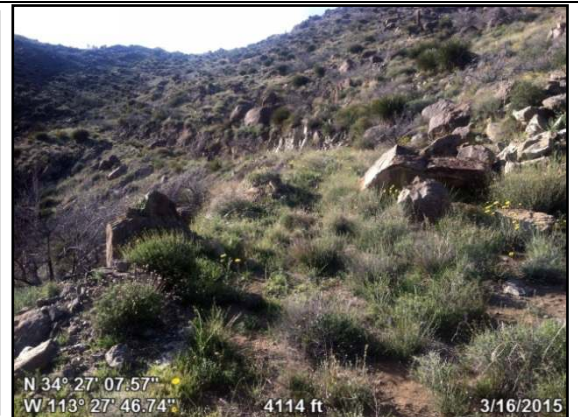
Title	Photopoint 072
Unit name	Poachie Range
Route name	Not Named
Determination	Reclaimed
Maintenance	None
Feature	Revegetated

Photopoint 072. This old primitive route is long gone.

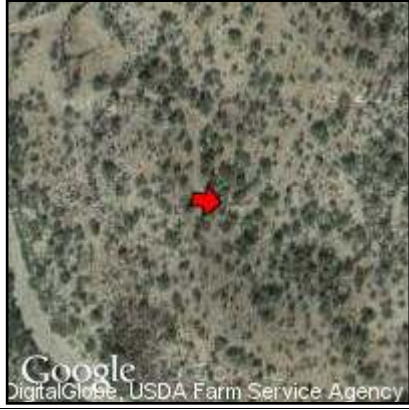
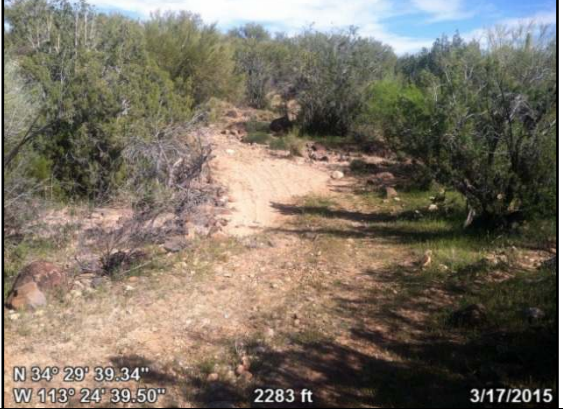
Attributes	
Title	Photopoint 076
Unit name	Poachie Range
Route name	Not Named
Determination	Way
Maintenance	None
Feature	Typical condition of Route/Way

Photopoint 076. Well vegetated surface. Boulders rolled into route.

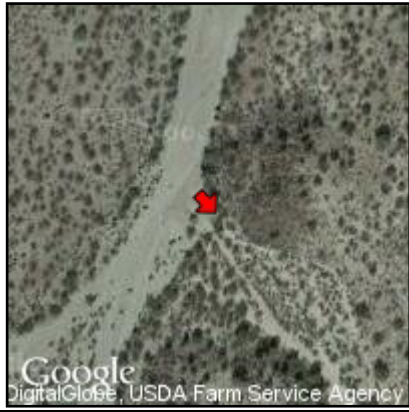
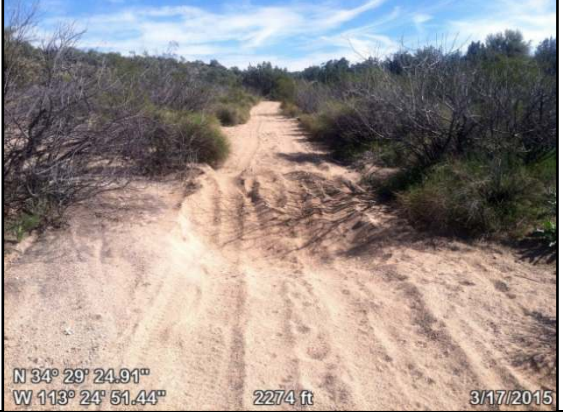
Attributes	
Title	Photopoint 078
Unit name	Poachie Range
Route name	Not Named
Determination	Way
Maintenance	None
Feature	Typical condition of Route/Way

Photopoint 078. This way is blockaded with boulders after 1/10th mile.

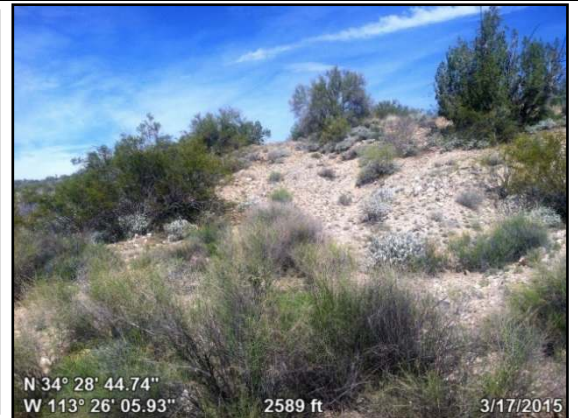
Title	Photopoint 079
Unit name	Poachie Range
Route name	Not Named
Determination	Way
Maintenance	None
Feature	Revegetated

Photopoint 079. This way has obviously been reclaimed and is naturalizing.

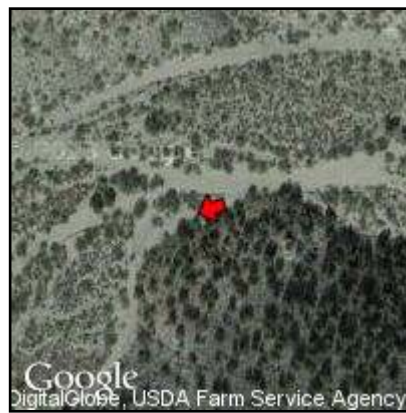
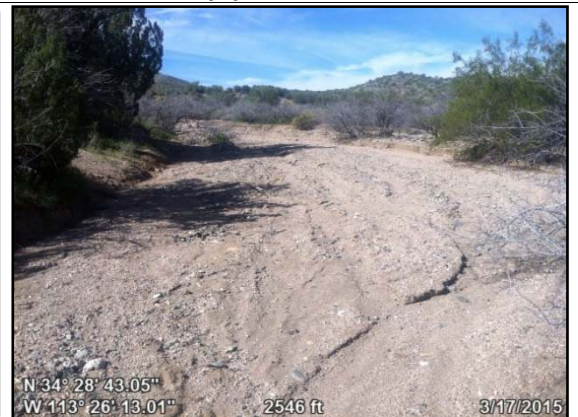
Title	Photopoint 080
Unit name	Poachie Range
Route name	Not named
Determination	Not a road or way
Maintenance	None
Feature	Just a wash

Photopoint 080. Not a route or way; just a wash.

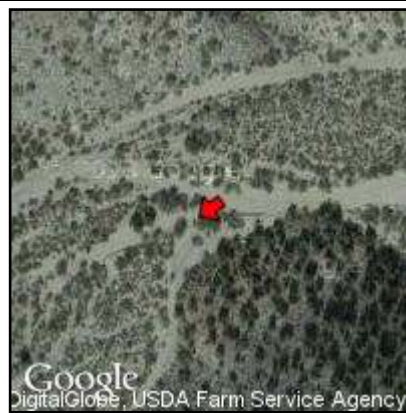
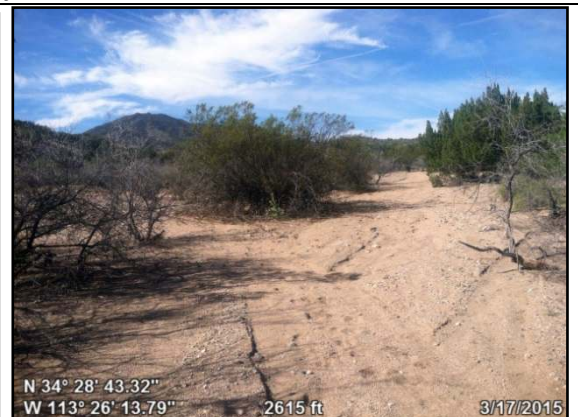
Title	Photopoint 081
Unit name	Poachie Range
Route name	Not named
Determination	Not a road or way
Maintenance	None
Feature	Just a wash

Photopoint 081. This is just a wash with no evidence of use.

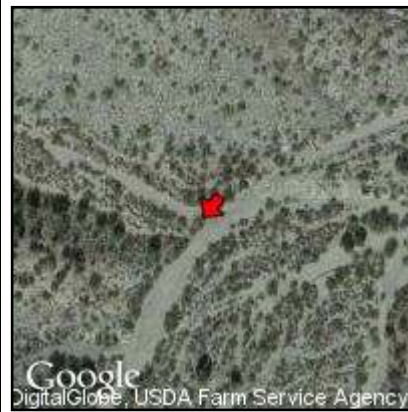
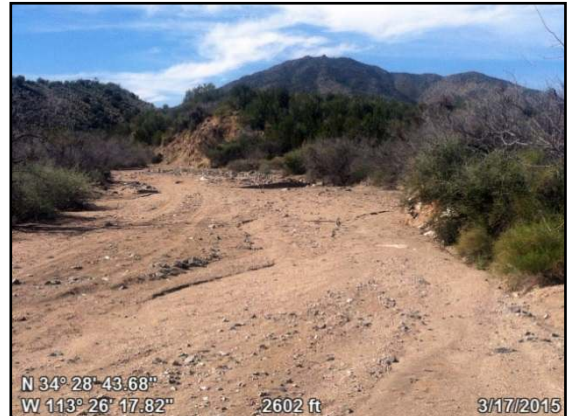
Attributes	
Title	Photopoint 082
Unit name	Poachie Range
Route name	Not Named
Determination	Way
Maintenance	None
Feature	Typical condition of Route/Way

Photopoint 082. Note that the radio tower and road on mountain in background are substantially unnoticeable to the average visitor and they do no impact the naturalness of the unit.

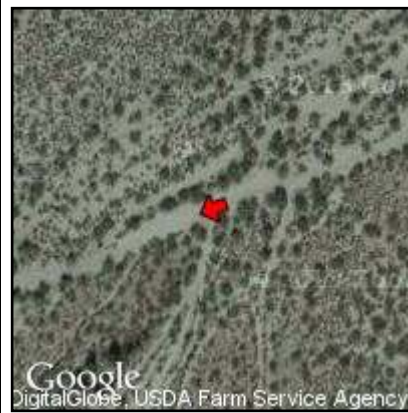
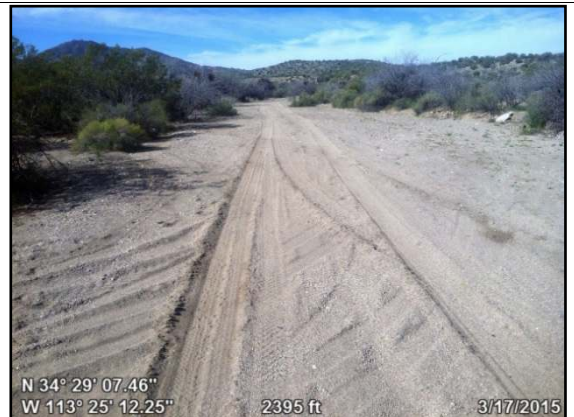
Attributes	
Title	Photopoint 083
Unit name	Poachie Range
Route name	BLM Route 7524
Determination	Way
Maintenance	None
Feature	Typical condition of Route/Way

Photopoint 083. A primitive route in a dry wash.

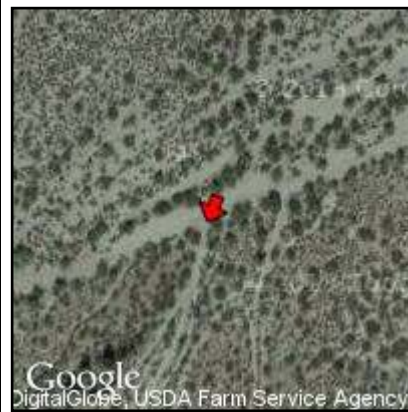
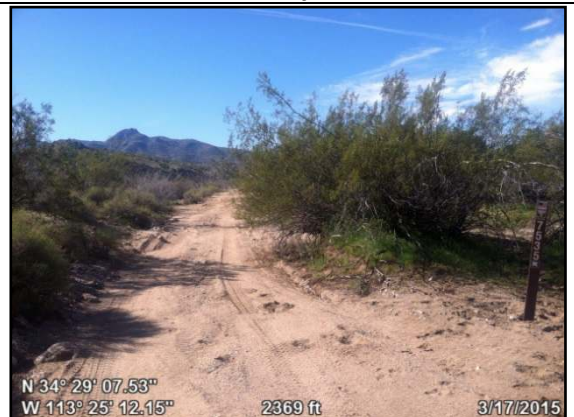
Attributes	
Title	Photopoint 084
Unit name	Poachie Range
Route name	BLM 7535
Determination	Way
Maintenance	None
Feature

Photopoint 084. An unmaintained way.

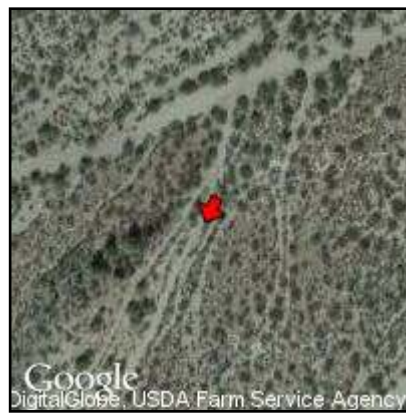
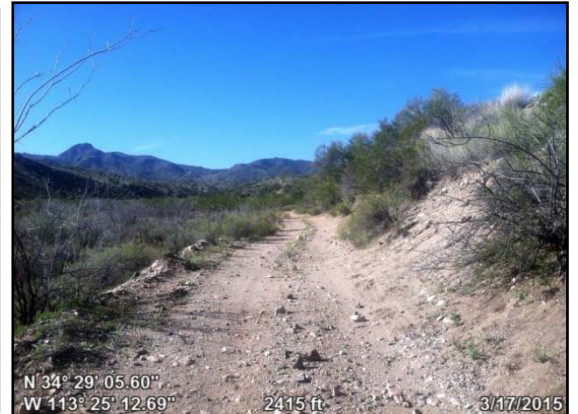
Title	Photopoint 085
Unit name	Poachie Range
Route name	BLM Route 7535C
Determination	Way
Maintenance	None
Feature	Good section of route

Photopoint 085. This primitive route leads to a spring.

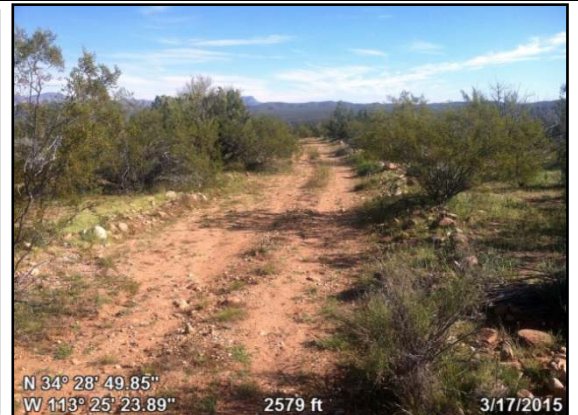
Title	Photopoint 086
Unit name	Poachie Range
Route name	BLM Route 7535
Determination	Way
Maintenance	None
Feature	Revegetating

Photopoint 086. Vegetation in way indicates a lack of maintenance.

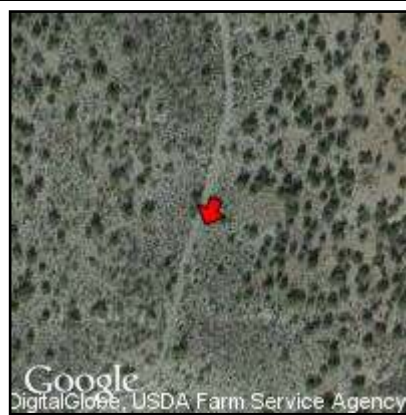
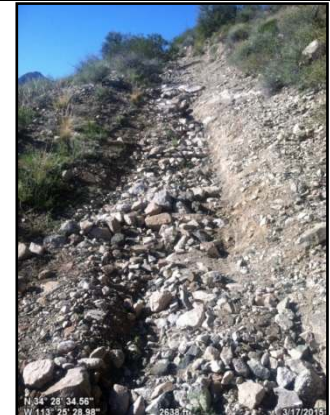
Title	Photopoint 087
Unit name	Poachie Range
Route name	BLM Route 7535
Determination	Way
Maintenance	None
Feature	Erosion

Photopoint 087. Extremely erosion makes this way impassable to most vehicles.

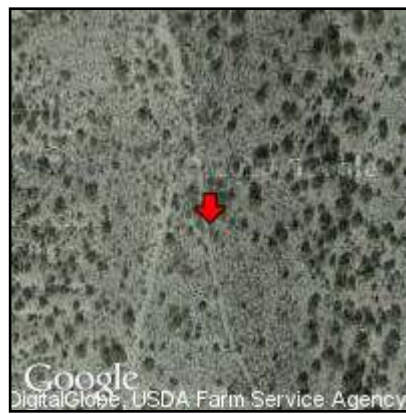
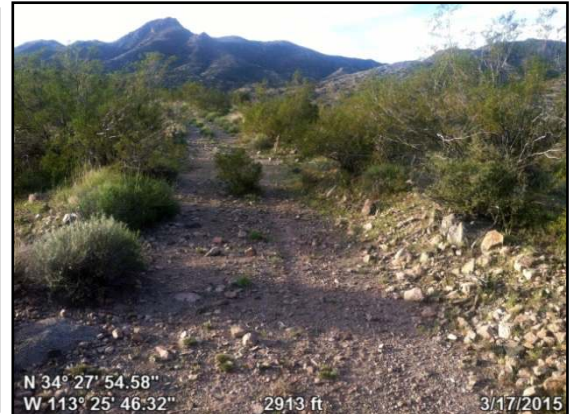
Title	Photopoint 091
Unit name	Poachie Range
Route name	BLM Route 7535
Determination	Way
Maintenance	None
Feature	Typical condition of Route/Way

Photopoint 091. This primitive route is clearly not being maintained.

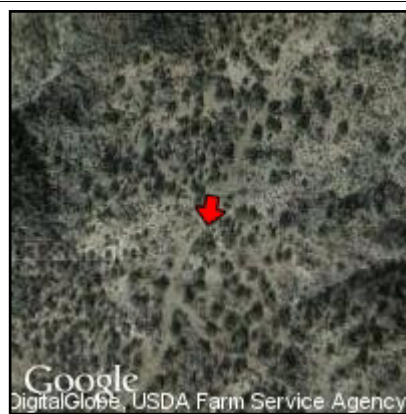
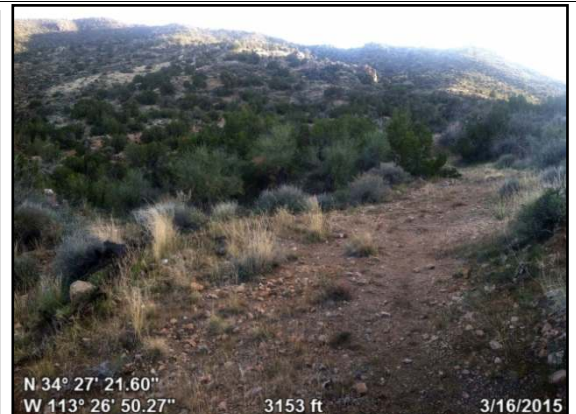
Title	Photopoint 092
Unit name	Poachie Range
Route name	Not Named
Determination	Reclaimed
Maintenance	None
Feature	Revegetated

Photopoint 092. Another unmaintained primitive route. These old mining roads make excellent trails for hiking and horseback riding.

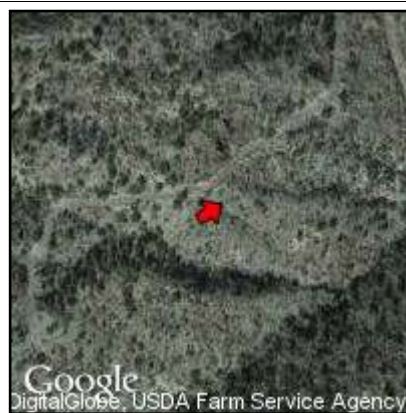
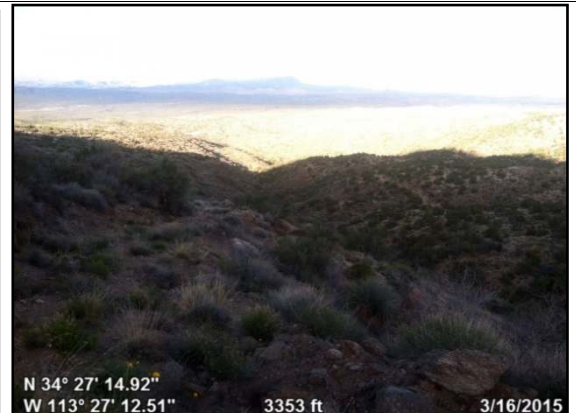
Title	Photopoint 093
Unit name	Poachie Range
Route name	Not Named
Determination	Reclaimed
Maintenance	None
Feature	Revegetated

Photopoint 093. The average visitor probably wouldn't even see evidence of this reclaimed way.

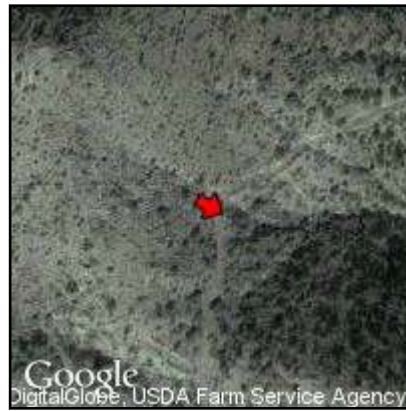
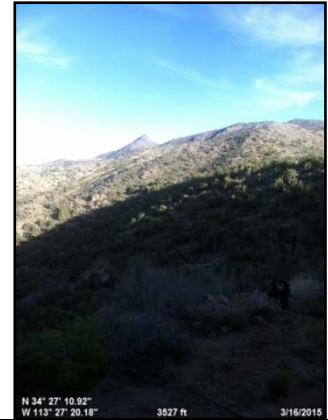
Title	Photopoint 094
Unit name	Poachie Range
Route name	Not Named
Determination	Reclaimed
Maintenance	None
Feature	Revegetated

Photopoint 094. This old primitive route has been reclaimed.

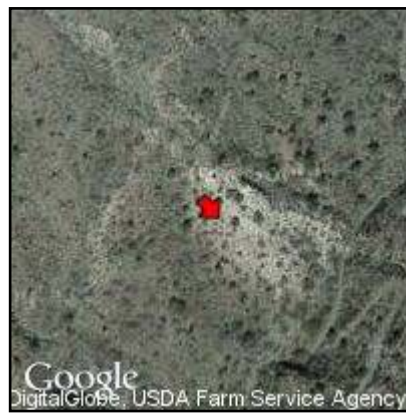
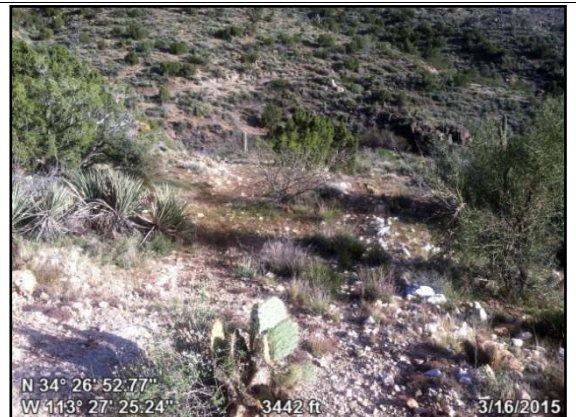
Title	Photopoint 095
Unit name	Poachie Range
Route name	Not Named
Determination	Reclaimed
Maintenance	None
Feature	Revegetated

Photopoint 095. This old way was reclaimed long ago, but is still easy to follow and provides a great path through the spiny desert vegetation.
