A proposal report the Bureau of Land Management, Kingman Field Office, Arizona

December 2017

Grand Wash Cliffs Unit Summary Map The 15,500-acre Grand Wash Cliffs proposed LWC straddles the western edge of the Colorado Plateau. Here, sheer cliffs of Cambrian, Devonian, and Mississippian sedimentary rocks, called the Grand Wash Cliffs, create roughly 1,000 feet of vertical relief in a short distance. Beneath these cliffs, ridges and foothills of Precambrian granitic rock extend into the landscape. The steep, rugged altitudinal gradient found here marks a transitional zone from Mohave Desert to higher elevation species assemblages. This transition forms an eco-tone, undoubtedly a biodiversity hotspot. Here, a backcountry recreationist can travel from warmer Mohave desert scrub, creosote-laden bajadas, up through granitic boulder-filled canyons, into a vast, sloping landscape of piñon-juniper, sagebrush-steppe, and interior chaparral ecosystems. The topographic and vegetative diversity of this unit creates outstanding opportunities for screening and thus solitude, and also for primitive and unconfined recreation in the forms of hunting, rock climbing, backpacking, horseback riding, a

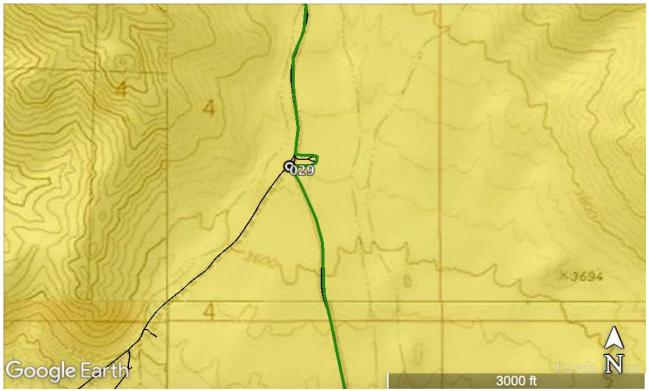
<u>Inset 1</u> – Point 029 shows a small exclusion. Here, a large metal tank is present. Instead of an access route, the entire area around the tank is disturbed and seems to be frequently used.

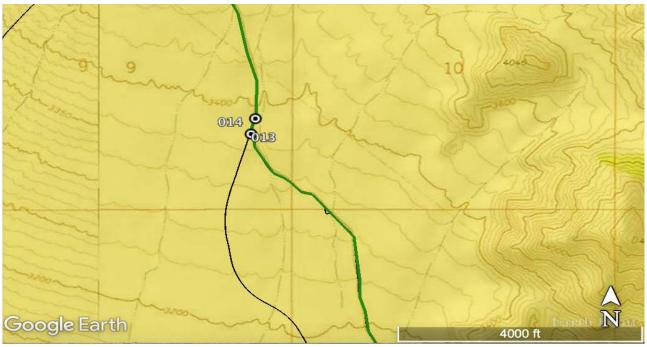
<u>Inset 2</u> – Points 013 and 014 show conditions of the unit boundary. Port 014 is of Tenny Ranch Road.

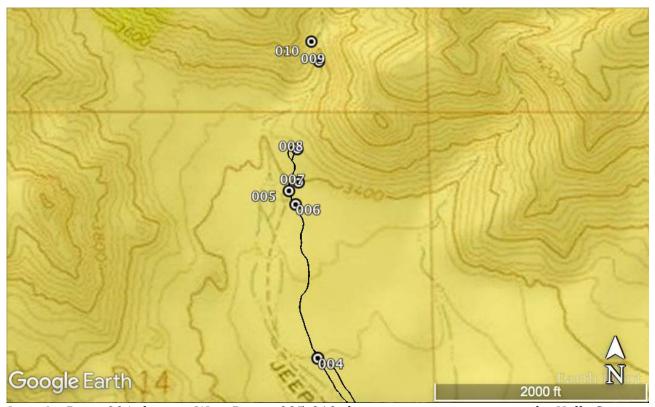
<u>Inset 3</u> – Point 004 shows a Way. Points 005-010 show impacts pertaining to the Hells Canyon Spring Development.

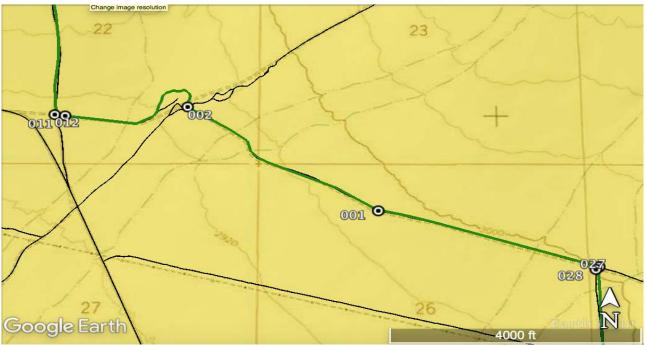
*Inset 4* – Points 011, 012, 001, and 028 show the conditions of the unit boundary. Points 002 and 027 shows primitive ways.

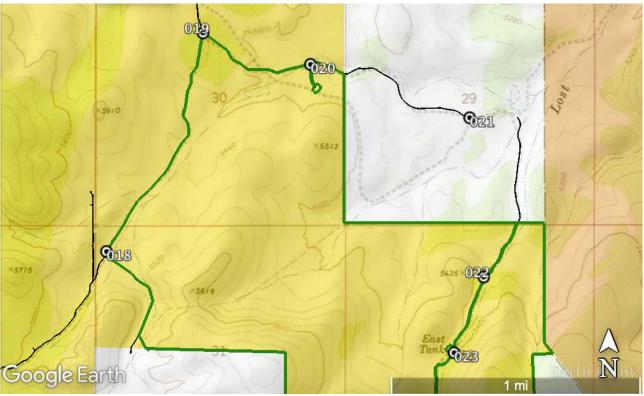
$\underline{\mathit{Inset 5}}$  – Points 018 and 019 show the conditions of the unit boundary. Point 021 shows a locked gate which bars public access to the cherrystem shown at points 022 and 023. Point 020 shows another cherrystem.

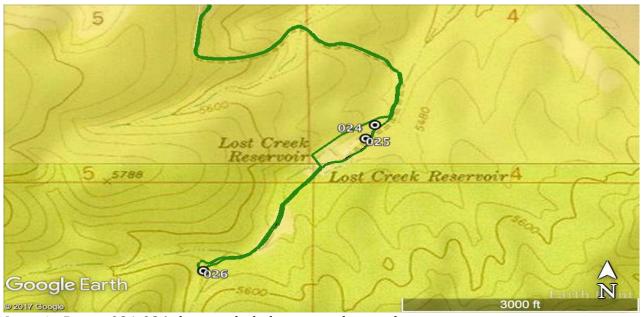
*Inset 6* – Points 024-026 show excluded impacts along a cherrystem.

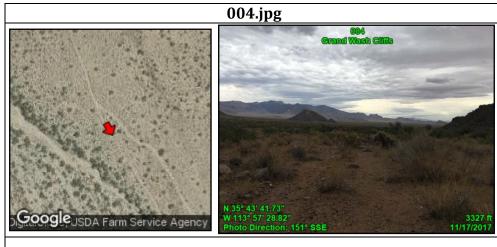
- **003** again shows the condition of the Way.
    - 005 shows large vegetation growing in the Way, indicating lack of maintenance.
    - **008** shows the end of the Way. It ends at the mouth of Hell's Canyon and turns around. This section of the route is completely covered in grass, which indicates a lack of maintenance.

Attributes		
Point	005	
Unit name	Grand Wash Cliffs	
Route: name	None	
Route:	Minimal evidence	
Construction	of blading	
Route:	None	
Improvements		
Route: Use	2-WD Vehicles	
	No exisiting	
	purpose; accesses	
Route: Purpose	dilapidated,	
	unused ranching	
	infastructure	
Route:	Way	
Determination		
	Kept open solely	
Other notes	by passage of	
	vehicles	
Route:	None	
Maintenance		
Feature	Overgrown	
reature	vegetation	
Feature notes	None	
Feature Class	None

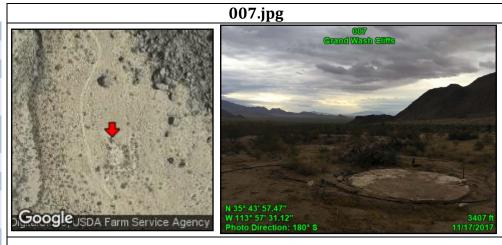
Attributes		
Point	800	
Unit name	<b>Grand Wash Cliffs</b>	
Route: name	None	
Route:	Minimal evidence	
Construction	of blading	
Route:	None	
Improvements		
Route: Use	2-WD Vehicles	
	No existing	
	purpose; accesses	
Route: Purpose	dilapidated,	
•	unused ranching	
	infastructure	
Route:	Way	
Determination		
	Kept open solely	
Other notes	by passage of	
	vehicles	
Route:	None	
Maintenance		
Feature	End of	
1 cature	route/turnaround	
-	NI	
Feature notes	None

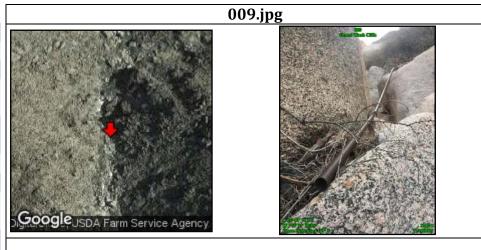
Attributes		
Point	010	
Unit name	<b>Grand Wash Cliffs</b>	
Route: name	N/A	
Route:	N/A	
Construction		
Route:	N/A	
Improvements		
Route: Use	N/A	
Route: Purpose	N/A	
Route:	N/A	
Determination		
Other notes	Well is disconnected from piping and laden with sediment	
Route:	N/A	
Maintenance		
Feature	Hell's Canyon Well	
Feature notes	Feature minimally affects naturalness

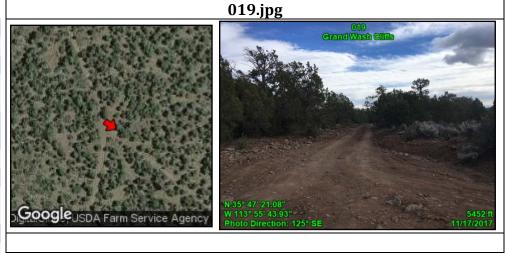
- **019** shows the condition of a wilderness inventory road at an intersection with Tenny Ranch Road.
- **020** shows the condition of a cherrystem road leading to a maintained water cistern. The water cistern is included in the cherrystem.

Attributes		
Point	020	
Unit name	<b>Grand Wash Cliffs</b>	
Route: name	None	
Route:	Bladed	
Construction		
Route:	None	
Improvements		
Route: Use	2-WD Vehicles	
Pouto Durnoco	Water cistern	
Route: Purpose	access	
Route:	Road	
Determination		
Other notes	Cherrystem	
Route:	Old evidence - 3-5

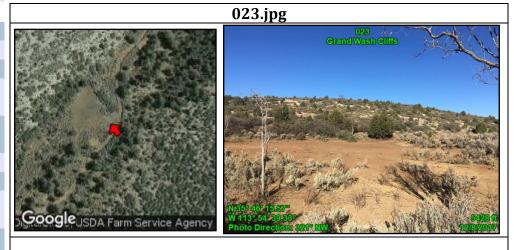
Attributes		
Point	024	
Unit name	<b>Grand Wash Cliffs</b>	
Route: name	N/A	
Route:	N/A	
Construction		
Route:	N/A	
Improvements		
Route: Use	N/A	
Route: Purpose	N/A	
Route:	N/A	
Determination		
Other notes	Fed by Lost Tank	
Route:	N/A	
Maintenance		
Feature	Water cistern	
Feature notes	None

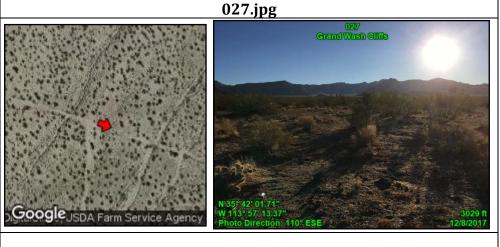
- **028** shows the condition of a wilderness inventory road and a maintained cistern which is excluded from the unit.
  - The road continues south until it meets power lines with an east/west vector, which then become the unit boundary.

#### **Attributes** Point 028 Unit name **Grand Wash Cliffs** None Route: name Route: Bladed Construction None Route: **Improvements** 2-WD Vehicles Route: Use Route: Purpose Multiple uses Road Route: Determination **Unit Boundary** Other notes Old evidence - 3-5 Route: Maintenance years ago Typical Condition

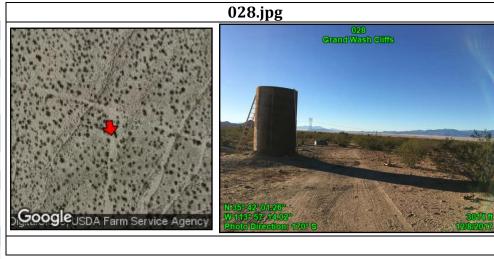
- **012-013** show the condition a unit boundary wilderness inventory road.
- **014-015** show the condition of Tenny Ranch Road, a wilderness inventory road.
- **029** shows an exclusion. A massive metal tank is here and some sort of livestock watering feature. The whole ground surface is impacted, showing signs of recent use. Instead of cherrysteming the KFO Route Inventory data shown here, a wider exclusion was included in the unit boundary because a greater area than the width of road is being utilized.

Attri	butes
Point	029
Unit name	<b>Grand Wash Cliffs</b>
Route: name	N/A
Route:	N/A
Construction	
Route:	N/A
Improvements	
Route: Use	N/A
Route: Purpose	N/A
Route:	N/A
Determination	
Other notes	Exclude this
other notes	impact
Route:	N/A
Maintenance	
Feature	Water cistern/
reacure	ranching impacts
Feature notes	None
Feature Class	<b>Boundary Element</b>
Feature Class	Boundary Element
