A proposal report to the Bureau of Land Management, Kingman Field Office, Arizona

January 2018

Music Mountains North and South Proposed LWCs

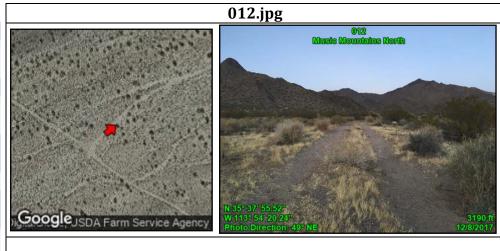
Attributes		
Point	013	
Unit name	Music Mountains North	
Route: name	N/A	
Route:	N/A	
Construction		
Route:	N/A	
Improvements		
Route: Use	N/A	
Route: Purpose	N/A	
Route:	N/A	
Determination		
Other notes	Linear path of PVC Survey Markers on agency land, in between ends of private land	
Route:	N/A	
Maintenance		
Feature	PVC Survey Markers (4 ft. tall)	
Feature notes	None	
Feature Class	Impact: Excluded

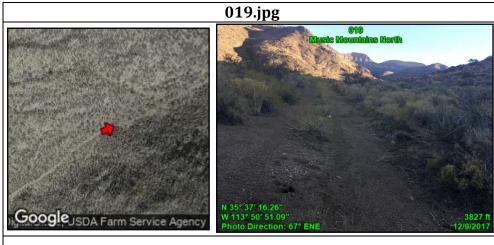
Attributes		
Point	020	
Unit name	Music Mountains	
	North	
Route: name	None	
Route:	Bladed	
Construction		
Route:	None	
Improvements		
Route: Use	No sign observed	
Route: Purpose	No apparent	
rtoute. Turpose	purpose	
Route:	Way	
Determination		
Other notes	None	
Route:	None	
Maintenance		
Feature	End of route:	
1 catal c	nothing here	
	"Dry Well" noted	
Feature notes	on USGS Quad is	
	missing	
Feature Class	Primitive Route

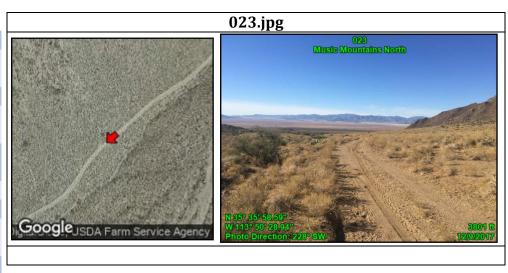
Attributes	
Point	024
Unit name	Music Mountains North
Route: name	None
Route:	Bladed
Construction	
Route:	None
Improvements	
Route: Use	2-WD Vehicles
Route: Purpose	Henifin Ranch access
Route:	Road
Determination	
Other notes	Cherrystem
Route:	Very recent blade -
Maintenance	past year
Feature	Typical Condition of Route
Feature notes	None
Feature Class	Boundary Element

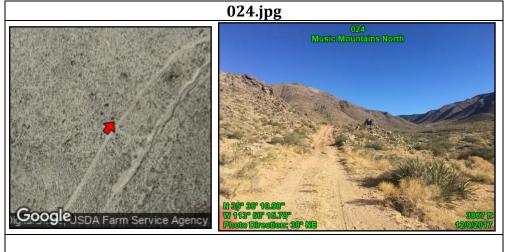
Attributes		
Point	025	
Unit name	Music Mountains North	
Route: name	N/A	
Route:	N/A	
Construction		
Route:	N/A	
Improvements		
Route: Use	N/A	
Route: Purpose	N/A	
Route:	N/A	
Determination		
Other notes	Cherrystem	
Route:	N/A	
Maintenance	·	
Feature	Corral, Windmill, Livestock watering	
Feature notes	Henefin Ranch (noted on USGS

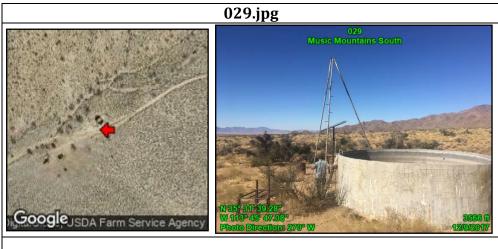
Attri	butes
Point	030
Unit name	Music Mountains South
Route: name	None
Route: Construction	Bladed. However, this photo shows a user-created reroute.
Route:	None
Improvements	
Route: Use	4-WD Trucks
Route: Purpose	No apparent purpose
Route:	Way
Determination	
Other notes	Kept open solely by passage of vehicles
Route:	None
Maintenance	
Feature	Typical Condition of Route
Feature notes	Feature minimally affects naturalness
Feature Class	Primitive Route

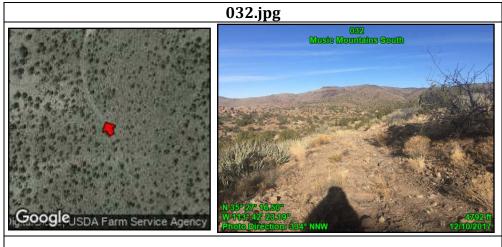
- **032** shows a wilderness inventory road which accesses private land.
- **033-035** show the condition of a wilderness inventory road.
- **036** shows "Upper Grapevine Spring". It is sediment laden and non-functional, although existing in what appears to be a perennial stream. It is substantially

Attributes	
Point	033
Unit name	Music Mountains South
Route: name	None
Route:	Bladed
Construction	
Route:	None
Improvements	
Route: Use	2-WD Vehicles
Route: Purpose	Multiple uses
Route:	Road
Determination	
Other notes	Unit Boundary
Route:	Old evidence - 3-5
Maintenance	years ago
Feature	Typical Condition of Route
Feature notes	None
Feature Class	Boundary Element

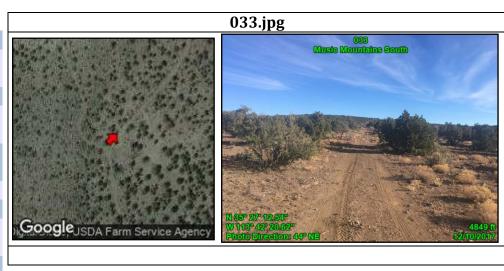
Attributes		
Point	034	
Unit name	Music Mountains South	
Route: name	None	
Route:	Bladed	
Construction		
Route:	None	
Improvements		
Route: Use	2-WD Vehicles	
Route: Purpose	Multiple uses	
Route:	Road	
Determination		
Other notes	Unit Boundary	
Route:	Old evidence - 3 - 5	
Maintenance	years ago	
Feature	Typical Condition of Route	
Feature notes	None	
Feature Class	Boundary Element

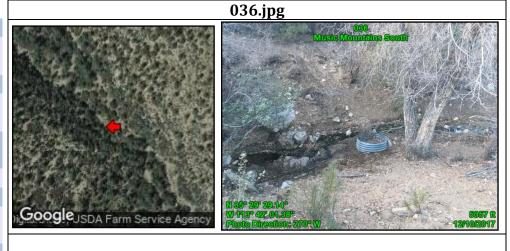
- unnoticeable because it is small in stature, hidden in vegetation, and sheltered by topography.
- **037-038** shows the condition of a primitive way with no apparent purpose. It is unmaintained, overgrown, and slightly eroded. It is kept open solely by the passage of vehicles. It minimally effects naturalness.

Point 037 Unit name Music Mountains South Route: name None Route: No evidence/user- Construction created Route: None Improvements Route: Use Misc. Off Road Vehicles Route: Purpose No apparent purpose Route: Way Determination Kept open solely by passage of vehicles Route: None Maintenance Feature Typical Condition of Route Feature Class Primitive Route	Attri	butes
Unit name Route: name Route: No evidence/user- Construction created Route: None Improvements Route: Use Route: Purpose Route: Way Determination Kept open solely by passage of vehicles Route: None Misc. Off Road Vehicles No apparent purpose Way Determination Kept open solely by passage of vehicles Route: None Maintenance Feature Typical Condition of Route Overgrown vegetation	Point	037
Route: No evidence/user- Construction created Route: None Improvements Route: Use Misc. Off Road Vehicles Route: Purpose No apparent purpose Route: Way Determination Kept open solely by passage of vehicles Route: None Maintenance Feature Typical Condition of Route Overgrown vegetation	Unit name

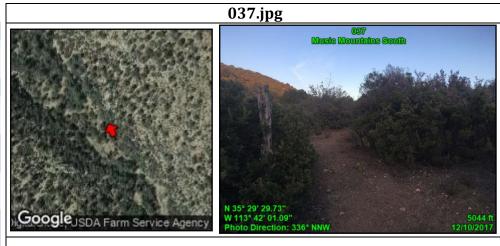
Attri	Attributes	
Point	038	
Unit name	Music Mountains South	
Route: name	None	
Route:	No evidence/user-	
Construction	created	
Route:	None	
Improvements		
Route: Use	Misc. Off Road Vehicles	
Route: Purpose	No apparent purpose	
Route:	Way	
Determination	-	
Other notes	Kept open solely by passage of vehicles	
Route:	None	
Maintenance		
Feature	Typical Condition of Route	
Feature notes	None	
Feature Class	Primitive Route

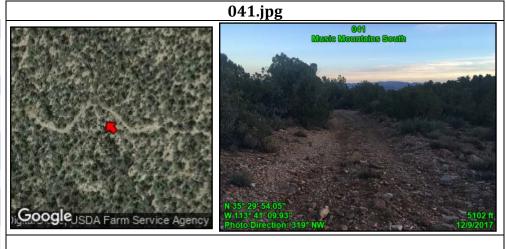
- **039-040** show the condition of a wilderness inventory road.
- **041-042** show a short cherrystem which excludes a functional spring development and it's associated access route.

Attributes		
Point	042	
Unit name	Music Mountains South	
Route: name	N/A	
Route:	N/A	
Construction		
Route:	N/A	
Improvements		
Route: Use	N/A	
Route: Purpose	N/A	
Route:	N/A	
Determination		
Other notes	Cherrystem	
Route:	N/A	
Maintenance		
Feature	Developed spring	
Feature notes	Functioning	
Feature Class	Impact: Excluded

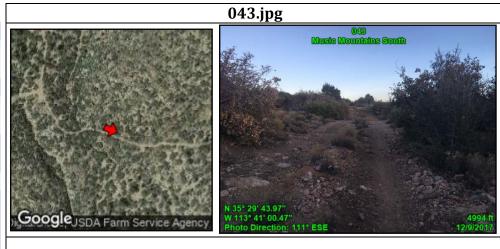
- **043-044** show the condition of a wilderness inventory road.
- **045-046** show a short cherrystem which excludes a weather system titled "Mohave Weather System Flat Rock Springs" and its associated access route.

Attri	butes
Point	044
Unit name	Music Mountains South
Route: name	None
Route:	Bladed
Construction	
Route:	None
Improvements	
Route: Use	4-WD Trucks
	Multiple uses
	(Connects major
Route: Purpose	routes, private
	land access, spring
	access)
Route:	Road
Determination	
	Kept open solely
Other notes	by passage of
	vehicles
Route:	Likely if needed
Maintenance	
Feature	Typical Condition
1 catal c	of Route
Feature notes	None
Feature Class	Boundary Element

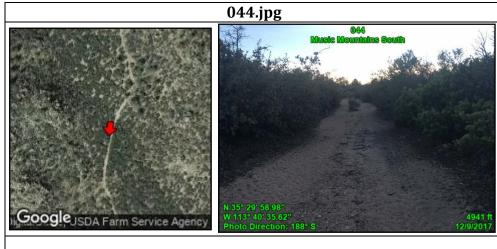
Attri	butes
Point	045
Unit name	Music Mountains South
Route: name	None
Route:	Bladed
Construction	
Route:	None
Improvements	
Route: Use	4x4 Trucks
Route: Purpose	Accesses Mohave Weather System "Flat Rock Springs"
Route:	Road
Determination	
Other notes	Cherrystem
Route:	None
Maintenance	
Feature	Typical Condition of Route
Feature notes	Rough road
Feature Class	Impact: Excluded

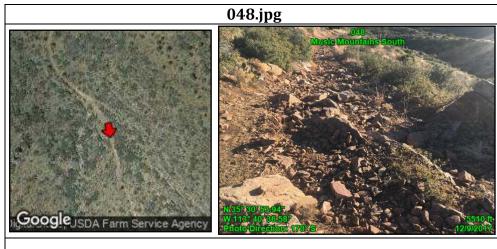
Attri	butes
Point	049
Unit name	Music Mountains
	South
Route: name	None
Route:	Bladed
Construction	
Route:	None
Improvements	
Route: Use	Misc. Off Road
Route. Use	Vehicles
Douter Durness	No apparent
Route: Purpose	purpose
Route:	Way
Determination	
Other notes	Route ends at Hualapai Indian Reservation border fence, kept open solely by passage of vehicles
Route:	None
Maintenance	
Feature	Typical Condition of Route
Feature notes	Overgrown route
Feature Class	Primitive Route

- 049-050 show the condition of the primitive way atop the slopes, within flatter, basalt-laded terrain. Here, it is clearly unmaintained and shows little evidence of construction. It minimally affects naturalness.

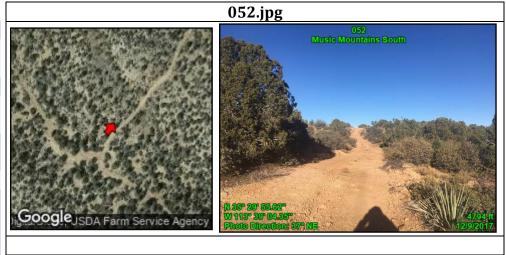
- **051** shows the condition of a wilderness inventory road.
- **052-053** show a cherrystem which excludes a windmill/well and its associated access route.

Attri	butes
Point	053
Unit name	Music Mountains South
Route: name	N/A
Route:	N/A
Construction	
Route:	N/A
Improvements	
Route: Use	N/A
Route: Purpose	N/A
Route:	N/A
Determination	
Other notes	Cherrystem
Route:	N/A
Maintenance	
Cashiira	Windmill/Well, Livestock
Feature	watering, and Blown-out stockpond
Feature notes	None

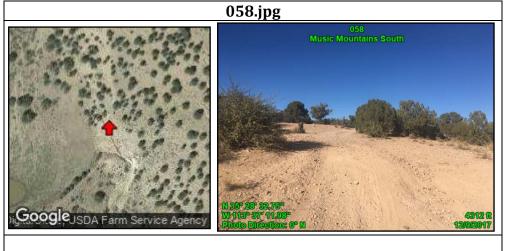
Attri	butes	
Point	059	
Unit name	Music Mountains South	
Route: name	None	
Route:	No evidence/user-	
Construction	created	
Route:	None	
Improvements		
Route: Use	4-WD Trucks	
Route: Purpose	No apparent purpose	
Route:	Way	
Determination		
Other notes	Kept open solely by passage of vehicles	
Route:	None	
Maintenance		
Feature	Typical Condition of Route	
Feature notes	Feature minimally affects naturalness	
Feature Class	Primitive Route

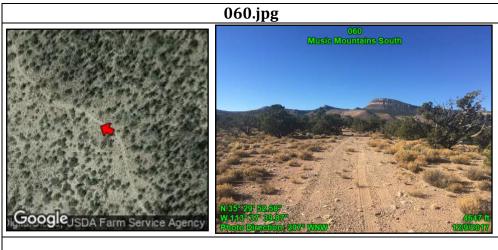
Attri	butes
Point	061
Unit name	Music Mountains South
Route: name	None
Route:	No evidence/user-
Construction	created
Route:	None
Improvements	
Route: Use	4-WD Trucks
Dauta, Durmaga	No apparent
Route: Purpose	purpose
Route:	Way
Determination	
	Kept open solely
Other notes	by passage of
	vehicles
Route:	None
Maintenance	
Feature	Typical Condition
reature	of Route
Feature notes	None
Feature Class	Primitive Route

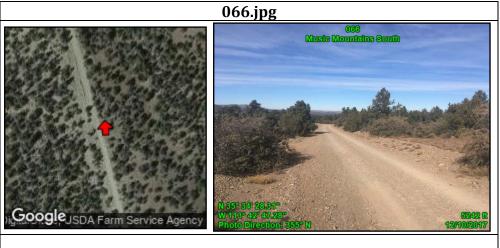
Attributes		
Point	067	
Unit name	Music Mountains South	
Route: name	None	
Route:	Bladed	
Construction		
Route:	None	
Improvements		
Route: Use	No sign observed	
Doute, Dumogo	No apparent	
Route: Purpose	purpose	
Route:	Way	
Determination		
Other notes	Not passable	
Route:	None	
Maintenance		
Feature	Typical Condition	
reature	of Route	
Feature notes	None	
Feature Class	Primitive Route

- **066** shows the condition of a major wilderness inventory route that accesses private and state lands, it is a boundary element.
- **067** shows a revegetated, unmaintained way with no purpose. It is substantially unnoticeable.
- **068-069** show a route which accesses private land; it is the unit boundary for both proposed LWCs. This route shows evidence of construction but shows no evidence of maintenance. However, it is likely to be maintained when need be, because it accesses private land.
 - This route continues (070-071) beyond the private land as a primitive way, where it becomes increasing faint and most importantly without purpose. It minimally affects naturalness.

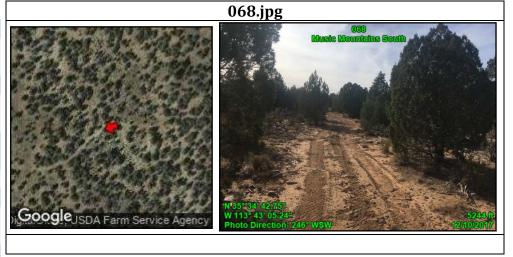
Attri	butes
Point	069
Unit name	Music Mountains South
Route: name	None
Route:	Bladed
Construction	
Route:	None
Improvements	
Route: Use	4-WD Trucks
Route: Purpose	Private land access
Route:	Road
Determination	
Other notes	Non
Route:	Likely if needed
Maintenance	
Feature	Typical Condition of Route
	Condition
Feature notes	deteriorates
	approaching
	private land
Feature Class	Primitive Route

Inset 5: Points 066-076; showing boundary elements and primitive ways in both proposed LWCs. Points 072-73 show a cherrystem leading to used, maintained stockpond. Points 068-69 show the unit boundary, which is an access route to private land. This route continues past the private land onto BLM land where it no longer serves an apparent purpose and is unmaintained.

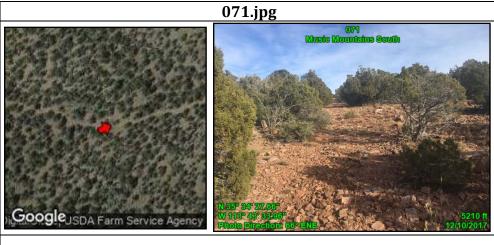
Attri	ibutes
Point	071
Unit name	Music Mountains South
Route: name	None
Route:	Bladed
Construction	
Route:	None
Improvements	
Route: Use	4-WD Trucks
Route: Purpose	No apparent purpose
Route:	Way
Determination	
Other notes	None
Route:	None
Maintenance	
Feature	Typical Condition of Route
Feature notes	None
Feature Class	Primitive Route

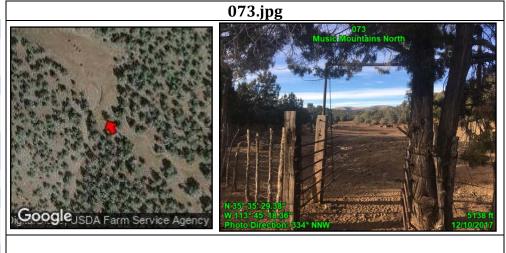
Attributes		
Point	073	
Unit name	Music Mountains North	
Route: name	N/A	
Route:	N/A	
Construction		
Route:	N/A	
Improvements		
Route: Use	N/A	
Route: Purpose	N/A	
Route:	N/A	
Determination		
Other notes	Exclude this impact	
Route:	N/A	
Maintenance		
Feature	Stockpond	
Feature notes	Used and maintained	
Feature Class	Impact: Excluded

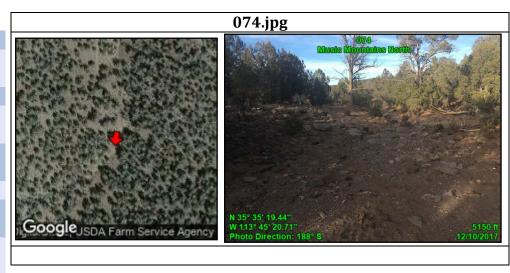
Attributes		
Point	074	
Unit name	Music Mountains North	
Route: name	None	
Route:	Bladed	
Construction		
Route:	None	
Improvements		
Route: Use	4-WD Trucks	
Route: Purpose	No apparent purpose	
Route:	Way	
Determination	-	
Other notes	None	
Route:	None	
Maintenance		
Feature	Typical Condition of Route	
Feature notes	None	
Feature Class	Primitive Route

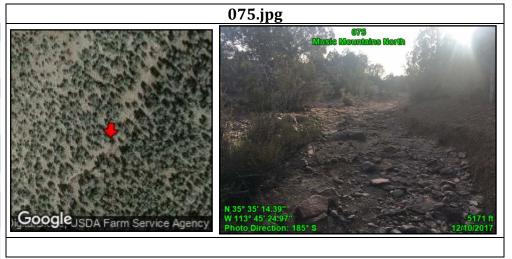
Attributes		
Point	075	
Unit name	Music Mountains North	
Route: name	None	
Route:	Bladed	
Construction		
Route:	None	
Improvements		
Route: Use	4-WD Trucks	
Route: Purpose	No apparent purpose	
Route:	Way	
Determination		
Other notes	Impassable	
Route:	None	
Maintenance		
Feature	Erosion	
Feature notes	None	
Feature Class	Primitive Route

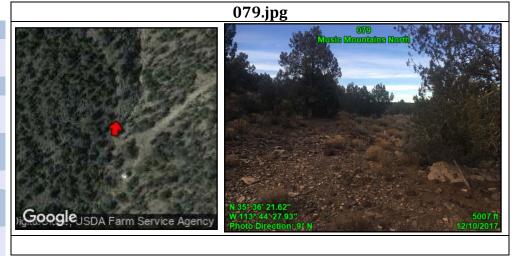
Attributes		
Point	079	
Unit name	Music Mountains North	
Route: name	None	
Route:	Bladed	
Construction		
Route:	None	
Improvements		
Route: Use	No sign observed	
Route: Purpose	No apparent purpose	
Route:	Reclaimed &	
Determination	unused	
Other notes	None	
Route:	None	
Maintenance		
Feature	Typical Condition of Route	
Feature notes	Revegetated	
Feature Class	Primitive Route

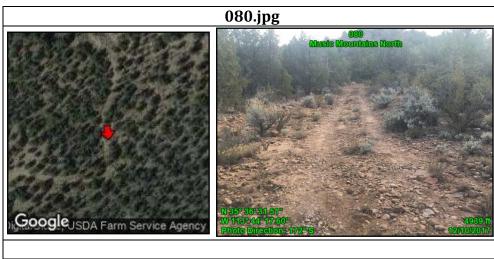
Attributes		
Point	080	
Unit name	Music Mountains North	
Route: name	None	
Route:	Bladed	
Construction		
Route:	None	
Improvements		
Route: Use	4-WD Trucks	
Route: Purpose	Multiple uses	
Route:	Road	
Determination		
Other notes	Unit Boundary	
Route:	Likely if needed	
Maintenance		
Feature	Typical Condition of Route	
Feature notes	None	
Feature Class	Boundary Element

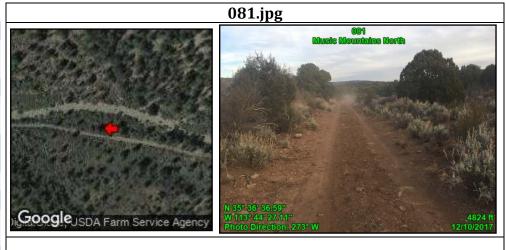
Attributes		
Point	081	
Unit name	Music Mountains North	
Route: name	None	
Route:	Bladed	
Construction		
Route:	None	
Improvements		
Route: Use	2-WD Vehicles	
Route: Purpose	Multiple uses	
Route:	Road	
Determination		
Other notes	None	
Route:	Old evidence - 3-5	
Maintenance	years ago	
Feature	Typical Condition of Route	
Feature notes	None	
Feature Class	Boundary Element

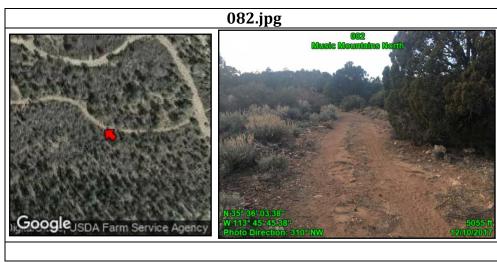
Attributes		
Point	082	
Unit name	Music Mountains North	
Route: name	None	
Route:	Bladed	
Construction		
Route:	None	
Improvements		
Route: Use	4-WD Trucks	
Route: Purpose	Multiple uses	
Route:	Road	
Determination		
Other notes	None	
Route:	Old evidence - 3 - 5	
Maintenance	years ago	
Feature	Typical Condition of Route	
Feature notes	None	
Feature Class	Boundary Element

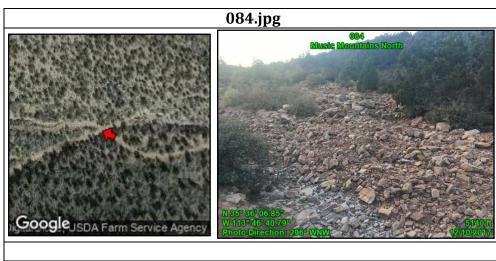
Attributes		
Point	084	
Unit name	Music Mountains North	
Route: name	None	
Route:	Bladed	
Construction		
Route:	None	
Improvements		
Route: Use	No sign observed	
Route: Purpose	Stockpond access	
Route:	Way	
Determination		
Other notes	Impassable	
Route:	None	
Maintenance		
Feature	Erosion	
Feature notes	None	
Feature Class	Boundary Element

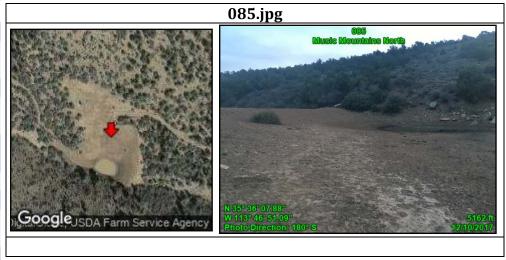
Attributes		
Point	085	
Unit name	Music Mountains North	
Route: name	N/A	
Route:	N/A	
Construction		
Route:	N/A	
Improvements		
Route: Use	N/A	
Route: Purpose	N/A	
Route:	N/A	
Determination		
Other notes	None	
Route:	N/A	
Maintenance		
Feature	Stockpond	
Feature notes	None	
Feature Class	Impact: Acceptable

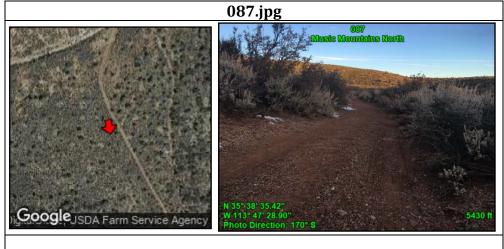
Attributes		
Point	087	
Unit name	Music Mountains North	
Route: name	None	
Route:	Bladed	
Construction		
Route:	None	
Improvements		
Route: Use	4x4 Trucks	
Route: Purpose	Multiple uses	
Route:	Road	
Determination		
Other notes	Unit Boundary	
Route:	Likely if needed	
Maintenance		
Feature	Typical Condition of Route	
Feature notes	None	
Feature Class	Boundary Element

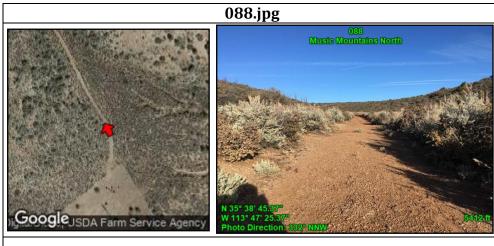
Attributes		
Point	088	
Unit name	Music Mountains North	
Route: name	None	
Route:	Bladed	
Construction		
Route:	None	
Improvements		
Route: Use	4x4 Trucks	
Route: Purpose	private land access	
Route:	Road	
Determination		
Other notes	Unit Boundary	
Route:	Likely if needed	
Maintenance		
Feature	Typical Condition of Route	
Feature notes	None	
Feature Class	Boundary Element
